SERVICE BULLETIN

Service Bulletin No. 645 Engineering Aspects are FAA Approved

SUBJECT: Small End Connecting Rod Bushing Inspection

MODELS AFFECTED: Engines with a serial number listed in Table 1 of this Service Bulletin

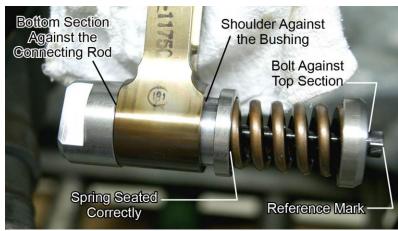
Figure 7
ST-531 Correctly Installed in the Connecting Rod

- The bottom section of the tool is in contact with the connecting rod
- The shoulder of the center section of the tool is in contact with the connecting rod bushing
- The head of the bolt is in contact with the top section of the tool
- The spring is seated correctly in the tool as shown in Figure 7. Figure 8 shows **incorrect** seating of the spring.

- 6. Use a marker to make a reference mark on the bolt head (Figure 7) to ensure an accurate count of the required number of turns during the procedure.
- 7. Measure the distance from the collar on the center section of the ST-531 to the edge of the connecting rod (Figure 9).

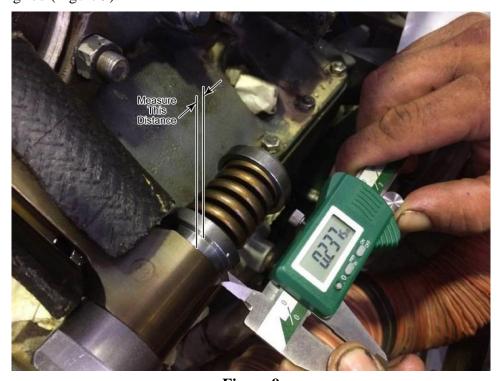
Figure 9
Measure this Distance with the Bolt Finger-Tight

- 9. Re-measure the distance from the collar on the center section of the ST-531 to the edge of the connecting rod (Figure 9).
- 10. If the collar to connecting rod measurement has changed after turning the bolt six full turns, the connecting rod bushing has moved.

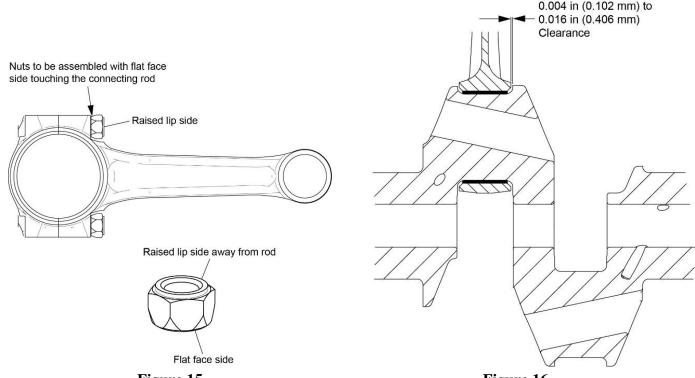
Figure 15
Connecting Rod Nut Installation

ENSURE THE NEW NUT ON EACH NEW CONNECTING ROD BOLT IS INSTALLED CORRECTLY. EACH CONNECTING ROD NUT HAS TWO DIFFERENT SURFACES, ONE SURFACE IS FLAT AND THE OTHER HAS A RAISED LIP. BE SURE TO INSTALL EACH NUT ON THE CONNECTING ROD BOLT WITH THE FLAT FACE TOUCHING THE ROD. THE RAISED LIP SURFACE IS AWAY FROM THE ROD. THE CONNECTING ROD BOLT CANNOT BE TIGHTENED CORRECTLY IF THE NUT ON THE CONNECTING ROD IS INSTALLED INCORRECTLY.

- 10. Install the connecting rod on the crank pin journal aligned with the connecting rod cap.
- 11. Install a new nut on each new connecting rod bolt where the flat face of the nut touches the connecting rod as shown in Figure 15.
