SERVICE BULLETIN

DATE: August 31, 2005 Service Bulletin No. 548A
(Supersedes Service Bulletin No. 548)

SUBJECT: Diaphragm-Type Fuel Pump Inspection/Replacement

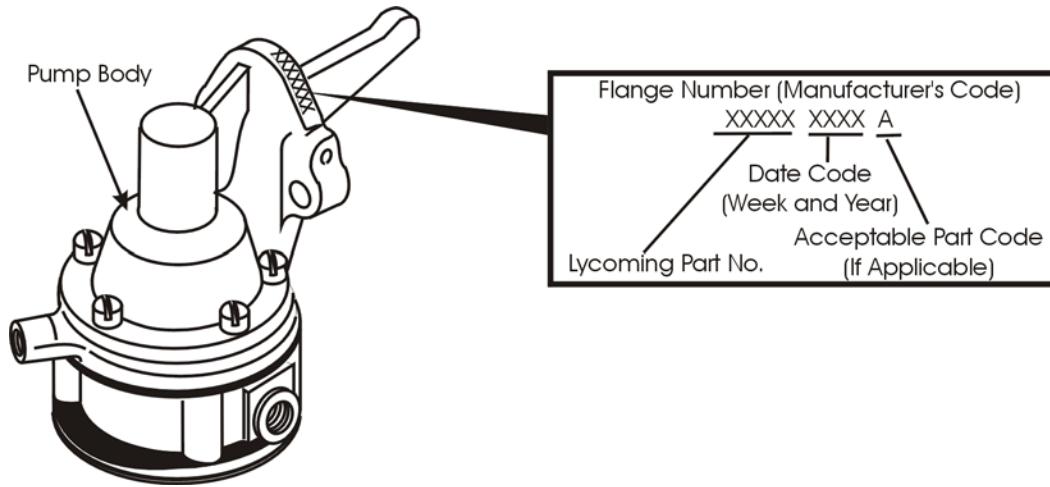
Figure 1

To identify affected pumps, check the manufacturer's code scribed on the flange of the pump (See Figure 1). If the first five digits are 15399, 15472, 15473, or 16335, and the 6th through 9th digits are 0700, 0800, 1100, 1200, 1300, 1400, 1500, 1600, 1800, 2000, 2100, 2200, 2300, 2400, 2800, 2900, 3000, 3100, 3200, 3300, 3400, 3500, 3600, 3700, 3800, 3900, 4000, 4100, 4200, 4300, 4400, 4500, 4600, 4700, 4800, 4900, 5000, 5100, 5200, 0101, 0201, 0301 or 0401, the pump is affected and must be replaced.

If the letter "A" is marked as a suffix to the date code, the pump has been brought into conformity and need not be replaced.

If your Lycoming engine has a diaphragm-type fuel pump with Lycoming P/N LW-15399, LW-15472, LW-15473, or LW-16335 installed, and has a date code of 0700 through 0401, the pump must be replaced within the next 100 hours of operation or 180 calendar days from the date of this Service Bulletin, whichever occurs first.
