SERVICE INSTRUCTION

Service Instruction No. 1524
Engineering Aspects are
FAA DER Approved

SUBJECT: Alternator Bracket Kit for 130A Alternators

MODELS AFFECTED: All Lycoming new, overhauled, rebuilt, or repaired IO-360-A1B6, -B1G6, -C1E6, -C1G6, O-360-A1G6, and TIO-360-C1A6D engines.

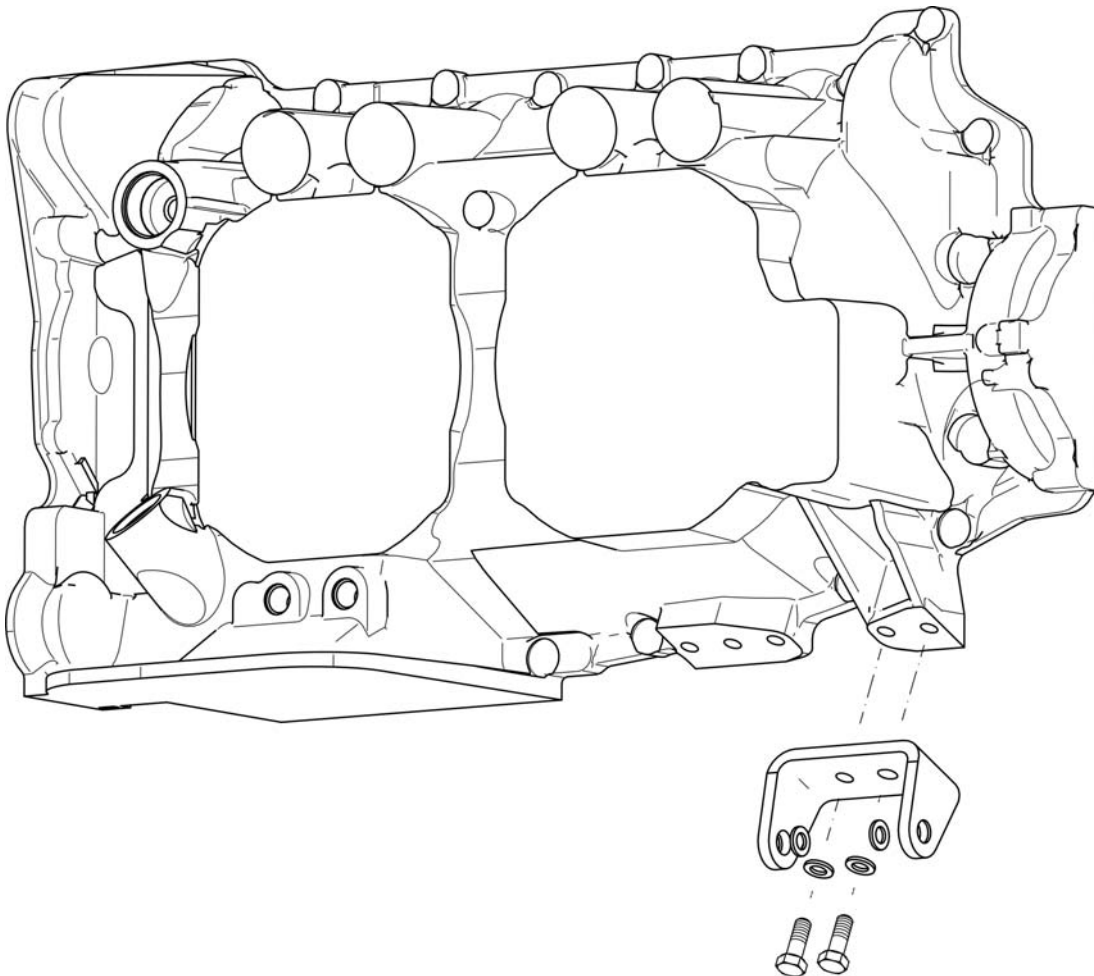
Figure 1: Illustrative Example of Single Alternator Attaching Bracket

Lycoming has determined that a crack may develop in the crankcase near the alternator attaching bracket on any of the above listed engine models utilizing a 130A alternator assembly and only a single alternator attaching bracket. See Figure 1 for the illustrative example. If the existing bracket is drilled for a .375 in. diameter bolt instead of a .4375 in. diameter bolt, contact Lycoming Engines for a replacement bracket.

Oil may be lost through the crack and subsequent damage to the engine may result. Additionally, Lycoming Engines requires cracked crankcases to be replaced before further flight.

The new Alternator Bracket Kit, P/N 05K26328, has been created to supply additional support components to the existing alternator attaching bracket by installing another bracket between the crankcase and alternator. The kit contains the parts listed below to accomplish this modification in the field.

1. Remove the 130A alternator.
2. Visually examine the crankcase for evidence of oil leaks near the existing alternator attaching bracket. If oil is found, confirm that the oil leak is caused by a crack by performing a dye penetrant inspection. If a crack is found, ground the aircraft before further flight and replace the crankcase. If a crack is not found, troubleshoot and repair the source of the oil leak before continuing with Steps 3 through 6.

3. Discard the existing .4375-20 x 4.33 inch long, hex head bolt. In most applications, this bolt will be P/N AN7-42. This bolt will be replaced by P/N AN7-44 which is included in the bracket kit. If the existing bolt is not .4375 in., but instead .375 in., contact Lycoming Engines for bracket replacement.
