SERVICE INSTRUCTION

Service Instruction No. 1508C
(Supersedes Service Instruction No. 1508B)
Engineering Aspects are
FAA (DER) Approved

SUBJECT: Dual Magneto Attachment

MODELS AFFECTED: All Lycoming engines with dual magnetos

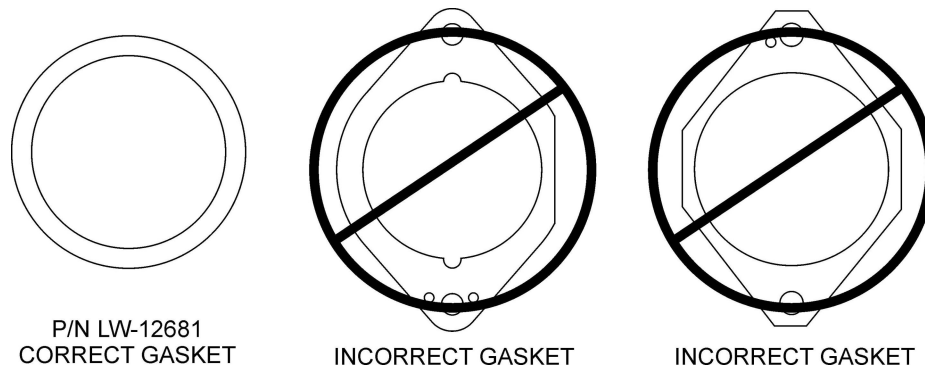
Figure 1
Correct and Incorrect Gaskets

- Incorrect fastening hardware installation
- Incorrect torquing of the fastening hardware
- Incorrect gasket used for the magneto installation
- Incorrect magneto clamps installed
- Incorrect gap between the magneto clamp and the accessory housing

4. Clean the magneto flange; remove all gasket material for a smooth, clean flange surface.
5. Install the dual magneto with the correct new magneto gasket P/N LW-12681. No other gaskets are acceptable. See Figure 1.
