SERVICE INSTRUCTION

DATE: July 2, 2003 Service Instruction No. 1485A
(Supersedes Service Instruction No. 1485)

SUBJECT: Exhaust Valve and Guide Identification Procedure

MODELS AFFECTED: All Lycoming reciprocating aircraft engines unless installed in a rotary-wing aircraft.

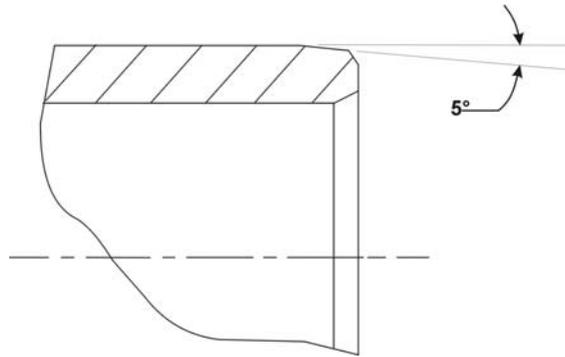
Figure 1.

Cylinder assemblies which incorporated the improved "Hi-Chrome" exhaust valve guides when the engine was shipped from Lycoming are identifiable by the letter "C" stamped inside a circle on the boss for the drain back fitting. The individual guides made with the improved material can be identified by a 5° chamfer at the top of the guide (See Figure 1).

Once guides made from the improved material are installed in all cylinders on the engine, it is no longer necessary to complete the mandatory 400 hour inspections specified in the latest revision of Service Bulletin No. 388. It is recommended that the inspection procedure from the latest revision of Service Bulletin No. 388 be completed at 1000 hours of operation or half way to the recommended TBO, whichever occurs first. (For recommended TBO, refer to the latest revision of Service Instruction No. 1009.)

Prior to discontinuing the mandatory 400 hour inspections specified in the latest revision of Service Bulletin No. 388, you must confirm that **all** cylinders on the subject engine have the new exhaust guides installed. A logbook entry should be made for future reference.
