SERVICE BULLETIN

DATE: March 17, 2009 Service Bulletin No. 585
Engineering Aspects
FAA Approved

SUBJECT: Incorrect Exhaust Valve Rotator Cap Shipped with Cylinder Kits P/N 05K21119, 05K21121, and 05K21122

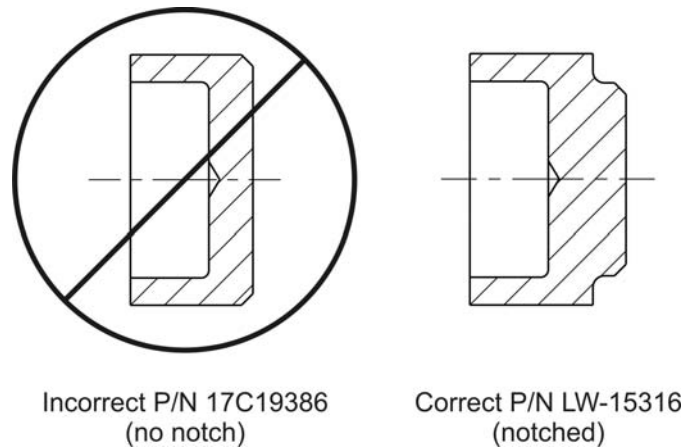
Figure 1. Physical Identification of Incorrect Exhaust Rotator Caps

Cylinder Kits, P/N 05K21119, 05K21121, and 05K21122, may contain exhaust valve rotator cap P/N 17C19386 in lieu of P/N LW-15316. The correct exhaust valve rotator cap must be installed in the engine in order to maintain the correct upper exhaust valve spring seat to valve rocker arm dynamic clearance. If the correct dynamic clearance is not maintained, damage such as wear, pitting, or scoring to the upper exhaust valve spring and valve rocker arm may occur.

A.3. If the incorrect part number is found, please follow the normal Lycoming warranty procedure by contacting an authorized Lycoming distributor for replacement exhaust valve rotator caps and warranty reimbursement. Warranty part replacement is available through the authorized Lycoming distributor for a period of one year from the date of this Service Bulletin.

- B.1. Remove the rocker box cover.
- B.2. Check the exhaust valve rotator cap part number. The correct part number is LW-15316. The part number is located on the side of the exhaust valve rotator cap. However, it may be difficult to see the part number. See Figure 1 for physical identification of the correct rotator cap. See Figure 2 for an illustrative example of the cylinder head assembly.

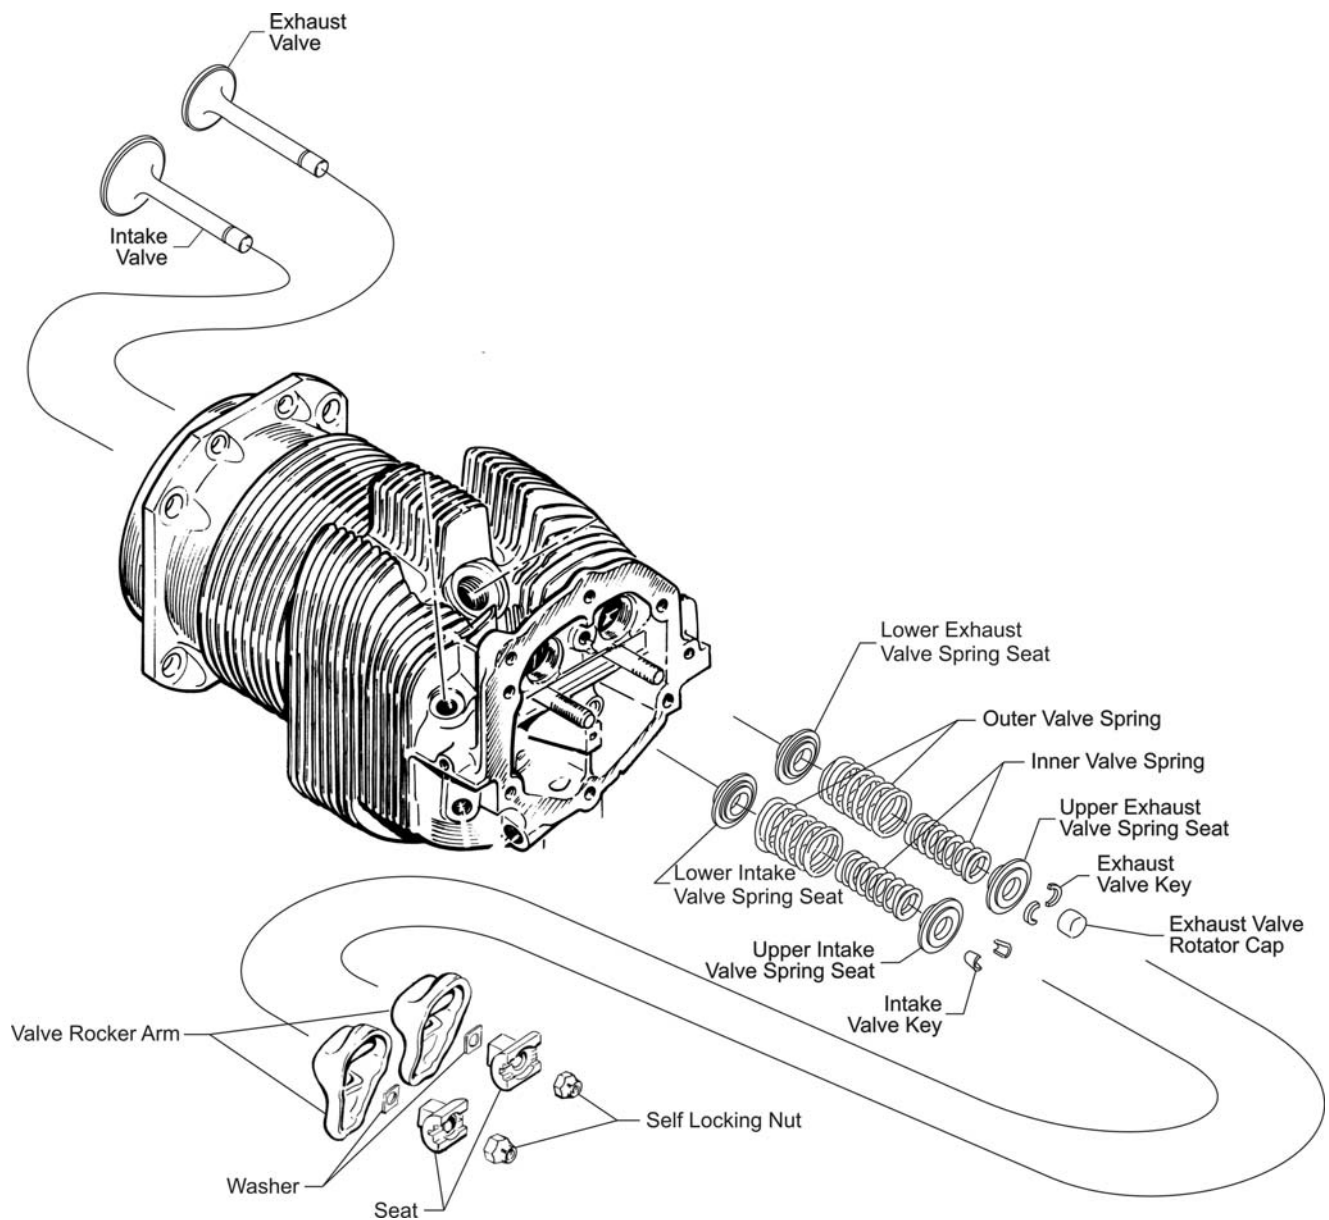
Figure 2. Illustrative Example of Cylinder Head Assembly

- B.2.b. If the part number is incorrect, the upper exhaust valve spring seat and valve rocker arm must be inspected. Continue to Step B.3.
- B.3. Inspect the upper exhaust valve spring seat and valve rocker arm for evidence of interference, wear, pitting, scoring, or other damage.

- B.3.b. If there is evidence of damage, the parts must be replaced. Continue to Step B.4.
- B.4. Replace the upper exhaust valve spring seat, valve rocker arm (exhaust only), and exhaust valve rotator cap with new parts.

- B.5. Check the dry tappet clearance as outlined in the applicable Overhaul Manual or Maintenance and Overhaul Manual.
- B.6. Using a new gasket, reinstall the rocker box cover.
- B.7. Make an appropriate log book entry.
