SERVICE INSTRUCTION

Service Instruction No. 1340A
(Supersedes Service Instruction No. 1340)

SUBJECT: Piston Pin Identification

MODELS AFFECTED: All Lycoming aircraft engines except the following: O-235, O-290, O-435-A, GO-435-C2, VO-435, TVO-435.

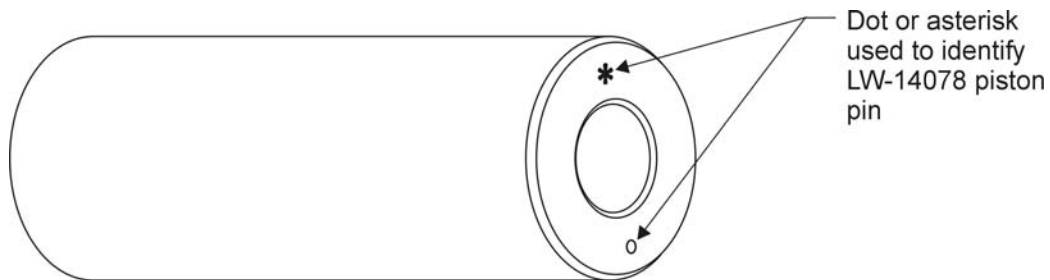
Figure 1

To distinguish the new pin, either a small, circular indentation or a small etched asterisk has been placed on the end of the pin as shown in the figure.

Heavy Wall Piston Pin Showing Location of Identification Marks on End of Pin

Before assembly in an engine, all piston pins must be inspected to determine if either this small dot or small asterisk is on the end of the pin. Use care when looking for this mark because on some pins the mark may be smaller than the one shown in the figure. Do not use any new or reuse any used heavy wall pins that do not have either identifying mark.
