Service Bulletin No. 606  
Engineering Aspects are  
FAA Approved

SUBJECT: Correction of Engine Data Plate on IO-540-AE1A5 Engines

MODELS AFFECTED: IO-540-AE1A5

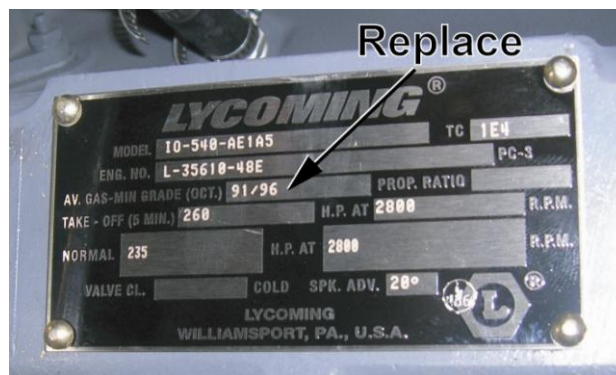
Figure 1  
Data Plate

Due to an administrative error, 91/96 could be incorrectly imprinted on all existing IO-540-AE1A5 data tags issued before July 17, 2013.

USE OF 91/96 FUEL COULD CAUSE DETONATION AND MECHANICAL DAMAGE TO THE ENGINE. IF YOU HAVE USED THE INCORRECT FUEL FOR YOUR ENGINE, REFER TO THE LATEST REVISION OF SERVICE BULLETIN NO. SB 398.

1. Remove the existing 91/96 notation on the engine data plate (Figure 1) with a vibropeen or other similar device.
2. Stamp 100/100LL on to the data plate. The stamp must be clearly legible.
3. It will be the sole responsibility of the altering agent to record compliance with this Service Bulletin in the permanent engine records and/or engine logbook.
