Service Bulletin No. 619
Engineering Aspects are
FAA Approved

SUBJECT: Hardness Check for Rocker Arm, Part Number LW-15014

MODELS AFFECTED: O-320-H2AD, O, LO, TO, LTO-360-E1A6D

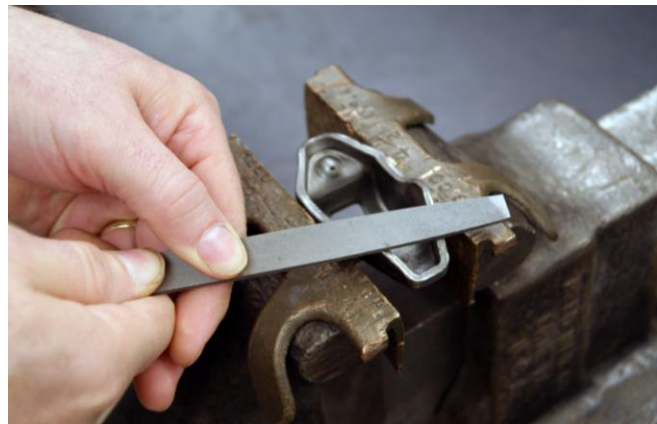
Figure 1
Apply File Across Edge of a Rocker Arm

1. Hold the rocker arm securely.
2. With firm hand pressure, apply the flat single bastard cut, fine file and move it across the edge of the rocker arm as shown in Figure 1.
3. During filing if the rocker arm does not feel like filing aluminum or soft metal and there are no shavings after 10 passes with the file, the rocker arm is hardened.

NOTICE: If the rocker arm is not hardened, it will have a feel similar to filing aluminum or any soft metal. File shavings are also an indication of a non-compliant rocker arm.

4. If there are file shavings, remove the rocker arm from the spares inventory and contact Lycoming Field Service by phone at 570-327-7222 or 877-839-7878.

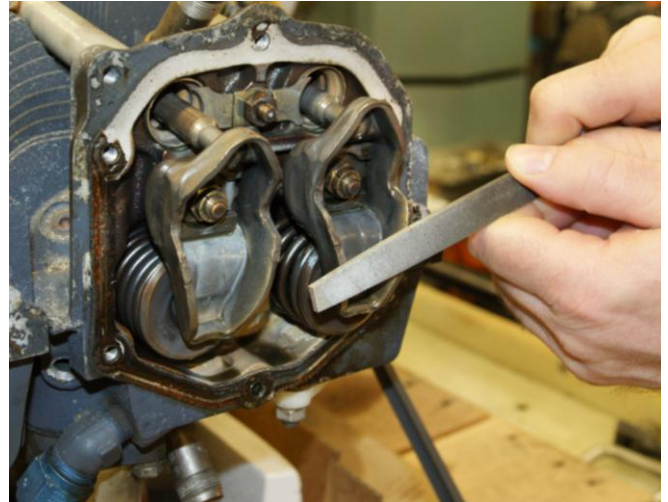
Figure 3
Apply File Across Edge of a
Rocker Arm Installed on the Engine

6. With firm hand pressure, apply the flat single bastard cut, fine file and move it across the edge of the rocker arm as shown in Figure 3.
7. With each pass of the file in the same location on the rocker arm, look in and around the rocker arm for any file shavings from the rocker arm. Collect and remove any metal shavings. Complete this step nine more times and collect any file shavings.

8. During filing, if the rocker arm does not feel like filing aluminum or soft metal and there are no shavings after 10 passes with the file, the rocker arm is compliant:

- A. Install the rocker box cover with a new gasket on the cylinder head.
 - B. Torque the rocker box cover screws to 50 in.-lb. (6 Nm).
 - C. Record the Hardness Check results for each rocker arm in the engine logbook.

9. If there are file shavings, remove the rocker arm from the engine and contact Lycoming Field Service by phone at 570-327-7222 or 877-839-7878.
10. Replace the non-compliant rocker arm with a compliant rocker arm per instructions in the applicable Lycoming Overhaul Manual or Operator's Manual.
