# MANDATORY SERVICE BULLETIN

DATE: February 3, 2016 Service Bulletin No. 623  
Engineering Aspects are  
FAA Approved

SUBJECT: Reprint of Hartzell Engine Technologies (HET) Service Bulletin SB-062

### Alternator Models ALU, ALX & ALY Series HET P/N ALA-0020G Through Bolt Replacement

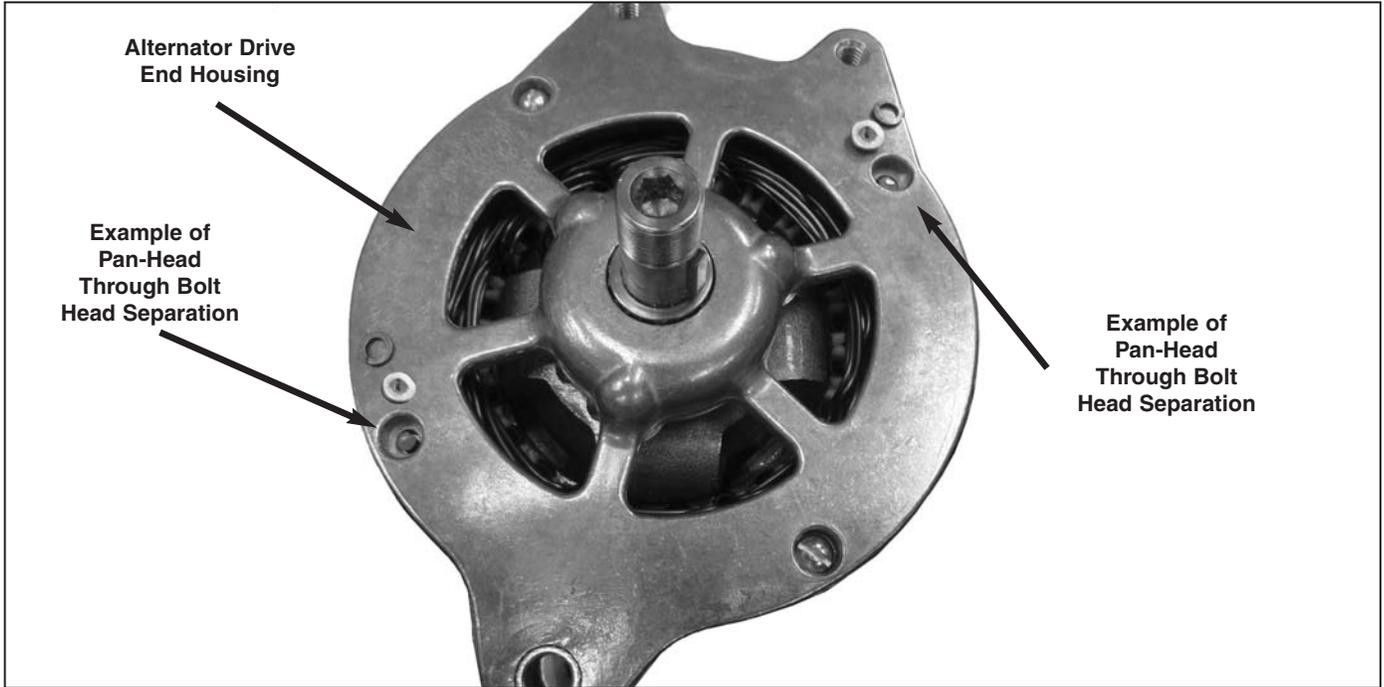
- (1) Affected serial numbers of alternator model ALU, ALX, and ALY may have a pan-head style HET P/N ALA-0020G through bolt installed. These pan-head through bolts have had incidences of bolt head separation. Refer to Figure 1.
- (2) To eliminate the risk of through bolt head separation, all pan-head through bolts must be replaced with HET P/N ALA-0020G fillister-head style through bolts on the affected alternators. Refer to Figure 2 and Figure 3.
- (3) The pan-head version of the HET P/N ALA-0020G through bolt is being discontinued and will no longer be used.
- (4) Regulatory action is unknown.

Figure 1 - ALX-8521LS Pan-Head Through Bolt Head Separation Example Shown with Fan Removed.

- (1) This Service Bulletin provides Instructions for Continued Airworthiness (ICA).
- (2) This Service Bulletin requires an inspection of the affected alternators shown in Tables 1, 2, or 3 and return of any that are found with pan-head through bolts installed.
  - a. The alternator will be repaired using HET P/N ALA-0020G fillister-head through bolts.

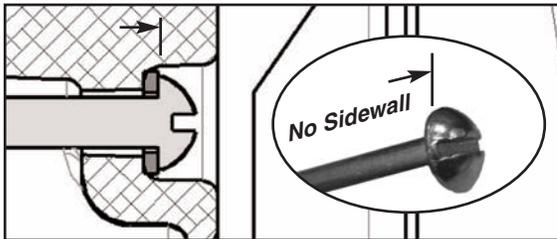
Figure 2 - Pan-Head Through Bolt (If found alternator must be repaired)

- (1) Using a bright white light, inspect the alternator drive end housing at each through bolt location (four each) beneath the fan. Refer to Figure 4.
  - a. If a pan-head through bolt is installed, return the affected alternator to HET for repair per 3.C Corrective Action. Refer to Figure 2.
  - b. If positive identification that four fillister-head through bolts are installed, the affected alternator is in compliance with this service bulletin. Proceed to 3.D(3), Return to Service. Refer to Figure 3.

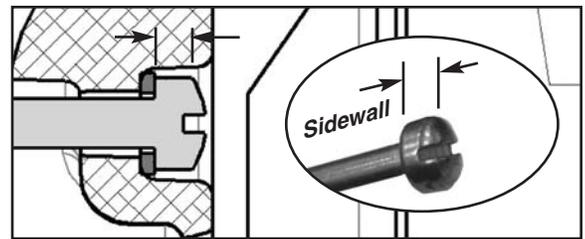
Figure 3 - Fillister-Head Through Bolt (If four found, alternator is acceptable)

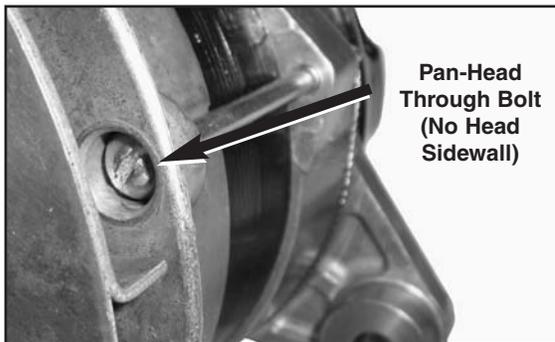
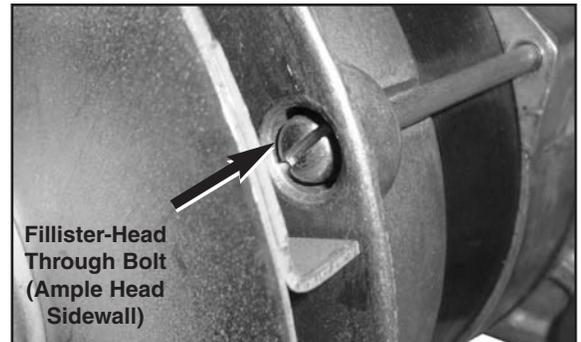
Figure 4 - Through Bolt Head Inspection Example Shown.
