MANDATORY SERVICE BULLETIN

Service Bulletin No. 625
Engineering Aspects are
FAA Approved

SUBJECT: Alternator Fan Backplate

MODELS AFFECTED: Lycoming engine models IO-360-A1B6, IO-360-C1G6, TIO-360-C1A6D, IO-540-K1G5, TIO-540-AH1A, and AEIO-580-B1A that have alternator assembly part number (P/N) 32C21703 or 32C22492 and any spare alternator assemblies P/N 32C21703 or 32C22492.

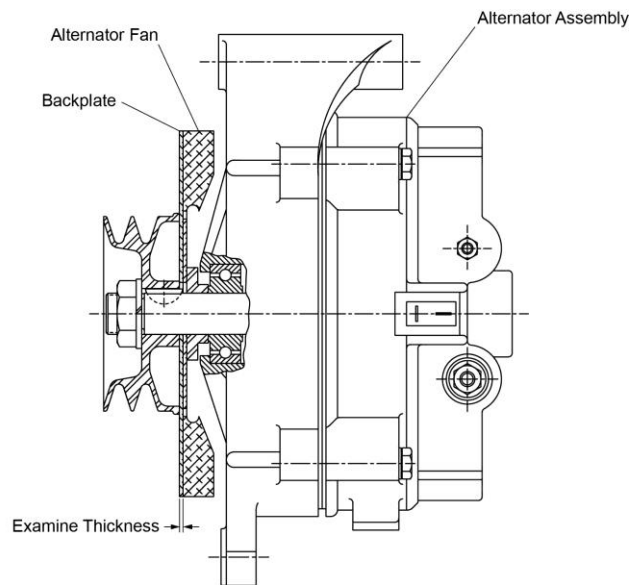
Figure 1
Alternator Fan Backplate

This Service Bulletin is notification of a requirement to replace specific alternator assemblies identified herein as a corrective action for potentially non-conforming alternator fan backplates in the field. Continued operation of an alternator with a non-conforming alternator fan backplate can cause undue flex and stress on the backplate during engine operation.

1. Identify and remove any alternator assembly identified in Tables 1 or 2 from all of your affected Lycoming engine models identified above or in inventory.
2. Examine each suspect alternator assembly (Figure 1) for the correct alternator fan backplate thickness of 0.052 to 0.072 in. (1.321 to 1.829 mm) instead of 0.027 to 0.044 in. (0.686 to 1.118 mm).

3. If the alternator assembly has a fan backplate thickness measuring less than 0.052 in. (1.321 mm) follow the warranty instructions in this Service Bulletin.
4. Show compliance to this Service Bulletin in the logbook of each affected engine by recording the serial number of each returned non-compliant alternator assembly and the serial number of the replacement alternator. Also, record notes in your inventory records of compliance and findings in your spares inventory.

1. Contact an Authorized Lycoming Distributor to order a replacement alternator assembly.
2. Upon receipt, complete the installation procedure.
3. Return the removed alternator assembly to Lycoming Engines through the same Authorized Lycoming Distributor that ordered the replacement alternator assembly and file a warranty claim for:
 - A. Reimbursement of the replacement parts.
 - B. Associated Freight.
 - C. Removal and Reinstallation Labor Allowance of not more than 1.5 hours.
