SERVICE INSTRUCTION

Service Instruction No. 1423A
(Supersedes Service Instruction No. 1423)
Engineering Aspects are
FAA Approved

SUBJECT: Thermostatic Oil Cooler Bypass Valve Part Number (P/N) 75944

MODELS AFFECTED: All Lycoming engines using Thermostatic Oil Cooler Bypass Valve Part Number (P/N) 75944

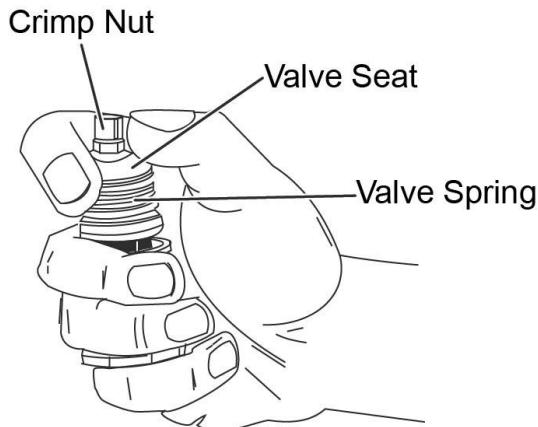
Figure 1
Thermostatic Oil Cooler Bypass Valve Crimp Nut

This revision of the Service Instruction identifies a change: Thermostatic oil cooler bypass valve part number P/N 53E22144 now supersedes P/N 75944 when it is necessary to replace bypass valve P/N 75944 if it is damaged, its crimp nut (Figure 1) is loose, or for any other reason.

Unless otherwise indicated in the latest revision of Service Instruction No. SI-1565, P/N 53E22144 is the only replacement bypass valve to be installed.

NOTICE: The replacement bypass valve P/N 53E22144 (that is now to be used instead of P/N 75944), does not need to be immersed in Loctite® and does not need to have the letter “L” vibro-peened on the bypass valve per the previous revision of this Service Instruction.
