SERVICE INSTRUCTION

DATE: December 20, 2000 Service Instruction No. 1503
Engineering Aspects are
FAA Approved

SUBJECT: Accessory Drive Gear and Shaft Dowel Replacement

MODELS AFFECTED: Textron Lycoming VO-435-B1A model engines.

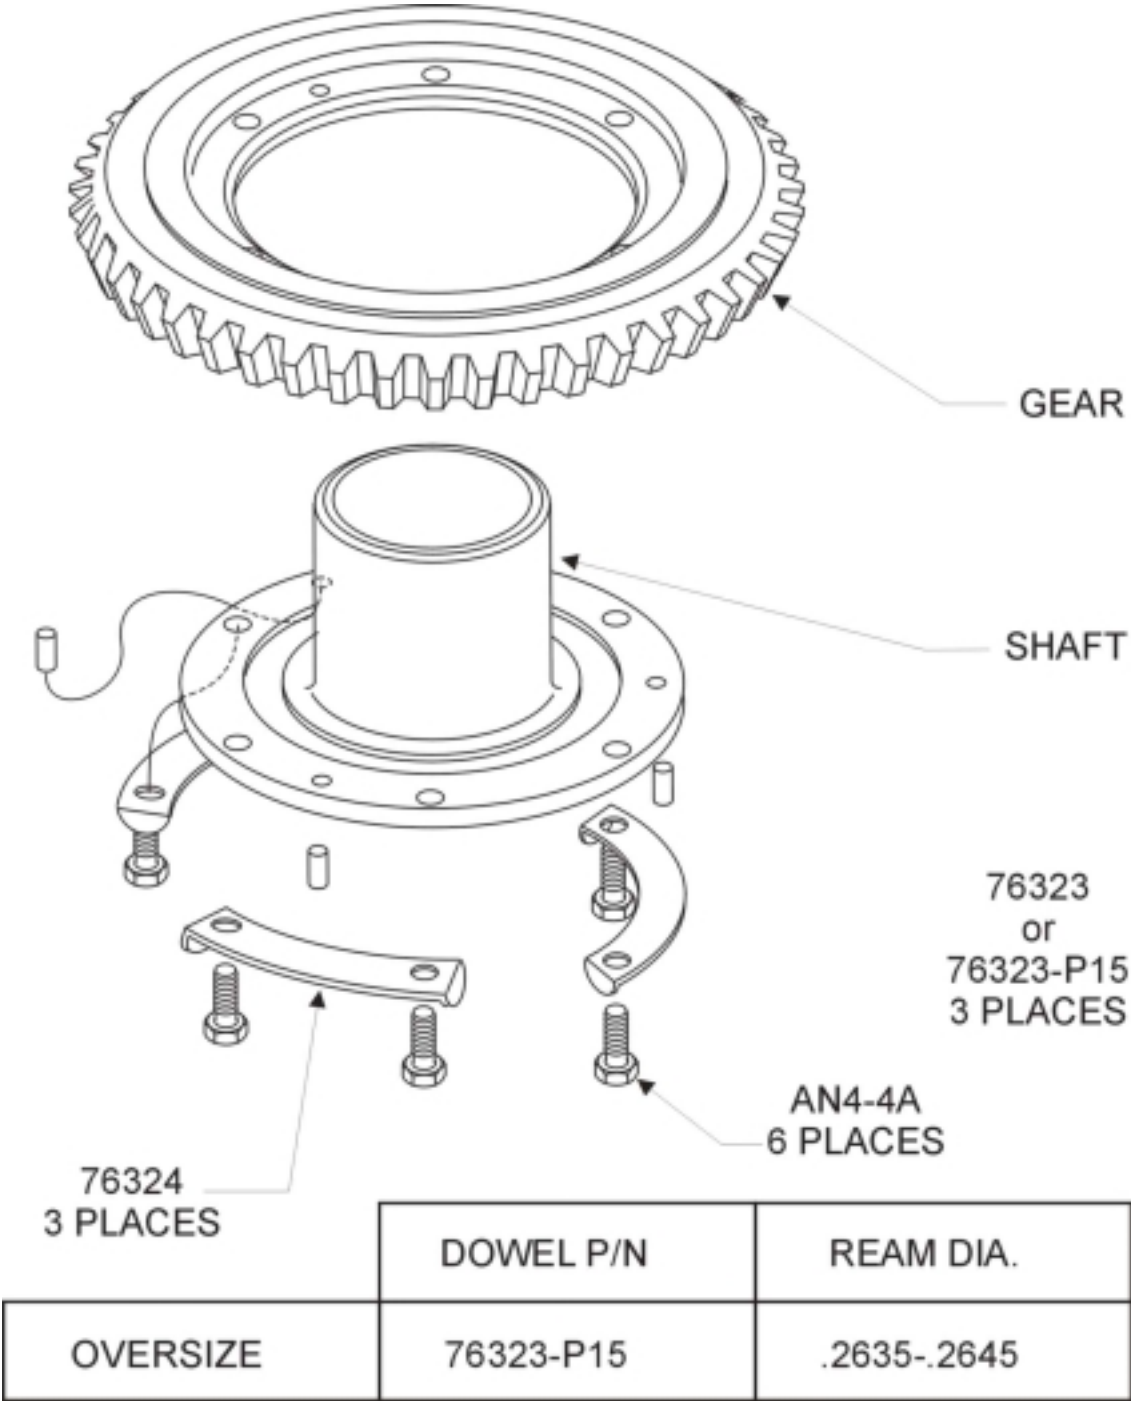
Any time the accessory drive gear and shaft assembly, P/N 76327, is disassembled, replace the three standard dowels, P/N 76323, connecting the gear and shaft with oversize dowels P/N 76323-P15.

1. Mark the gear and shaft to allow the parts to be reassembled in the same orientation.
2. To remove the existing dowels from the assembly, remove the bolts securing the three lock tabs to the shaft flange and remove the lock tabs P/N 76324. Drive the dowels out of the assembly. (See Figure.)

3. Install the oversize dowels.
 - a. Reassemble the gear to the shaft, align dowel holes and reinstall the six bolts, but do not install the tabs.
 - b. Ream the three aligned dowel holes through the gear and the shaft flange to .2635-.2645. Be sure to remove material around the entire diameter on both pieces.

- c. Press the oversize dowels P/N 76323-P15 into the holes until they are flush with the shaft flange. Mark P15 next to the dowel holes to show that oversize dowels have been installed.

- d. Remove the six bolts and install the three new P/N 76324 lock tabs and torque the bolts to 100-120 in.-lbs. and lock the tabs.
