MANDATORY SERVICE BULLETIN

Service Bulletin No. 579
Engineering Aspects are
FAA Approved

SUBJECT: Clearance Between Oil Sump Assembly and Oil Sump Baffle

MODELS AFFECTED: New, rebuilt, overhauled, or repaired Lycoming IO-540-L1C5; TIO-540-S1AD; IO-580-B1A series engines.

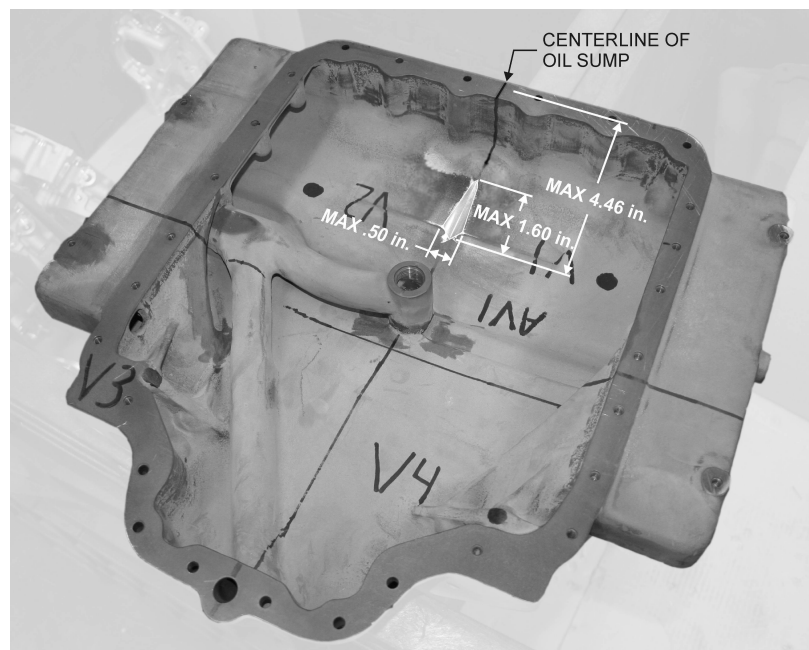
8. Thoroughly examine the inner surface of the oil sump for wear grooves.
9. If a wear groove exists on the bottom inner surface of the oil sump, towards the front of the crankcase, then an additional clearance cut must be made. If a wear groove does not exist, proceed with step 10. Affected sumps that already have been reworked at Lycoming will have the clearance cut at the centerline of the sump. If the clearance cut exists proceed to step 10.

Figure 1. Sump Showing Acceptable Location of Wear Groove Clearance Cut

- a. Using Figure 1 and 2 in conjunction with the outline of the existing wear groove, use a die grinder or other similar equipment to remove the material. Maintain existing surface finish. Deburr all edges.

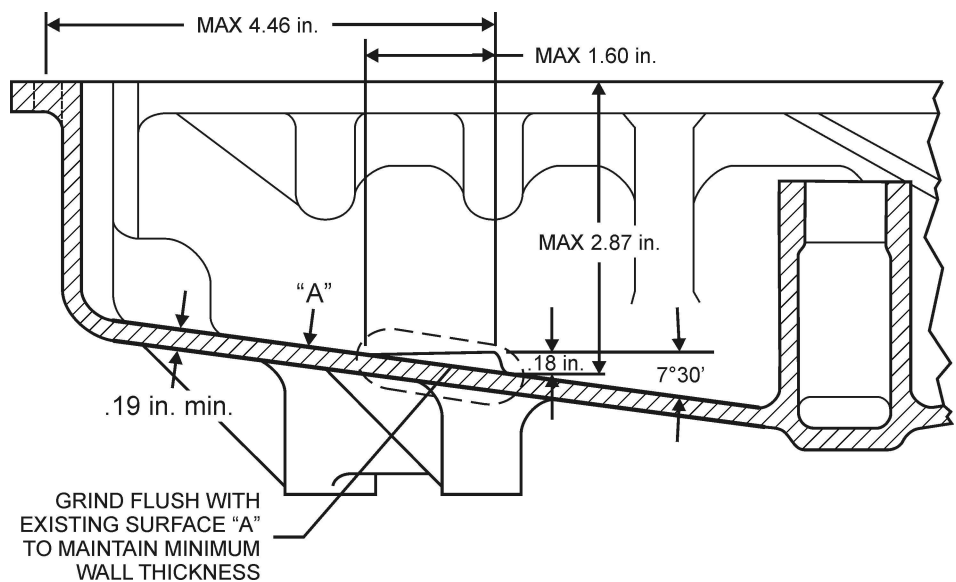
Figure 2. Cross Section of Sump Showing Reference Dimensions

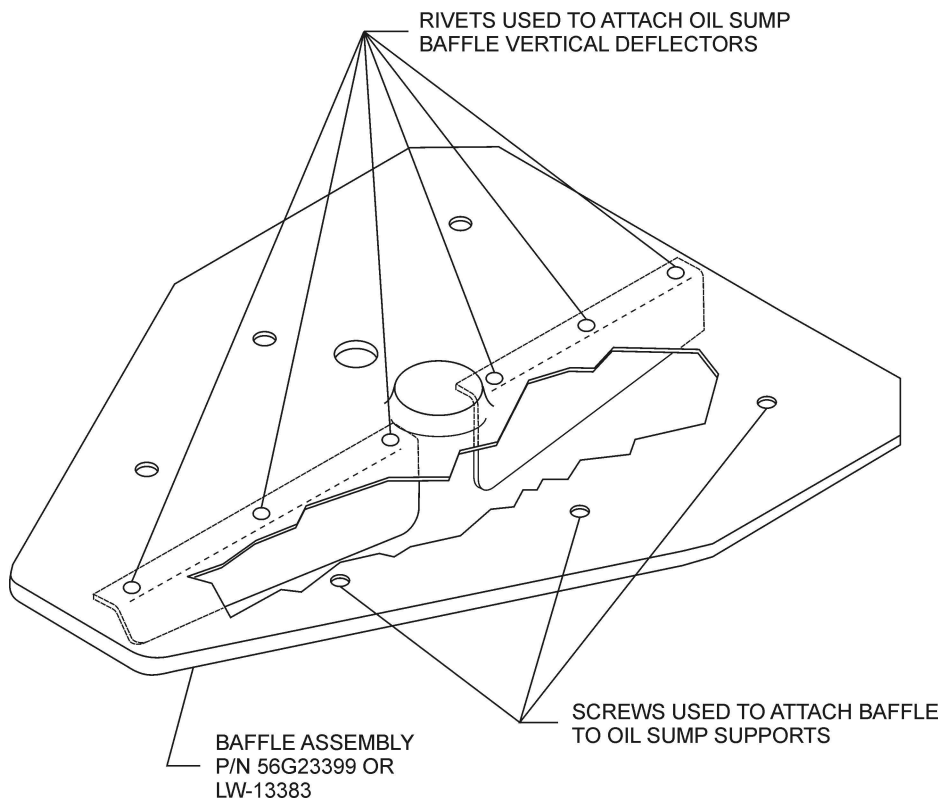
5. Examine the baffle. If the baffle is damaged, it must be replaced before reassembly. Examples of damage may include, but is not limited to, a deformed baffle plate, deformed fins, cracked attachment holes, or missing rivets. See Figure 3.

Figure 3. Example of Oil Sump Baffle
