## SERVICE BULLETIN

Service Bulletin No. 604  
Engineering Aspects are  
FAA Approved

SUBJECT: Compliance with Hartzell Engine Technologies (HET), LLC (Previously Kelly Aerospace) Alert Service Bulletin No. 048 dated 11/16/2012, Turbocharger model TAO411, P/N 410188-0019 Turbine Wheel Replacement

## **Turbocharger TA0411 P/N 410188-0019 Turbine Wheel Replacement**

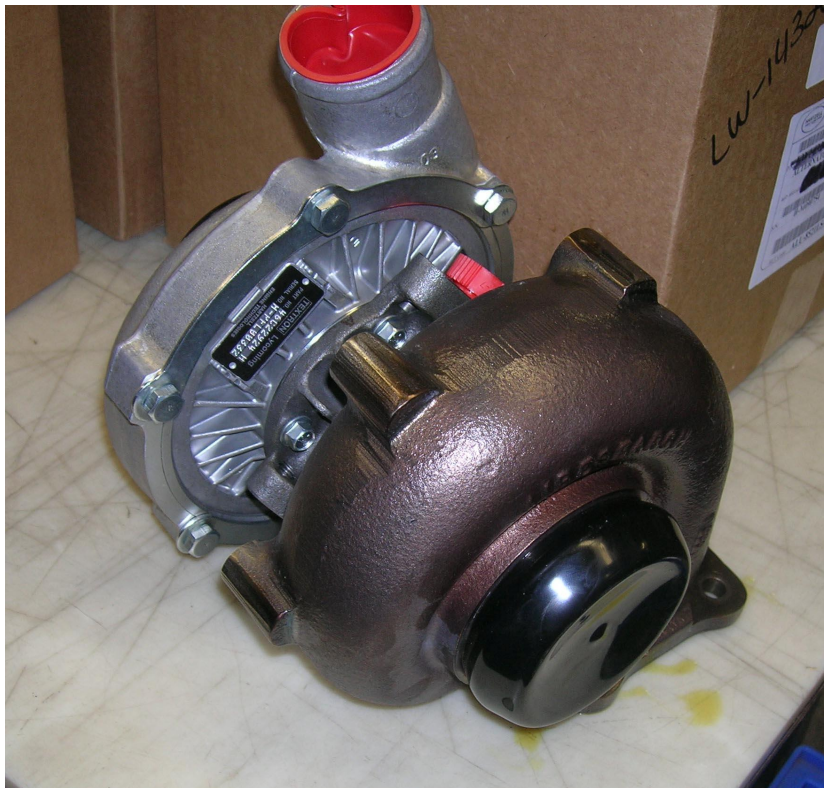
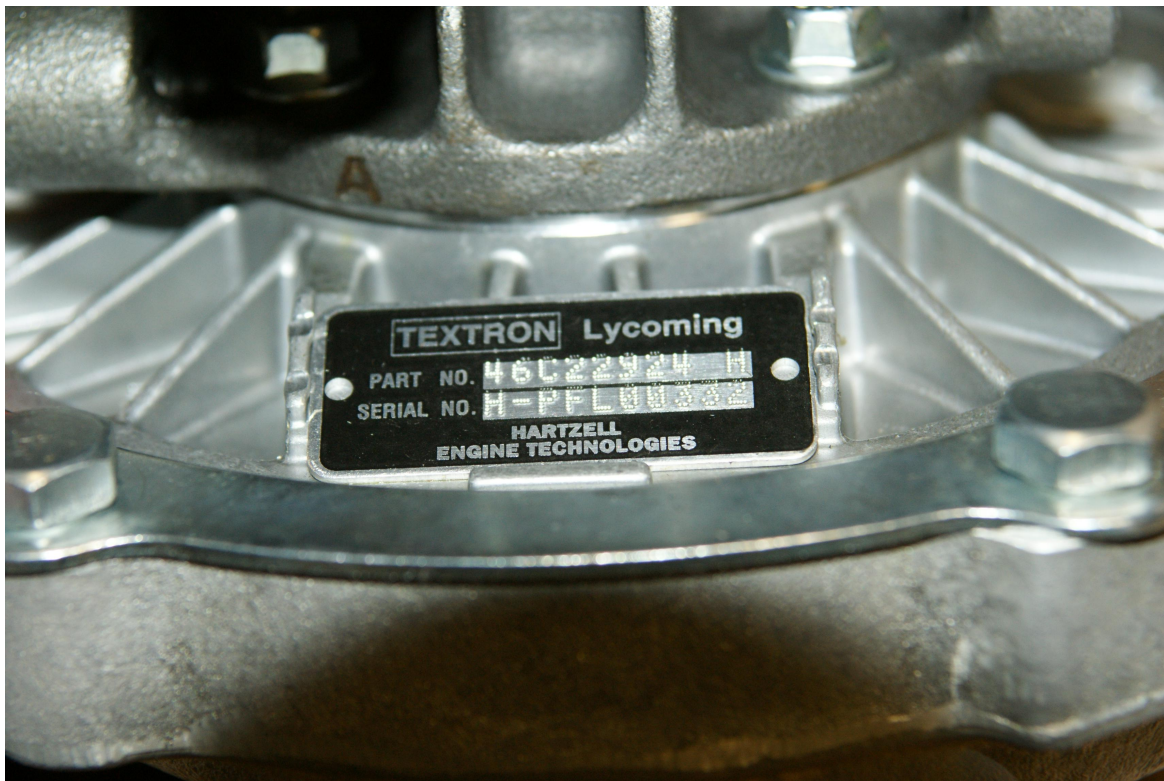
Figure 1  
Turbocharger Data Plate

2. Refer to the turbocharger data plate (Figure 1) and Table 1 for affected turbocharger serial numbers. If the serial number on the turbocharger data plate matches a serial number on Table 1, remove the turbocharger from the engine. Order a replacement turbocharger.

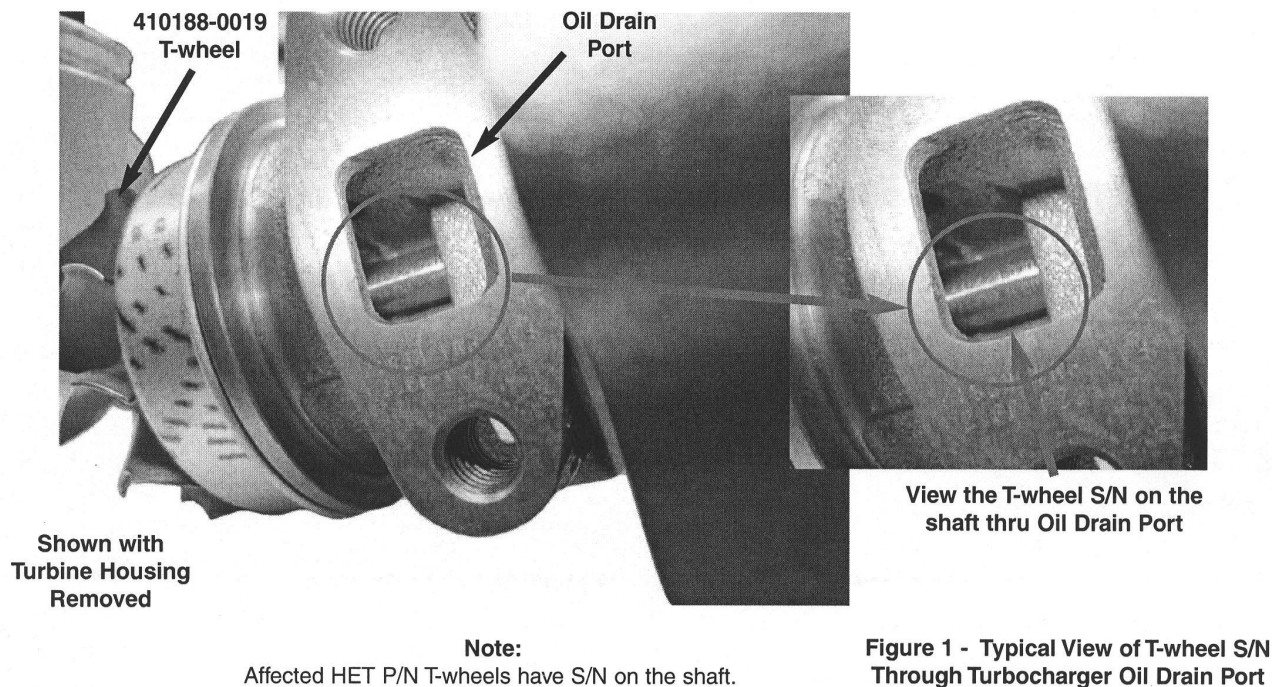
- (b) If the serial number **is listed** in Table 2, continue with Corrective Action 3.B(1).
  - (c) If the turbocharger was overhauled or repaired between August 29, 2012 and November 16, 2012 and the HET P/N 410188-0019 T-wheel was replaced, then determine if the serial number etched on the T-wheel shaft is affected. This may be done by removing the oil drain fitting and with adequate lighting, observing the shaft. (see Fig. 1).
