SERVICE LETTER

Service Letter No. L251
November 23, 2010

SUBJECT: Connecting Rod Bolt Marking

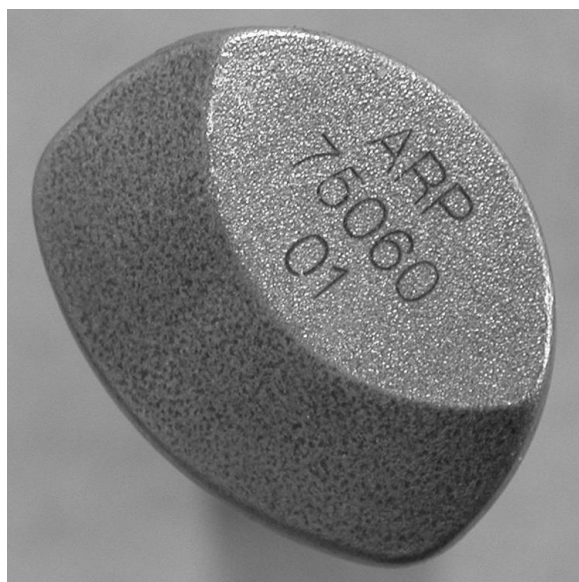
This Service Letter is a notice that recent lots of connecting rod bolts P/N 75060 have a variant marking of the part number on the bolt head as shown in Figure 1. Figure 2 shows the typical marking. **The bolt with the variant marking (in Figure 1) can still be used. It will not change measurements for stretch applications.** The part number marking in Figure 1 does not change form, fit or function.

Figure 1. Variant Connecting Rod Bolt
Part Number Marking

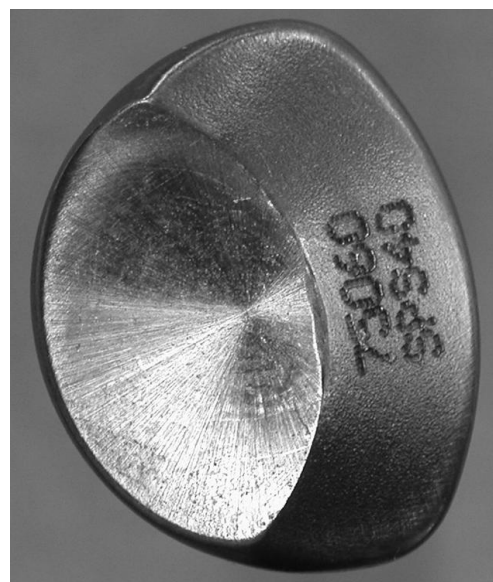
Figure 2. Typical Connecting Rod Bolt
Part Number Marking
