SERVICE BULLETIN

Service Bulletin No. 475C
(Supersedes Service Bulletin No. 475B)
Engineering Aspects are
FAA Approved

SUBJECT: Crankshaft Gear Modification and Assembly Procedures

MODELS AFFECTED: All Lycoming direct drive piston aircraft engines (including VO-360 and IVO-360; excepting O-320-H, O-360-E, LO-360-E, TO-360-E, LTO-360-E, and TIO-541 series engines).

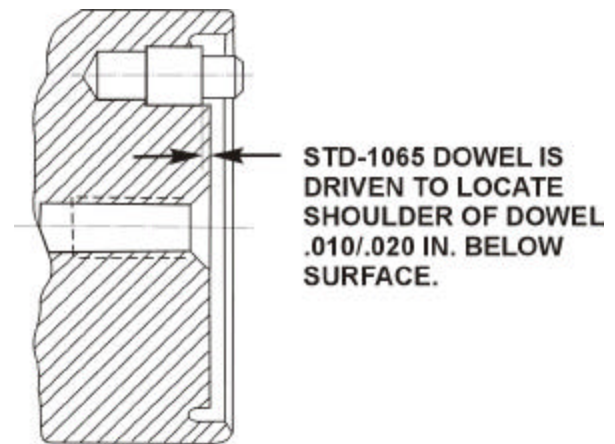
Figure 2. Section Thru End of Crankshaft Showing Driven Height of STD-1065 Dowel

2. Check the condition of the dowel in the end of the crankshaft. It should be perfectly smooth with no indication of nicks or deformation. If it is out of round, it should be removed and replaced with a new one. Replacement instructions are in paragraph 4. If dowel condition is acceptable, insure that it is installed as shown in Figure 2 or 3.

IF THE DOWEL MUST BE REMOVED, IT IS VERY IMPORTANT TO DO SO WITHOUT DAMAGING THE HOLE IN THE CRANKSHAFT. A SATISFACTORY METHOD CONSISTS OF DRILLING A 1/8 IN. DIA. HOLE THROUGH THE CENTER OF THE DOWEL; THEN FILL THE HOLE WITH OIL AND INSERT A PIECE OF 1/8 IN. DIA. DRILL ROD IN THE HOLE. STRIKE THE END OF THE DRILL ROD A SHARP BLOW WITH A HAMMER. HYDRAULIC PRESSURE OF THE OIL WILL FORCE THE DOWEL FROM THE CRANKSHAFT.

- e. Chamfer edge of pilot diameter 45° x .03 as shown in Figure 1.
- 4. If the dowel has been removed, check the condition of the dowel hole in the crankshaft. If out of round or oversize, ream as required for installation of an oversize dowel. Available oversize dowels and the corresponding size for reamed holes are shown in Table 1.
- 5. Install a new dowel in the crankshaft as shown in Figures 2 and 3. Insure that the correct dowel is installed.

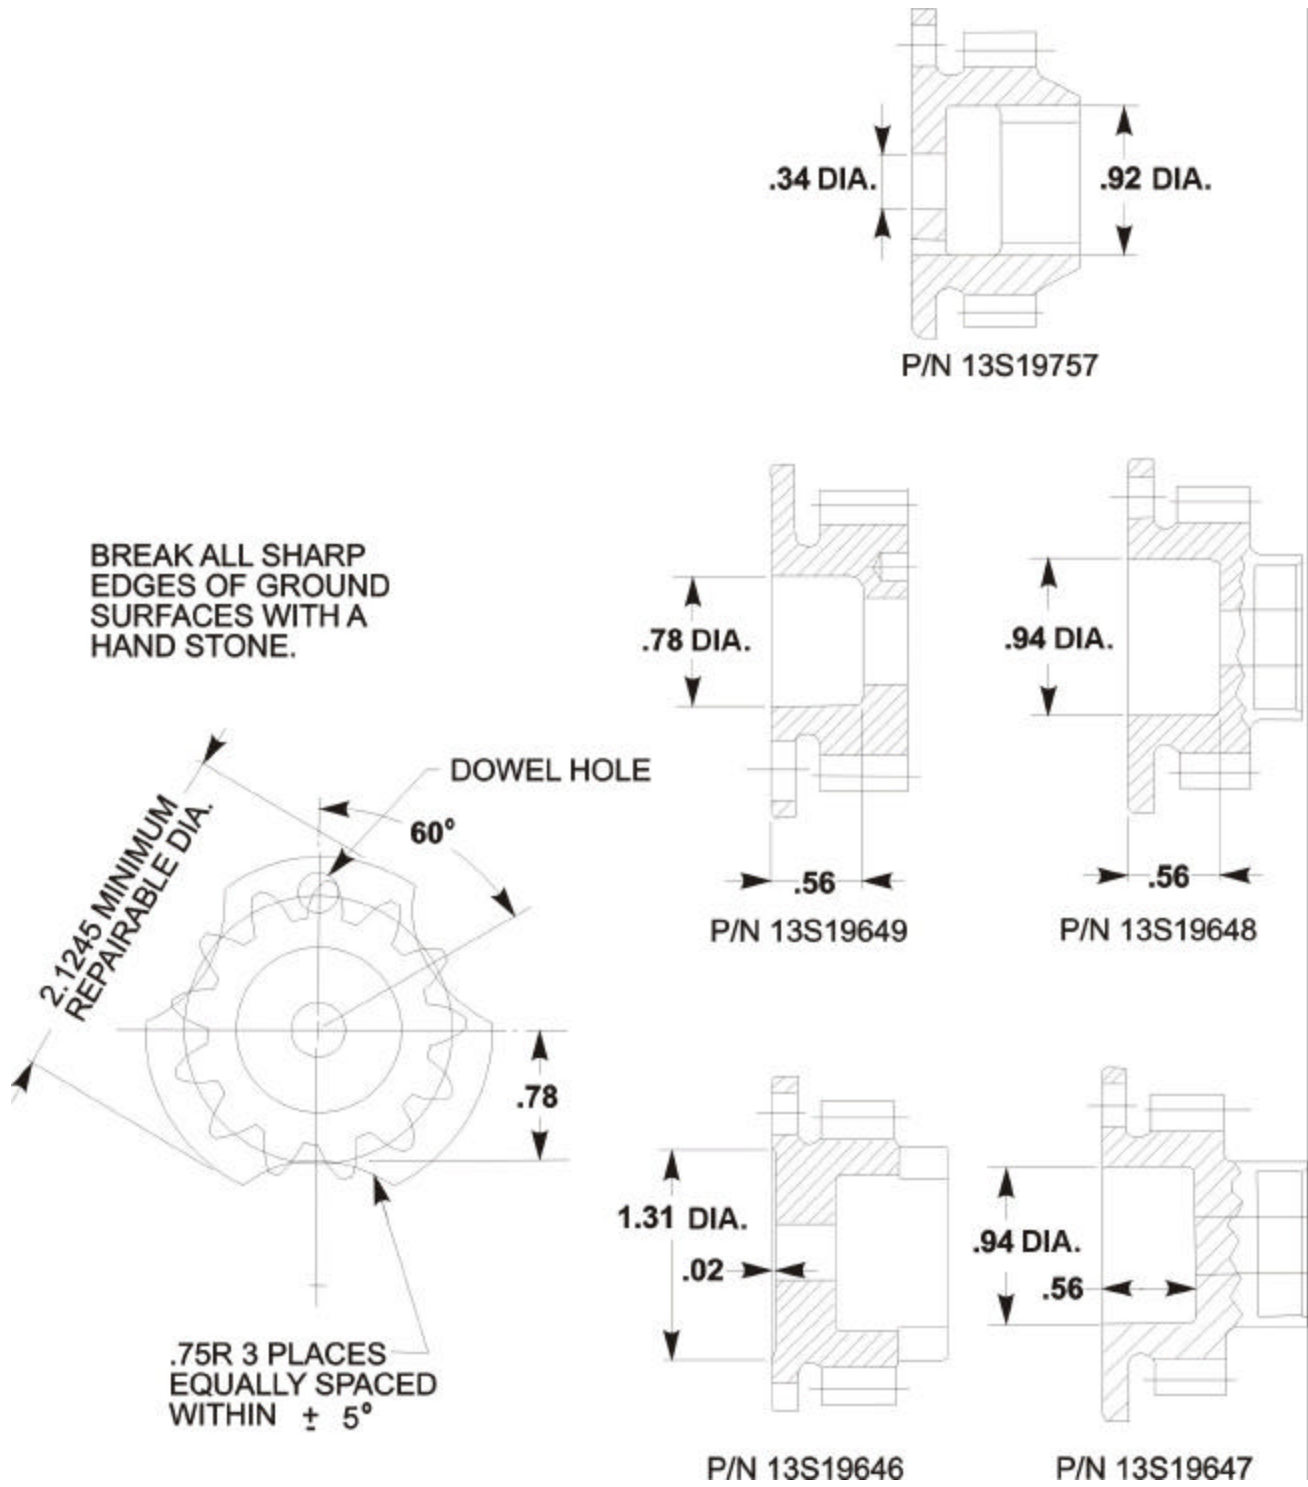
Figure 5. Details for Rework of Crankshaft Gears to Current Configuration

CRANKSHAFT GEARS FOR APPLICABLE ENGINES ARE NOW MANUFACTURED WITH THREE 3/4 INCH RADIUS SCALLOPS CUT INTO THE O.D. OF THE PILOT FLANGE AND A COUNTERBORE ON THE BACK SIDE OF THE GEAR. THESE ENLARGED SCALLOPS HAVE BEEN ADDED TO ALLOW INSPECTION OF THE GEAR AND CRANKSHAFT ASSEMBLY. SERVICEABLE GEARS MUST BE MODIFIED AS SHOWN IN FIGURE 5. PRIOR TO BEING REASSEMBLED ON THE CRANKSHAFT, OR A NEW GEAR THAT HAS BEEN MANUFACTURED TO THIS CONFIGURATION MUST BE INSTALLED. BEFORE MODIFYING THE GEAR, MEASURE THE DIAMETER OF THE PILOT FLANGE. IF IT IS LESS THAN 2.1245 INCH, IT SHOULD NOT BE RESUED. THE ORIGINAL 2.1250/2.1255 DIMENSION OF THE CRANKSHAFT GEAR MUST BE RESTORED WITH A FLASH COPPER PLATE OF UP TO .0005 INCH MAX.

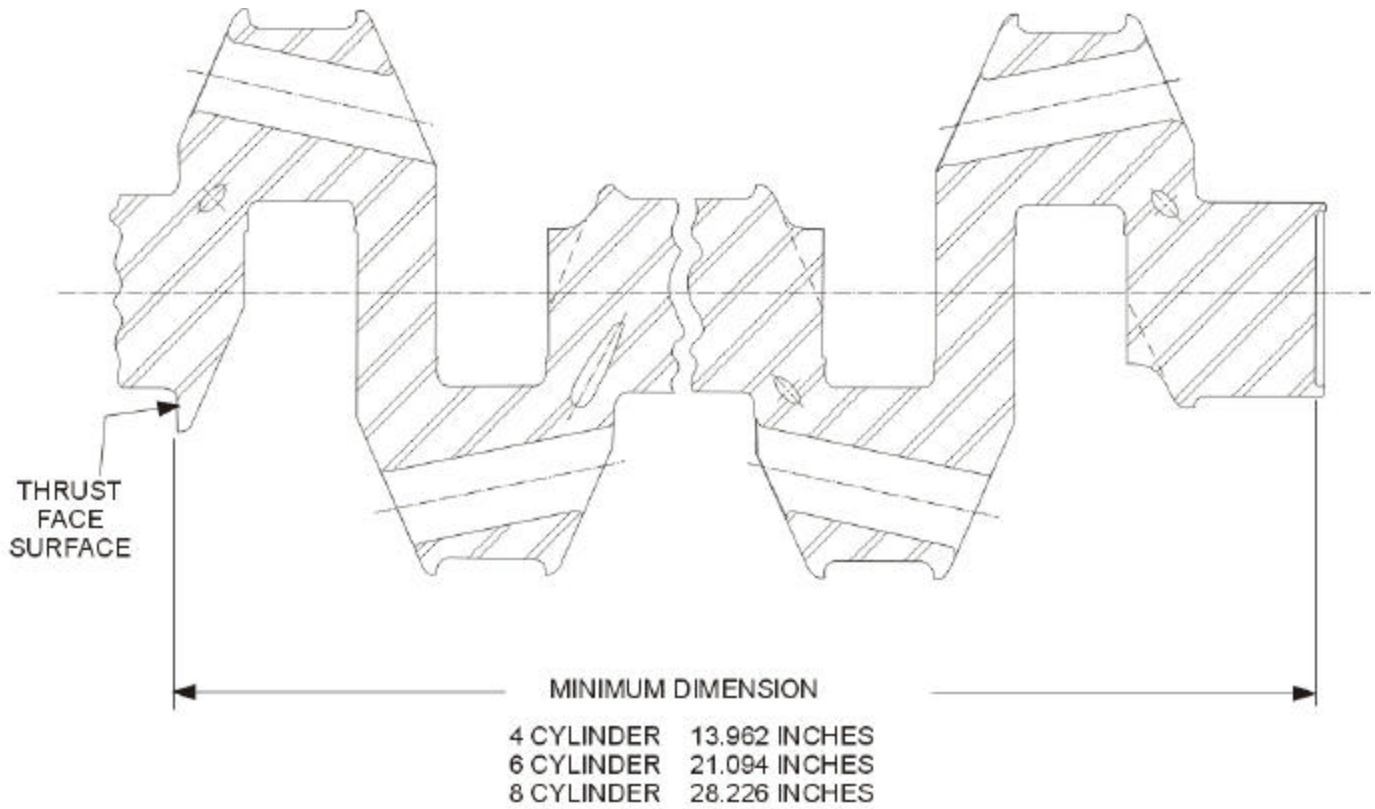
Figure 7. Minimum Dimension of Crankshaft

THE CRANKSHAFT COUNTERBORED GEAR MOUNTING FACE SHOULD BE CHECKED FOR DAMAGE. IF THE SURFACE REQUIRES REPAIR OTHER THAN SPECIFIED IN “CAUTION” ON PAGE 1, THE CRANKSHAFT SHOULD FIRST BE MEASURED AS SHOWN IN FIGURE 7. IF THE CRANKSHAFT MEASURES MORE THAN THE MINIMUM DIMENSION SHOWN IN FIGURE 7, THE SURFACE MAY BE REWORKED DOWN TO THE DIMENSIONS SHOWN. (DO NOT PLATE THIS SURFACE.) THE SURFACE MUST BE TRUE WITHIN .001 IN. TOTAL INDICATOR READING TO REAR MAIN BEARING AND THE SURFACE FINISH MUST BE HELD TO 45 TO 90 MICRONS.

INSURE MINIMUM DIMENSION IS MEASURED BETWEEN THRUST FACE SURFACE AND PILOT.
