MANDATORY SERVICE BULLETIN

DATE: October 30, 2006 Service Bulletin No. 572
Engineering Aspects are
FAA Approved

SUBJECT: Missing Oil Passage Hole at Idler Shaft Location

MODELS AFFECTED: This Service Bulletin applies to new, rebuilt, overhauled or repaired Lycoming O-235 engines and accessory housing kit P/N 05K21678 shipped from Lycoming between September 1, 2003 and June 1, 2006.

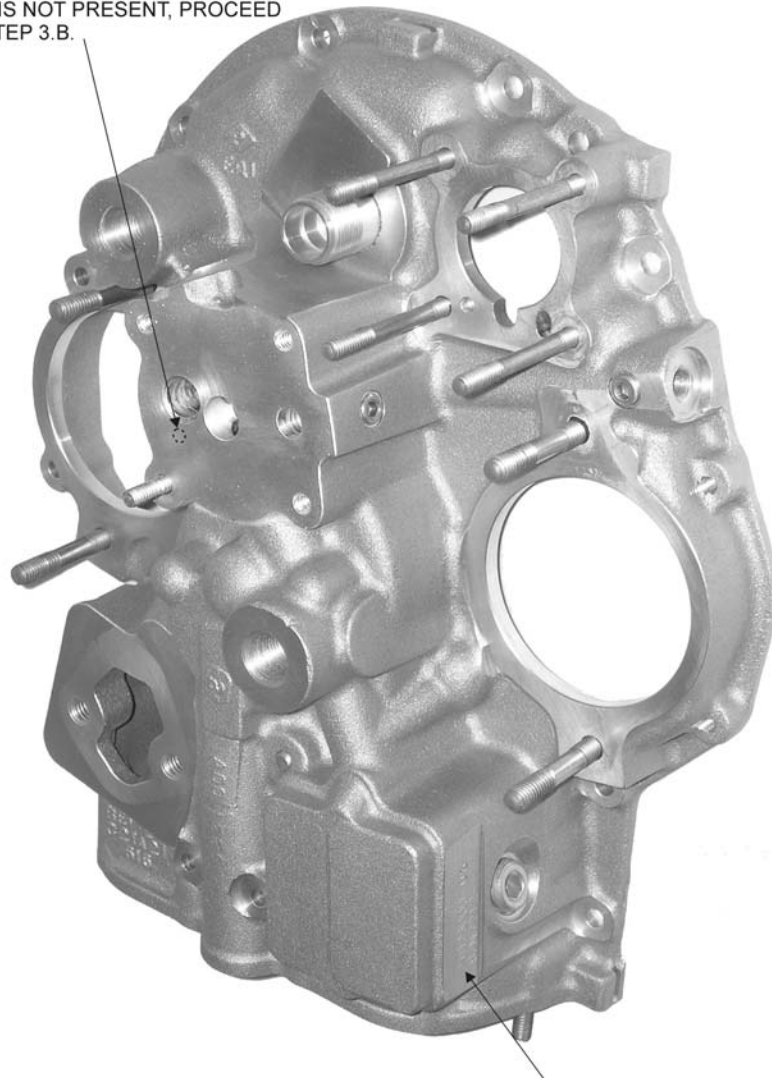
3. If the serial number contains "7212", then followed by the four numbers 0001 thru and including 0060, proceed with the following steps:
 - a. Remove the oil filter base or pressure screen housing and inspect for the presence of a 3/16-inch hole at the location shown in Figure 1.

THE OIL PASSAGE HOLE CAN BE FOUND NEAR THIS LOCATION. IF THIS IS NOT PRESENT, PROCEED WITH STEP 3.B.

THE ACCESSORY HOUSING SERIAL NUMBER WILL BE STAMPED HERE. IF THE SERIAL NUMBER DOES NOT CONTAIN "7212" THEN NO FURTHER ACTION IS REQUIRED. IF IT DOES CONTAIN "7212" THEN PROCEED WITH STEP 3.

- b. If the 3/16-inch hole is not present, contact an authorized Lycoming distributor for further instructions regarding warranty part replacement.
 - c. If the 3/16-inch hole is present, verify that it passes through to the interior of the accessory housing by using compressed air or probing with a thin piece of wire.

- (1) If compressed air is used and no obstructions are present, then there will be an audible sound of air escaping into the interior of the accessory housing.
 - (2) If a probe is used, no obstructions will be encountered before a minimum insertion depth of 2.324 inches.
- d. If no obstructions are found, no further action is required.
 - e. If the passage hole is obstructed, contact an authorized Lycoming distributor for further instructions regarding warranty part replacement.
4. Warranty part replacement is available for a period of one year from the date of this Service Bulletin.
