MANDATORY
SERVICE BULLETIN

DATE: October 2, 2001

Service Bulletin No. 545A
(Supersedes Service Bulletin No. 545)
Engineering Aspects are
FAA ApprovedSUBJECT: **Part I.** Oil Filler Tube Inspection/Replacement
Part II. Kit Installation ModificationMODELS AFFECTED: I. All Textron Lycoming TIO-540-AJ1A and IO-540-AC1A5 aircraft engines shipped from the factory before October 30, 2000, unless Kit P/N 05K23081 has been installed.
II. All Textron Lycoming TIO-540-AJ1A and IO-540-AC1A5 aircraft engines that have had Kit P/N 05K23081 installed before May 1, 2001.TIME OF COMPLIANCE: I. Inspect within the next 10 hours of operation and replace within the next 50 hours of operation.
II. Inspect at next oil change and modify installation, if required.**PART I**

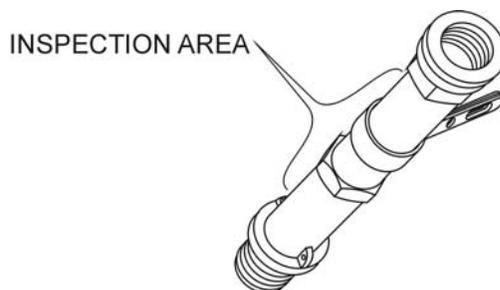
Figure 1

It has been determined that the existing oil filler tube installation could allow the clamp holding the tube to exert downward stress. This could result in damage to the filler tube.

In order to insure the structural integrity of the oil filler tube, it is necessary to inspect for gaps, openings, or damage to the tube and for the security of the clamp that supports the oil filler tube.

1. If Kit P/N 05K23081 has been installed (see Figure 2) proceed to Part II. If Kit P/N 05K23081 has not been installed, inspect tube (see Figure 1) for signs of gaps, cracks, leaks or damage. If damaged, replace before further flight.
2. Be sure that the clamp supporting the tube is not exerting downward pressure on the tube.

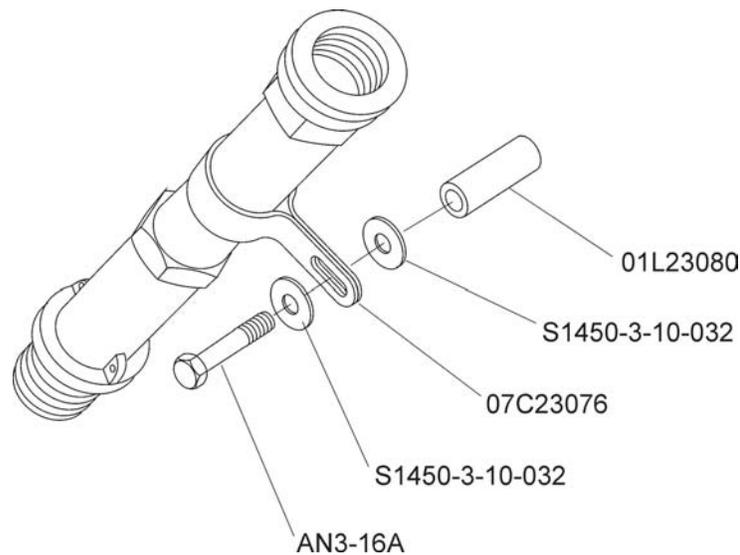
Subsequent to the original release of Oil Filler Tube Kit P/N 05K23081, the type, quantity and configuration of the washers have been modified.

If Kit P/N 05K23081 has been installed, refer to Figure 3. If two P/N S1450-3-10-032 washers are installed, no further action is required. If one S1450-3-8-032 washer is installed replace it as follows:

1. Remove the P/N AN3-16A bolt; retain the P/N 01L23080 spacer.
2. Discard the P/N S1450-3-8-032 washer.
3. Inspect the clamp (P/N 07C23076). If cracked or damaged, replace.
4. Reinstall the P/N AN3-16A bolt and the P/N 01L23080 spacer, using one P/N S-1450-3-10-032 washer under the bolt head and one between the bracket and spacer as shown in Figure 3. Torque the bolt to 49 in.-lbs.
5. Make an appropriate logbook entry of compliance.
