# SERVICE INSTRUCTION

Service Instruction No. 1509  
Engineering Aspects are  
FAA Approved

SUBJECT: Replacement of All P/N STD-1409 Nuts with P/N STD-2249 Nuts

MODELS AFFECTED: All Lycoming aircraft engines.

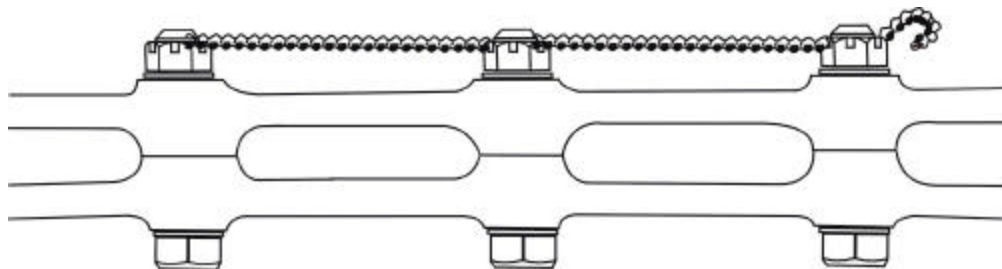
Figure 1.

Any time a P/N STD-1409 nut is removed from the crankcase parting line in the sump or from any other location (such as the oil pump body on TIO and TIGO-541 models, the magnetos and oil pump support on VO-360 and IVO-360 models, the oil suction tube on O-235 and O-320 models, and other applications), it should be replaced with P/N STD-2249 slotted nut.

The new P/N STD-2249 nut is to be torqued to 55 in.-lbs. and safety-wired (see Figure 1, below, for typical view of use in crankcase parting line in the sump).
