MANDATORY SERVICE BULLETIN

DATE: February 15, 2008 Service Bulletin No. 580
Engineering Aspects are
FAA Approved

SUBJECT: Reprint of Kelly Aerospace Service Bulletin No. 029.

TURBOCHARGER EXHAUST FLANGE INSPECTION AND/OR TURBINE HOUSING REPLACEMENT

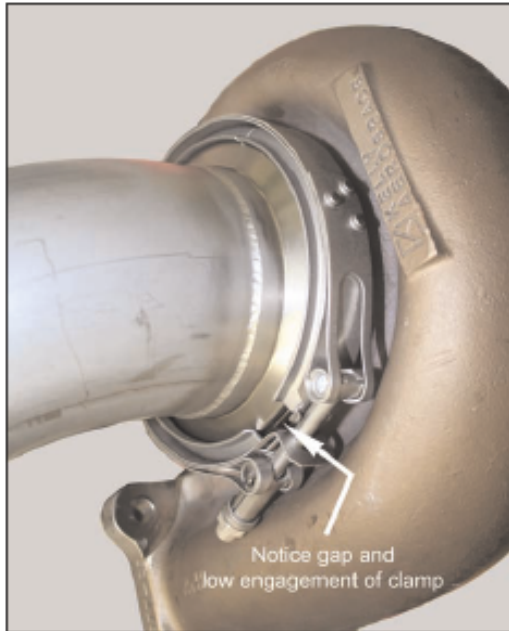
Figure 2 - "V" band Clamp Showing Gap

3. Carefully remove the "V" band clamp from around the turbocharger turbine housing at the turbocharger exhaust outlet taking care not to move the exhaust tube and tail pipe assembly. Figure 2 shows a "V" band clamp improperly installed, notice gap and clamp riding up on flange.

If the existing "V" band clamp is to be used, it should be inspected for damage on the inside of the "V" prior to re-use. If the inside radius of the "V" is flattened or cut it should not be used. Obtain the clamp part number from the appropriate aircraft or engine parts catalog.

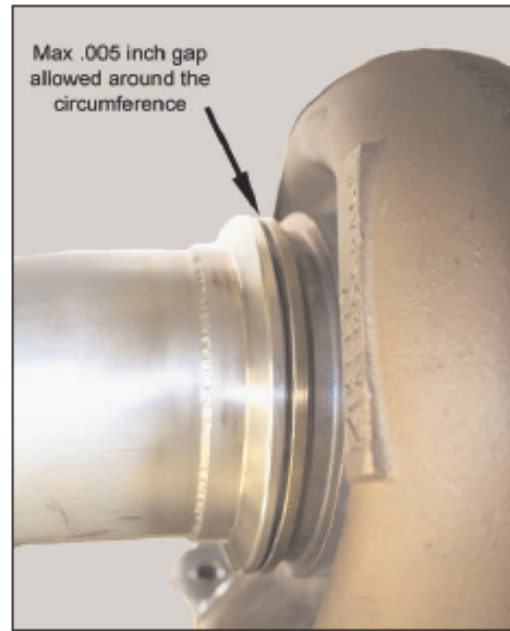
Figure 3 - Gap Inspection Area

4. Inspect the turbocharger turbine housing at the flange area captured by the "V" band clamp. Use a feeler gauge at the split line between the turbine housing flange and the exhaust tube flange all around the circumference. The maximum gap should not exceed .005 inch at any point. **If you suspect or know that the exhaust tube and tail pipe assembly was moved at any point prior to checking for the gap, apply pressure towards the turbine housing flange before taking a measurement.** Refer to Figure 3 on page 3.

5. If a gap exceeding tolerance is found, the turbocharger and tail pipe assembly should be removed. To accomplish this, follow the instructions contained in the Piper Aircraft or STC holder's maintenance manual or as applicable the appropriate Lycoming service information. Inspect and clean flange areas using methods recommended by Piper or Lycoming. **Do not attempt repair of the turbine housing.** Connect the cleaned exhaust tube to the turbocharger and re-inspect per step 4 above. If the gap still exceeds tolerance, the turbocharger turbine housing (P/N 441977-25) must be replaced. If gap tolerance is **not exceeded**, metal stamp a 1/8" upper case "T" in the area shown in Fig 4 (per step 7) to indicate the instruction was performed then proceed to step 10.

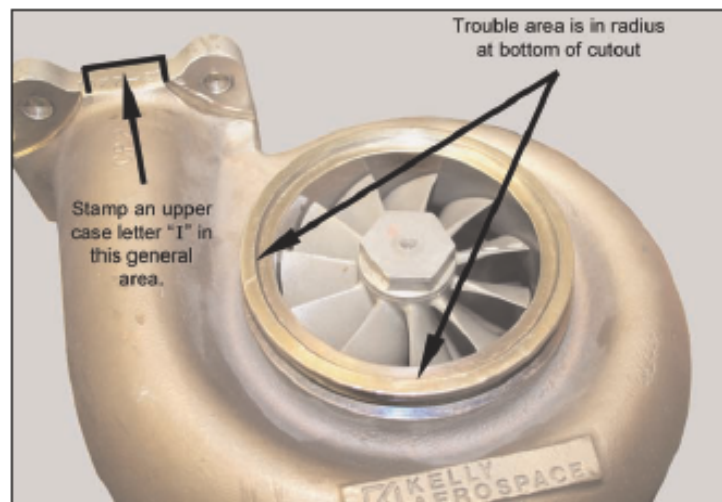
Figure 4 - Turbine Housing Trouble Area

It has come to the attention of Kelly Aerospace Power Systems (KAPS) that a possible interference condition may exist between the turbocharger turbine exhaust outlet flange area and the mating flange of the airframe exhaust tube. The piloted type exhaust tube flange may contact the fillet radius of the turbine housing relief cut not allowing the two flange faces to meet properly. (see Figure 3 on page 3) Turbine housings manufactured between August 25, 2006 and October 12, 2007 are suspect. If this condition exists, exhaust pipe security may be compromised. While the exhaust outlet side of the turbocharger turbine has relatively low pressures, the potential of an exhaust leak, a loosening of the "V" band clamp, and a rise of temperature within the engine cowling exist. Left uncorrected, failure of the "V" band clamp may occur with possible loss of the tail pipe connection with resultant uncontained hot exhaust gas within the engine cowl.

6. Upon removal, the turbocharger must be sent to a properly certificated part 145 repair station (or foreign equivalent) experienced in turbocharger repair.
7. Once the turbocharger has been repaired and returned, visually inspect for condition and orientation of the turbine housing then, using a 1/8" metal stamp of an upper case "T", stamp the turbine housing in the area shown in Figure 4. Care must be taken not to extend stamp within 1/8" of the mating edge as it may bulge and distort the mating surface. When stamped, proceed with the installation.
8. Utilizing the applicable aircraft, engine, and/or STC holders maintenance manuals or service instructions, re-install the turbocharger assembly.
