SERVICE BULLETIN

DATE: October 17, 2008
Service Bulletin No. 584B
(Supersedes Service Bulletin No. 584A)
Engineering Aspects
FAA Approved

SUBJECT: Reprint of MANDATORY Unison Service Bulletin No. SB3-08A

SUBJECT: Mandatory inspections on all Slick 4200/6200/4300/6300 and LASAR™ 4700/6700 magnetos

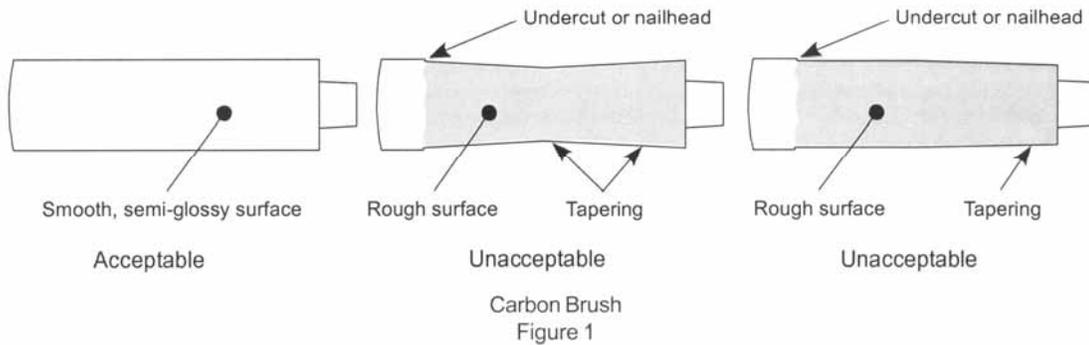
1. Use lighted magnification (4X minimum) to inspect carbon brush for rough surface and possible tapering. **REPLACE CARBON BRUSH THAT SHOWS ANY OF THE UNACCEPTABLE CONDITIONS SHOWN IN FIGURE 1 PER THE APPLICABLE MAINTENANCE AND OVERHAUL MANUAL.**

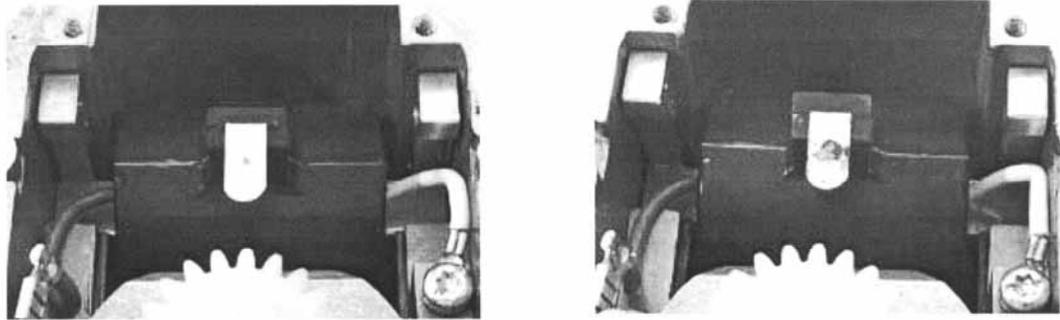
Evidence of Improper Wear of Carbon Brush
Figure 2

- Inspect coil tab for carbon residue coating left by carbon brush. See Figure 2. **REPLACE CARBON BRUSH PER THE APPLICABLE MAINTENANCE AND OVERHAUL MANUAL IF SUBSTANTIAL RESIDUE IS FOUND ON COIL TAB.** Use a cotton swab and alcohol to remove residue from coil tab, or replace coil if tab cannot be cleaned. Also inspect high tension coil tab for wear caused by carbon brush. Wear is indicated by a visible depression in the tab. If tab is worn, replace coil.

Acceptable

Unacceptable

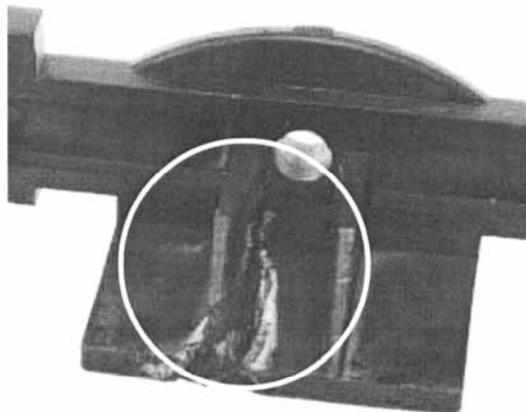
Bearing Bar
Figure 3

- Inspect bearing bar for evidence of brush residue contamination, burning, or arcing. See Figure 3. **REPLACE DISTRIBUTOR BLOCK ASSEMBLY PER THE APPLICABLE MAINTENANCE AND OVERHAUL MANUAL IF THERE IS ANY EVIDENCE OF ELECTRICAL ARCING OR BURNING.** The new bearing bar can be identified by either the manufacturer-dated packaging, or visually by noting the dams.

Unacceptable
(Developing bearing bar failure)

- If bearing bar does not show evidence of burning or arcing, clean and remove any normal residue per the applicable Maintenance and Overhaul Manual and reassemble into the magneto.

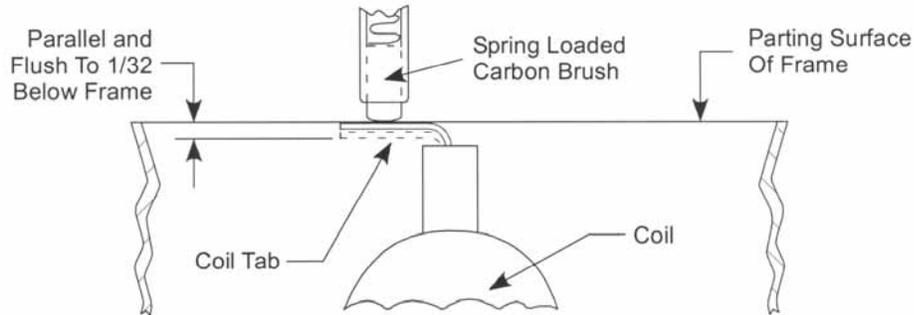
Coil Tab Positioning
Figure 4

CAUTION: IF THE COIL TAB PROTRUDES ABOVE THE MAGNETO FRAME, IT CAN MAKE DIRECT CONTACT WITH THE DISTRIBUTOR GEAR AXLE AND CAUSE THE MAGNETO TO MALFUNCTION.

- Prior to installing distributor block, make sure coil tab is parallel to and flush with frame mating surface to within 1/32 inch. See Figure 4.
