SERVICE BULLETIN

Service Bulletin No. 581A
Engineering Aspects are
FAA Approved

SUBJECT: Reprint of Precision Airmotive MANDATORY Service Bulletin Nos. PRS-107, Rev. 4 and PEX-1, Rev. 1

SUBJECT: HEX PLUG 383493 COMING LOOSE FROM REGULATOR COVER

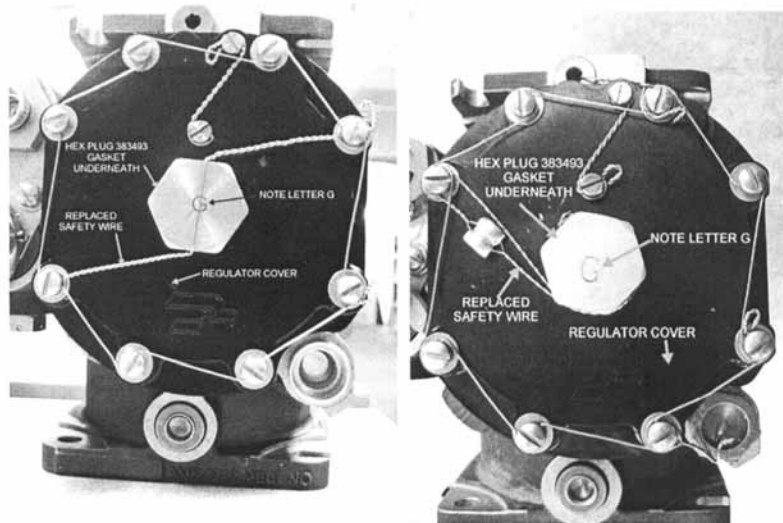
Note: The safety wire through the hex plug shown in the left hand photo is .025” wire wrapped around regulator screws under existing wire. It does not go through the holes in the screws. The safety wire through the hex plug shown in the right hand photo is .015” wire which passes through the regulator screw hole. This is the normal safety wire method used at the factory.

IMPORTANT: The letter “G” shown in the photos is to be stamped ONLY if the new gasket, part number 2577258 has been installed.

7. The hex plug must be safety wired with .015 thru .025 inch diameter wire to the regulator cover as shown in the photos on the next page. The wire shall pass thru the plug such that it pulls the plug in the tightened direction and does not rest on the corners of the hex on the plug (it is acceptable to wrap under the corners of the hex plug). These photos are just two examples of acceptable safety methods. Other safety wire methods such as those described in FAA AC 43-13-1B (or latest revision) are also acceptable.

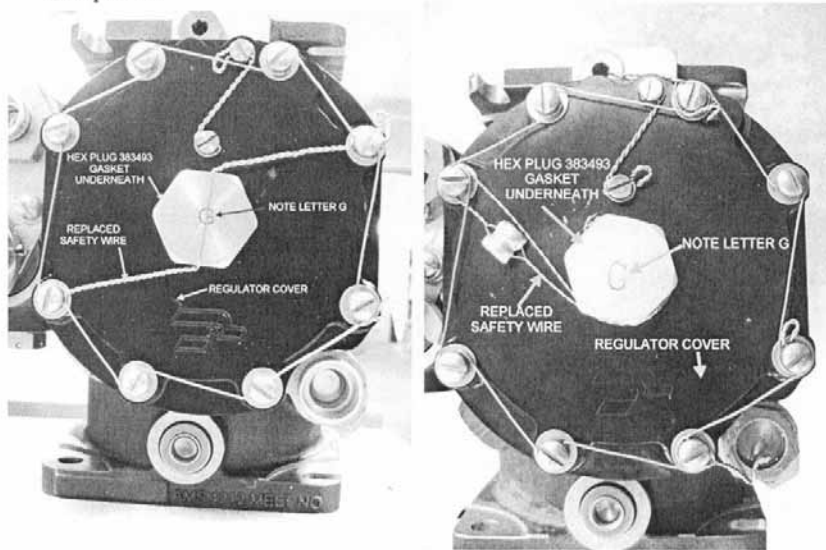
Note: The safety wire through the hex plug shown in the left hand photo is .025” wire wrapped around regulator screws under existing wire. It does not go through the holes in the screws. The safety wire through the hex plug shown in the right hand photo is .015” wire which passes through the regulator screw hole. This is the normal safety wire method used at the factory.

IMPORTANT: The letter “G” shown in the photos is to be stamped ONLY if the new gasket, part number 2577258 has been installed.

6. With an acceptable hex plug, an acceptable regulator cover, and an acceptable gasket, install the gasket over the hex plug and install plug into the regulator cover. Torque the hex plug to 90-100 in-lbs.
7. The hex plug must be safety wired with .015 or .025 inch diameter wire to the regulator cover as shown in the photos below. The wire shall pass thru the plug such that it pulls the plug in the tightened direction and does not rest on the corners of the hex on the plug (it is acceptable to wrap under the corners of the hex plug). These photos are just two examples of acceptable safety methods. Other safety methods such as those described in FAA AC 43-13 are also acceptable.
