SERVICE INSTRUCTION

DATE: August 22, 2008 Service Instruction No. 1520
Engineering Aspects are
FAA DER Approved

SUBJECT: Reprint of Precision Service Information Letter No. SIL RS-88

SUBJECT: Inspection of Regulator Hex Plug on RSA-5 and RSA-10 Fuel Injection Servos.

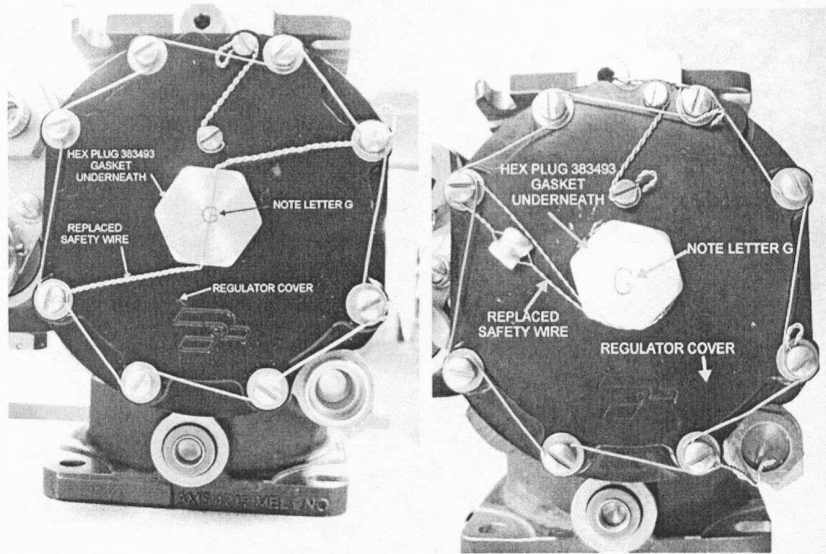
- A. **EFFECTIVITY:** This Service Information Letter is applicable to all RSA-5 and RSA-10 servos which do NOT have a “G” marked on the regulator hex plug (see photograph page 2.).

- C. **DETAILED INSTRUCTIONS:** If your aircraft has an RSA-5 or RSA-10 fuel injection servo that is NOT marked with a “G” on the regulator hex plug, during each annual or other periodic inspection (but at least annually) the regulator hex plug on the fuel injection servo should be inspected to verify that it is not loose. The regulator hex plug is a 1” brass hex plug on the large round cover on the side of the fuel injection servo. (See photograph page 2.)

6. Stamp or scribe the letter “G” onto the face of the hex plug as shown in the sample photos. This shall be done with the plug removed from the servo. DO NOT stamp the plug with it installed in the servo.

8. The hex plug must be safety wired with .015 thru .025 inch diameter wire to the regulator cover as shown in the photos below. The wire shall pass thru the plug such that it pulls the plug in the tightened direction and does not rest on the corners of the hex on the plug (it is acceptable to wrap under the corners of the hex plug). These photos are just two examples of acceptable safety methods. Other safety wire methods such as those described in FAA AC 43-13-1B (or latest revision) are also acceptable.
