MANDATORY SERVICE BULLETIN

DATE: March 27, 2006 Service Bulletin No. 568

SUBJECT: Reprint of Slick Aircraft Products Service Bulletin No. SB1-88B

SUBJECT: Periodic Inspection of Slick Models 6320, 6324, 6360, 6361, 6363, and 6365 Pressurized Magnetos

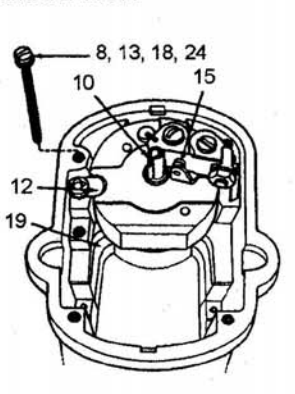
Figure 1

- (1) Check for rust and corrosion on screws (8, 13, 18, 24), bearing cap hold down clamps (12), rotor shaft (10), breaker point assembly (15), frame and coil laminations (19), etc. See Figure 1. Rust and corrosion are signs of contamination and require component cleaning or replacement (reference paragraphs 3.B and C of this bulletin and Slick Maintenance and Overhaul Manual L-1037.

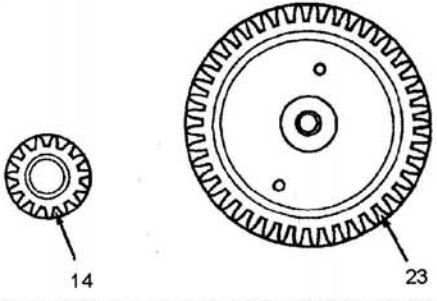
Figure 2

(2) Soft or sticky distributor and rotor gears (14, 23) indicate moisture contamination and require component replacement (reference Slick Maintenance and Overhaul Manual L-1037). See Figure 2.

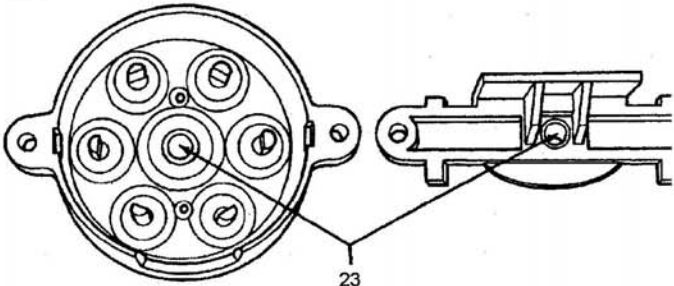
Figure 3

(3) Gummy or sticky distributor gear oilite bearing (23) indicates contamination. Check distributor block assembly according to instructions in Slick Maintenance and Overhaul Manual L-1037. See Figure 3.

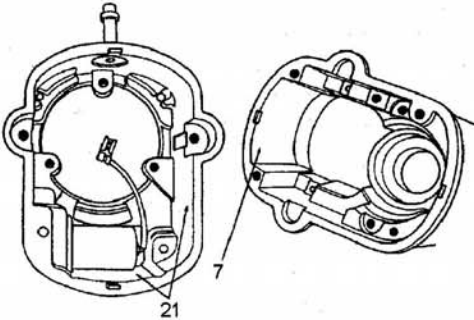
Figure 6

- (6) A yellow powder, yellow particles, oxides, or white chalky powder on the magneto frame (7) and housing (21) indicates moisture or corrosive contamination. See Figure 6. Clean or replace as necessary following procedures in paragraphs 3.B and C of this bulletin and Slick Maintenance and Overhaul Manual L-1037.

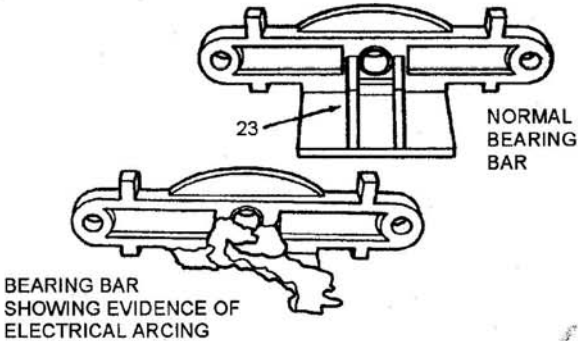
Figure 8

- (8) Electrical tracking or arcing in the distributor block and bearing bar (23) indicates contamination or lack of pressurization. See Figure 8. Check distributor block assembly according to instructions in paragraphs 3.B and C of this bulletin and Slick Maintenance and Overhaul Manual L-1037.

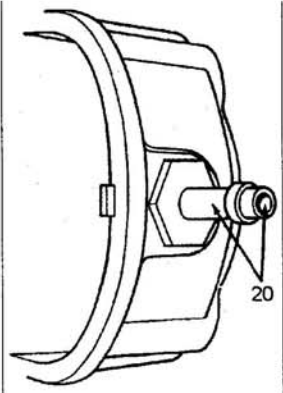
Figure 11

- (15) Inlet Nozzle (20) - Check and clean inlet nozzle M3180 to insure it is clean and free of obstruction. See Figure 11. Reference paragraphs 3.B and C of this bulletin. Yellow or white particles or an oily film in the inlet nozzle indicates moisture contamination and possible lack of pressurization. Reference the engine and/or airframe manufacturer's literature for pressurization system corrective action.

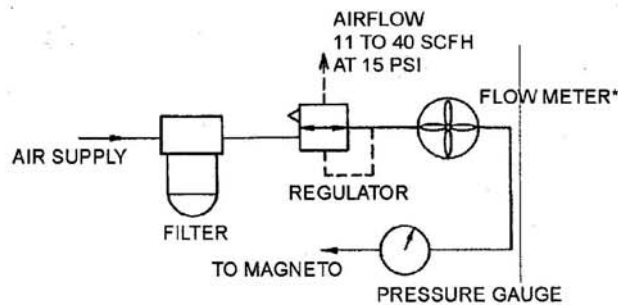
- B. Pressure Testing - After magneto reassembly, install a pressurized harness cap and apply 15 PSI filtered air to the inlet nozzle of the magneto. Air flow at 15 PSI should be 11 to 40 standard cubic feet per hour (SCFH). If flow is excessive, reposition gaskets and re-torque housing and harness cap screws. Screws should be torqued to 18-20 in.-lbs. See Figure 12 for Test Apparatus details. Testing should be conducted with magneto at room temperature.

NOTE: Airflow limits apply only to the magneto, and do not include any other engine accessories or plumbing. If the airflow is less than 11 SCFH, replace the tachometer sensor with either Piper PN 84652-002 Mod 1 or Teledyne Controls PN 0402-102 Mod 1.
