MANDATORY SERVICE BULLETIN

DATE: September 21, 2007 Service Bulletin No. 576
Engineering Aspects are
FAA Approved

SUBJECT: Reprint of Teledyne Continental Ignition Systems Service Bulletin No. SB633A

**SUBJECT: TWO-WIRE MAGNETO TACHOMETER
BREAKER CONTACT (POINTS) ASSEMBLY
PART NUMBER 10-400507**

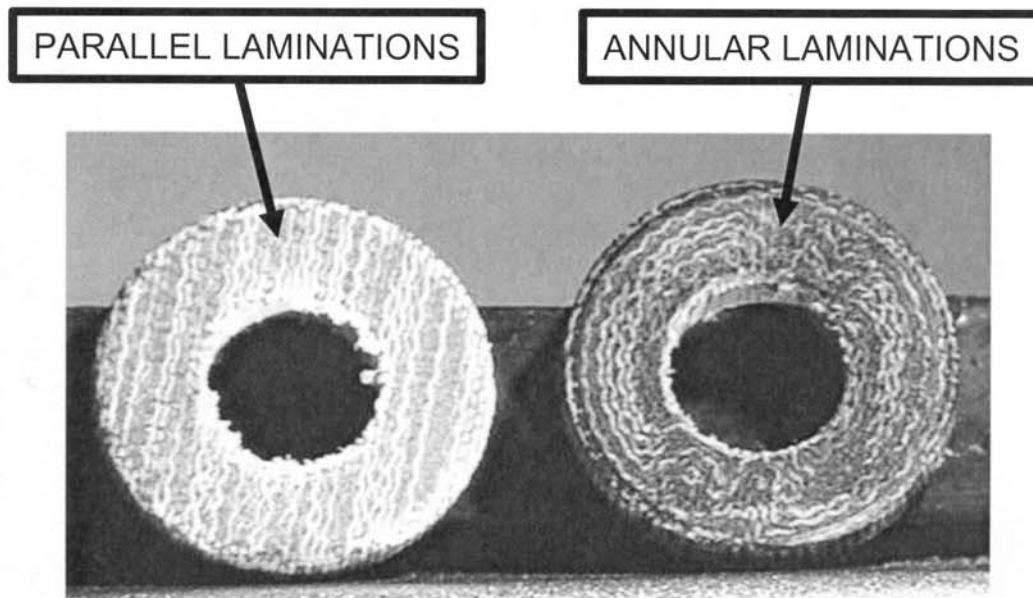
FIGURE 1
P/N 10-361639 PHENOLIC BUSHING INSPECTION

- (a) Inspect the P/N 10-361639 tachometer insulating bushings for cracks, crushing or other damage. Current bushings use phenolic material that is laminated in an annular (circular) pattern. (Reference Figure 1)

- (d) Visually inspect the P/N 10-361639 phenolic insulating bushings for damage after torque application. Any damaged bushings must be replaced before further service.

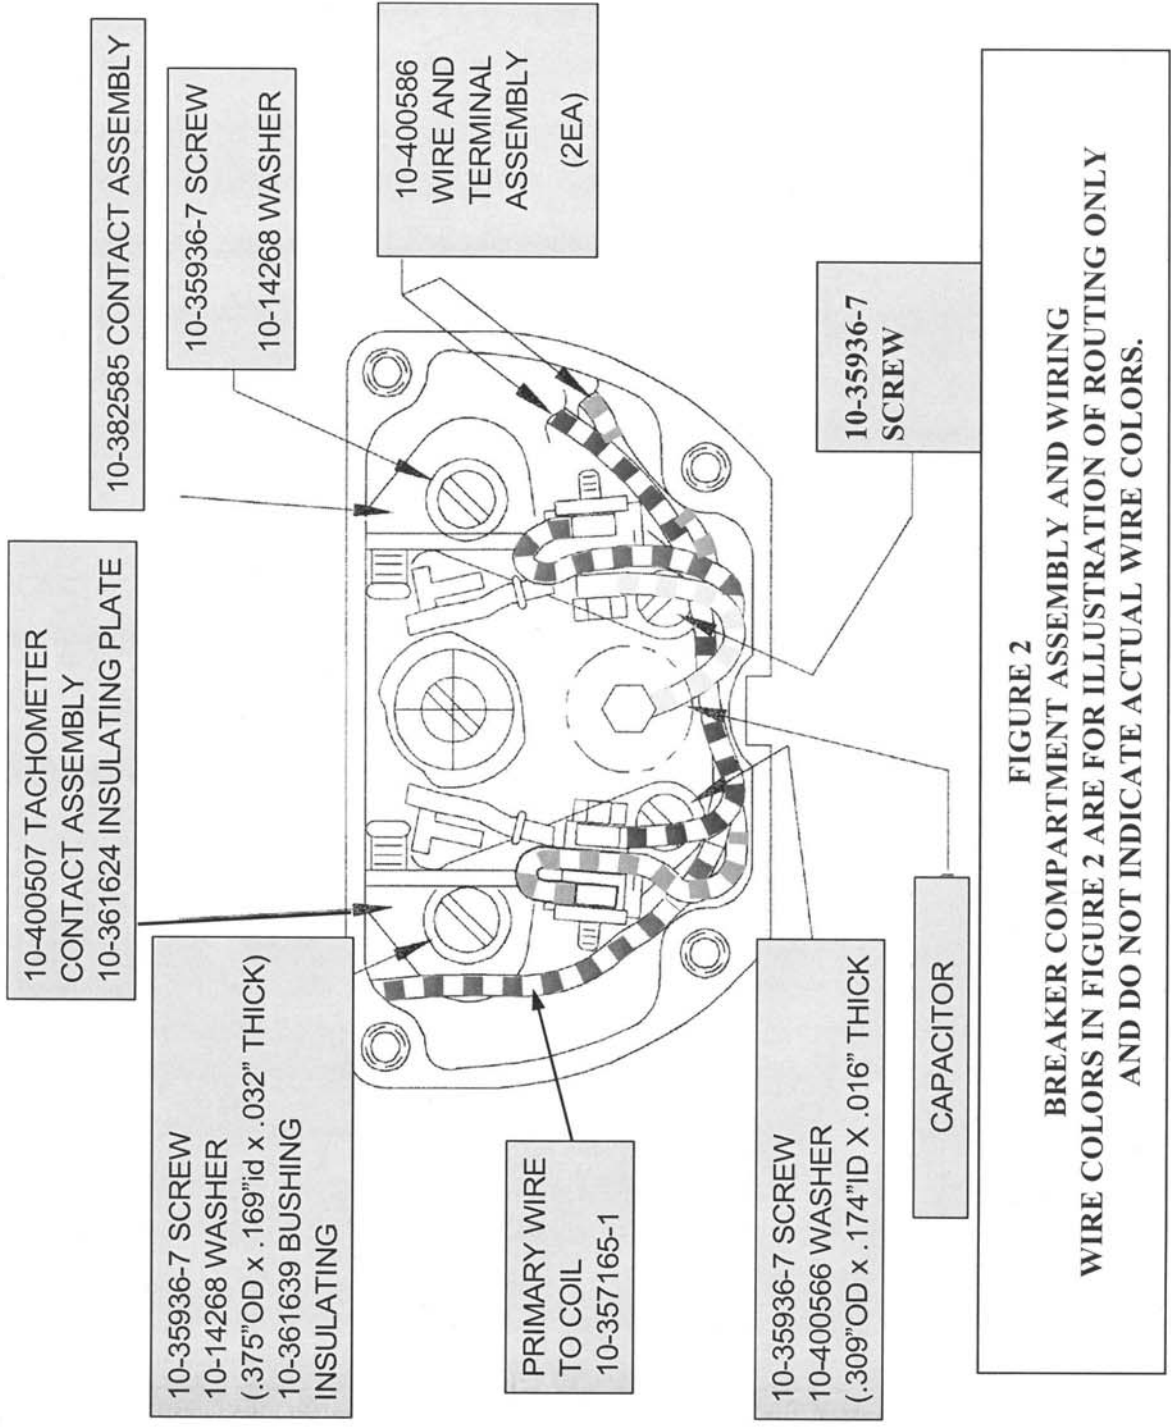
FIGURE 2
BREAKER COMPARTMENT ASSEMBLY AND WIRING
WIRE COLORS IN FIGURE 2 ARE FOR ILLUSTRATION OF ROUTING ONLY
AND DO NOT INDICATE ACTUAL WIRE COLORS.

1. Parts Assembly: Figure 2 depicts the correct current configuration of parts, assemblies and wiring in the magneto breaker compartment of the affected magnetos.

- (b) Any bushing found to have parallel laminations as shown in Figure 2 must be replaced before further service.
 - (c) Set tachometer contacts to .016 - .022 clearance on the high lobe of the cam. Apply 8-10 inch-pounds torque to the retaining screws.

2. The breaker compartment features four wires that must be assembled properly to ensure continued reliable service: the coil primary wire, the two tachometer wires, and the capacitor wire. (See FIGURE 2.) Whenever access allows, inspect wires to ensure that they are free of cuts or chafing damage. Wires must be routed as shown in FIGURE 2 to ensure that they do not interfere with the rotating cam and associated parts during operation, and to ensure that no wire is pinched between the breaker cover and distributor housing at assembly. Any excess coil wire may be protected by bending it away from the cam. Coil and capacitor wires feature insulation that is relatively soft. Indentations on the insulation on these parts are normal and expected. Any exposed wire strands is cause for replacement. Replace damaged parts as necessary. The two tachometer wires use a short length of tubing as an assembly aid: the position of the tubing at

- (e) Washer P/N 10-14268 is used under the screw at the adjusting slot in the P/N 10-400507 tachometer contact assembly. The washer is thicker and wider to spread the clamping load evenly to the bushing that bridges the slot.

- (f) Washer P/N 10-400566 is used under the screw at the pivot hole in the P/N 10-400507 tachometer contact assembly. This washer is smaller to ensure electrical insulation from the tachometer assembly. The insulating bushing is supported on all sides by the breaker support.

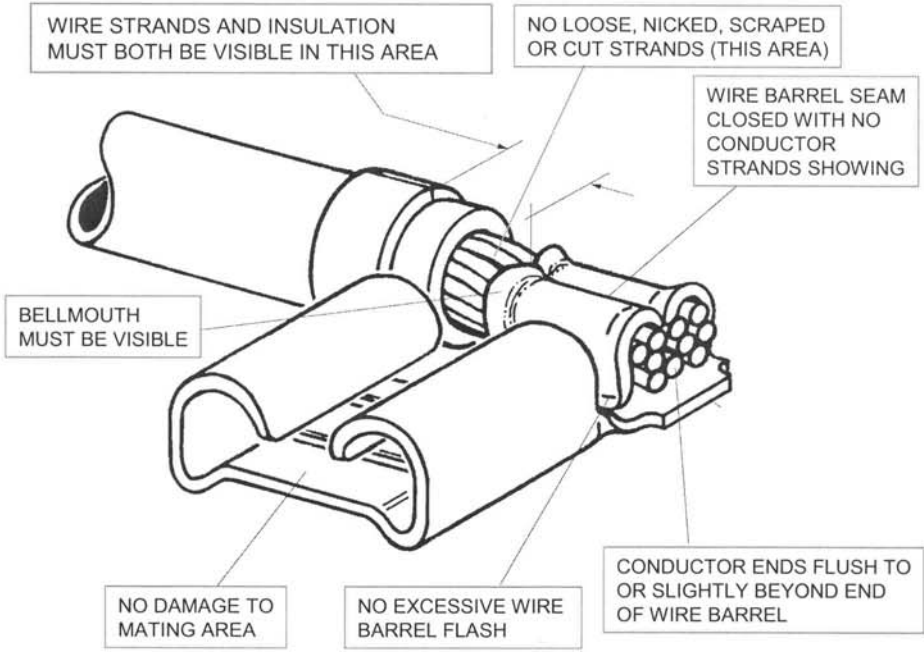
FIGURE 3

3. Whenever access allows, inspect the wiring terminals (Flag Terminals) for integrity as shown in Figure 3.
4. Hi-Pot insulation integrity test.
 - (a) As applicable, disconnect magneto tachometer wires from all airframe circuits in accordance with airframe manufacturer's instructions.

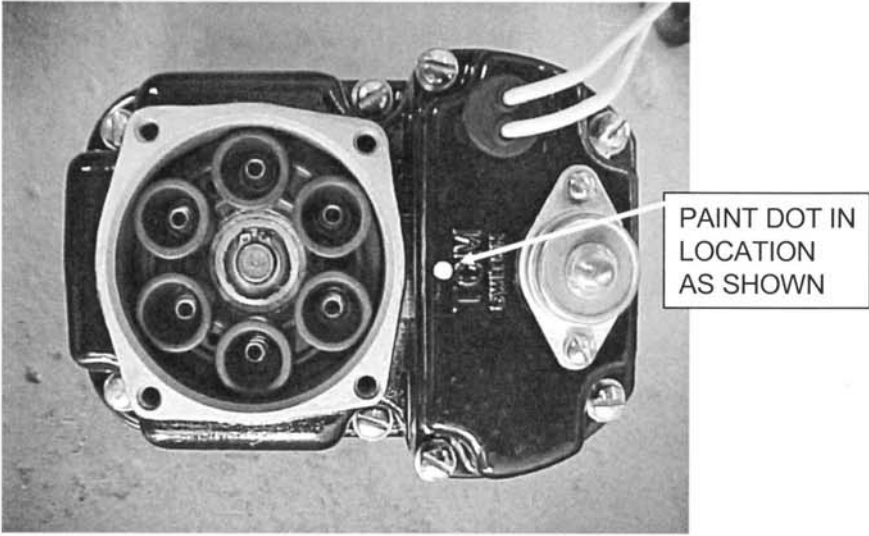
FIGURE 4

Initial compliance identification. Applicable to designated serial number range only.
NOTE: Initial compliance does not preclude recurring compliance performance in accordance with the recurring inspection requirements of this bulletin.
