MANDATORY
SERVICE BULLETIN

Service Bulletin No. 594

SUBJECT: Reprint of Hartzell Engine Technologies LLC (HET) (formerly Kelly Aerospace) Mandatory Service Bulletin 040 A.

TURBOCHARGER CHRA CONTAMINATION

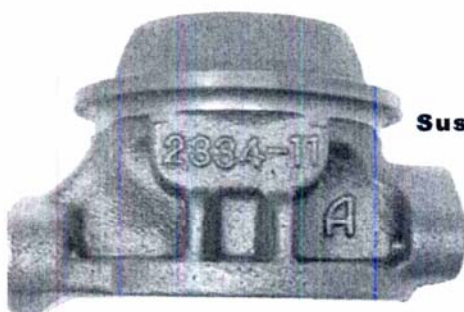
Figure 2 - Foundry Mark "Slanted A"

3. Using Figures 2, 3, and 4, identify the foundry mark located on the CHRA center housing as shown. Those with a circled "JT" are not affected and may proceed to the "Return to Service" section step 3 & 4. If a "slanted A" appears, continue with the DISASSEMBLY and CLEANING sections.

Suspect

4. If it has been determined that the CHRA center housing is affected per Table 1 and IDENTIFICATION section above, the turbocharger must be removed and disassembled to isolate the CHRA center housing.
5. Utilizing the most current Service Manual or Service Instructions of the applicable engine or airframe manufacturer, remove the turbocharger from the engine. To avoid the possibility of debris entering the turbocharger system connections, cap all open lines and ducts.

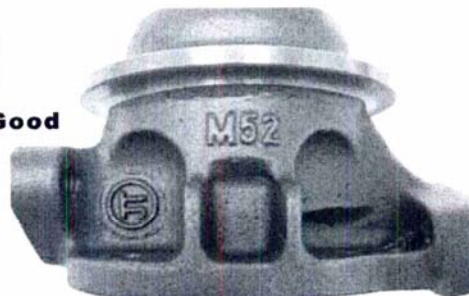
Figure 3 - Foundry Mark "JT"

Good

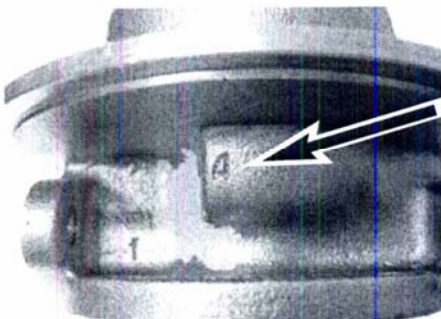
Foundry Mark May
Also Be An Indented
"Slanted A"

Suspect
