MANDATORY

SERVICE BULLETIN

DATE: October 30, 2015 Service Bulletin No. 411D
(Supersedes Service Bulletin No. 411C)
Engineering Aspects are
FAA (DER) Approved

SUBJECT: Adapter Kit for Magneto Isolation Drive

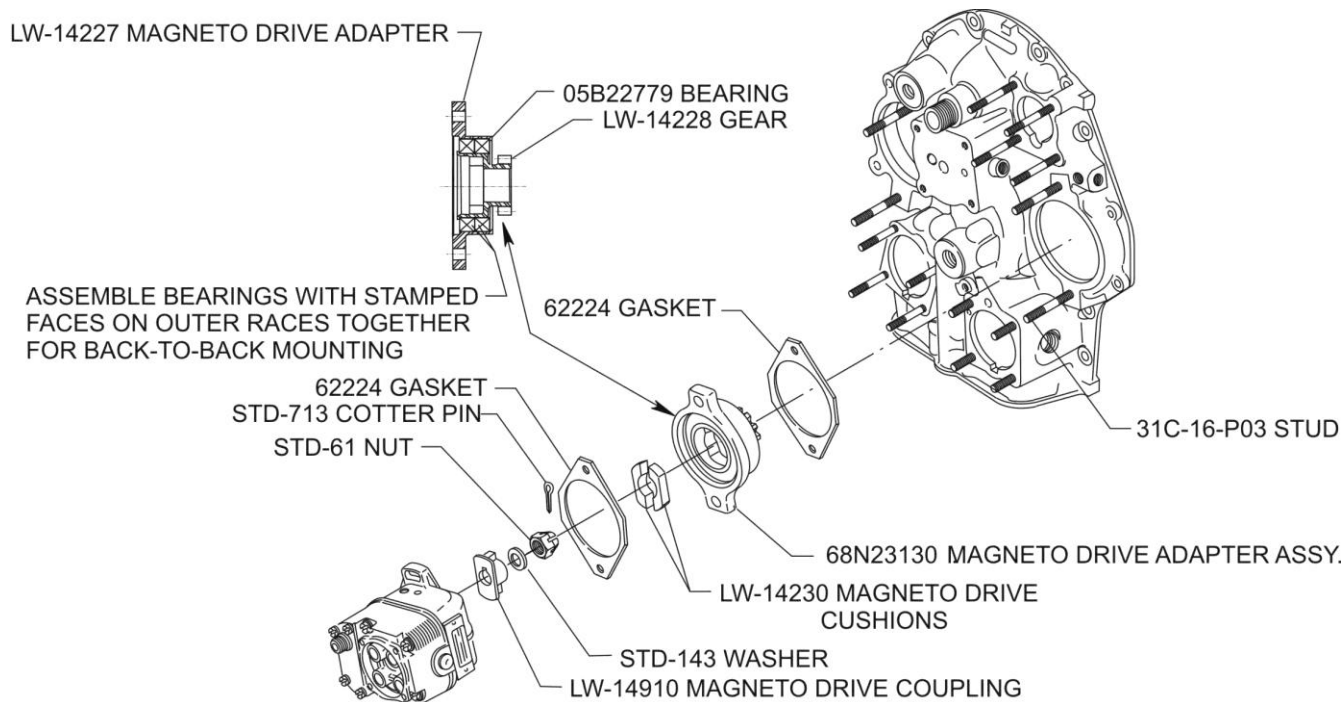
IO-360-B4A engines (not installed on Piper PA28-181 (Archer III) aircraft) and O-360-A4A, -A4J, and -A3A engines are built with a crankshaft designed to match the operating characteristics of the propeller. This combination, by effecting efficient power transfer, provides satisfactory performance of the aircraft. However, service records of aircraft with this engine and propeller combination indicate requirement for more than usual maintenance of the right hand magneto drive components.

To provide a more maintenance-free magneto drive system, a new magneto drive adapter and rubber cushion has been designed to isolate the magneto from the vibratory forces that could be transmitted by the driving components. This product improvement has been introduced in both new and rebuilt engines with serial number and date as shown above.

Figure 1
Magneto Drive and Component Parts
IO-360-B4A Engines (Not Installed On Piper PA28-181 (Archer III) Aircraft)
and O-360-A4A, -A4J, and -A3A Engines

Also, a modification kit is now available for field installation as described in the following procedure. Note that this modification consists of removing the right magneto, replacing the attaching studs in the accessory housing, and replacing the drive components of the magneto as shown in Figure 1.

1. Remove the right magneto and the attaching studs in the accessory housing.
2. Install the two (2) P/N 31C-16-P03 studs in the accessory housing. The correct driven height of these studs is 1.34 to 1.38 in. (34 to 35 mm).

3. Place a new P/N 62224 gasket over the studs on the magneto mounting pad in the accessory housing. Then install P/N 68N23130 magneto drive adapter over the studs.

6. Install the P/N LW-14910 magneto drive coupling on the magneto shaft; then reassemble the washer and nut removed in Step 4. Torque the nut to 20 to 25 ft.-lb. (27 to 34 Nm) and secure the nut with a new P/N STD-713 cotter pin.

7. Install two (2) P/N LW-14230 drive cushions in the P/N 68N23130 magneto drive adapter, then place a P/N 62224 gasket over the studs against the adapter and reassemble the magneto on the engine.

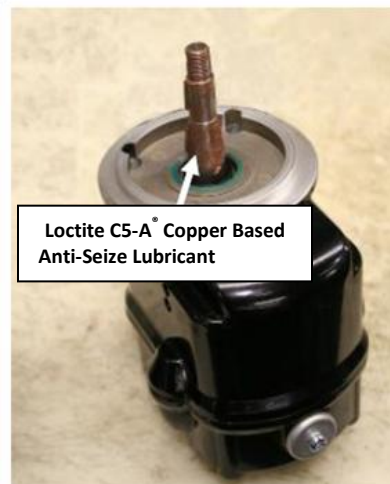
Figure 2
Apply Loctite C5-A[®] Copper Based
Anti-Seize Lubricant to the Shaft

4. Remove the cotter pin, nut, washer, and drive gear from the magneto drive shaft.
5. Clean the magneto shaft with a cloth wetted with methyl-ethyl ketone or clean unleaded gasoline. Dry thoroughly and apply a light coat of Loctite C5-A[®] Copper Based Anti-Seize Lubricant to the tapered portion of the magneto shaft (Figure 2).
