# MANDATORY

# SERVICE BULLETIN

Supplement No. 1

Service Bulletin No. 475C

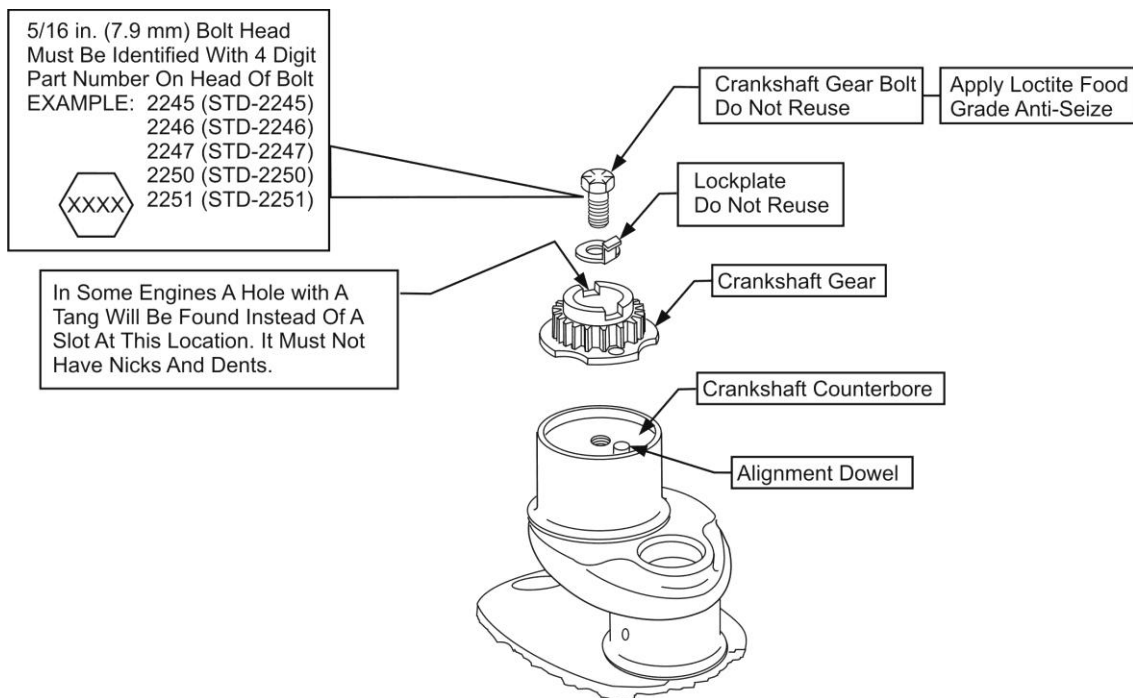
**Figure 1**  
**Crankshaft Gear Bolt and Lockplate**

**NOTICE:** Any time the crankshaft gear bolt (Figure 1) and lockplate are removed from the crankshaft gear, the bolt and lockplate are to be discarded and replaced with a new bolt and new lockplate for the applicable crankshaft gear. The discarded bolt and lockplate are not to be re-installed on any engine.

- Remove the crankshaft gear bolt, lockplate, and crankshaft gear from the crankshaft (Figure 1). Discard the bolt and the lockplate.

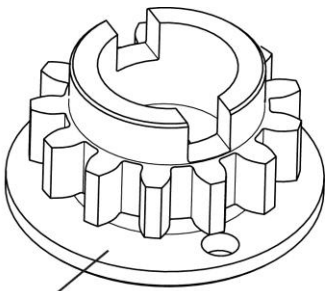
Over the years, because of design improvements to the crankshaft gear, the pilot flange on the gear has changed from a round shape (Figure 2), then briefly to a small scallop pilot flange (Figure 3), and finally to the current configuration of a large scallop pilot flange (Figure 4). The three-scallop pilot flange enables the insertion of a feeler gage to make sure the gear is correctly seated after the gear is installed on the crankshaft. The crankshaft gear must be correctly seated to ensure correct engagement with the other gears.

If the crankshaft gear does not have the larger three scallops as shown in Figure 4 and looks like either crankshaft gear shown in Figure 2 or Figure 3, discard the crankshaft gear and replace it with a new crankshaft gear with the larger scallops as shown in Figure 4. Refer to Table 2 and Figure 5 to identify the correct replacement crankshaft gear.

If the crankshaft gear looks like the large scallop pilot flange-type crankshaft gear (P/Ns 13S19646 and 13S19757) shown in Figure 4, make sure the gear has the 0.02 in. (0.51 mm) cut on the underside of the gear as shown in Figure 5. Otherwise, replace with a serviceable crankshaft gear.

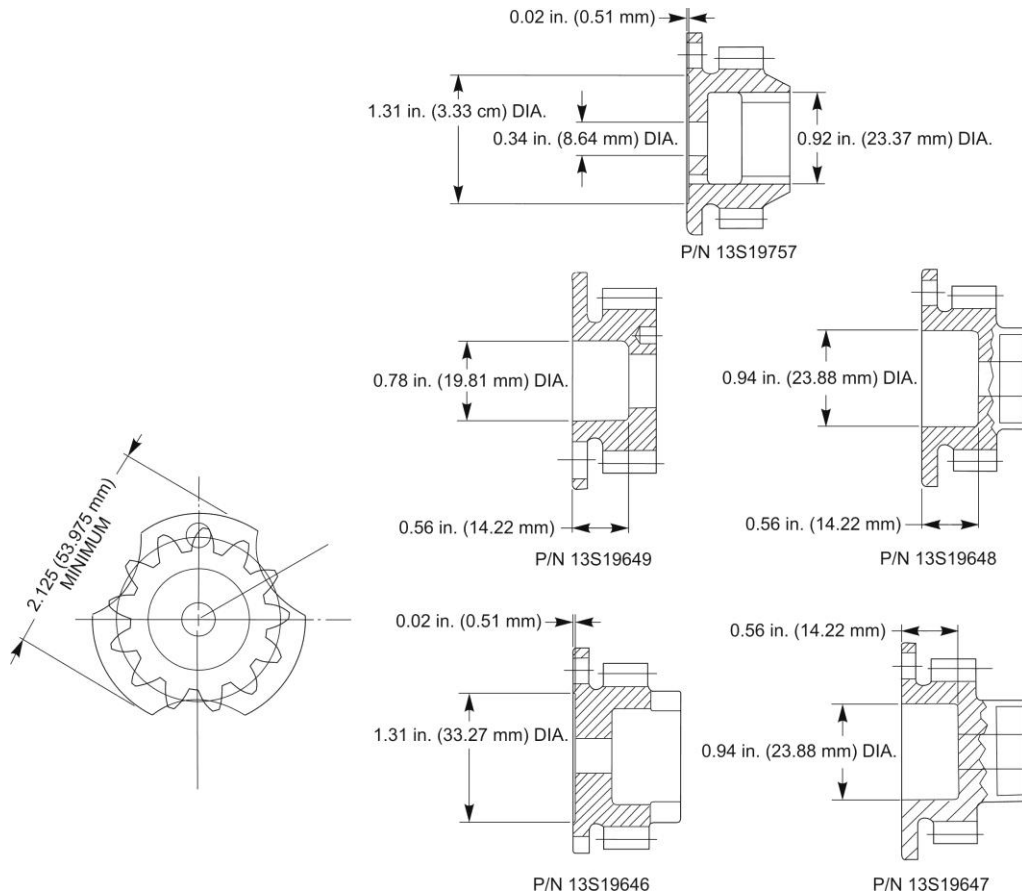
**Figure 5**  
**Details for Crankshaft Gears to Current Configuration**

3. Measure the diameter of the crankshaft gear pilot flange. If the diameter of the pilot flange is less than 2.125 in. (53.975 mm) (Figure 5), do not install this gear on the crankshaft. Replace the crankshaft gear with a serviceable crankshaft gear.

4. Measure the dimensions on the crankshaft gear as per those shown in Figure 5 for the respective crankshaft gear part number in Table 2.
5. Complete a magnetic particle inspection on the crankshaft gear anytime the crankshaft gear is removed. Refer to the latest revision of Service Instruction No. SI-1285.

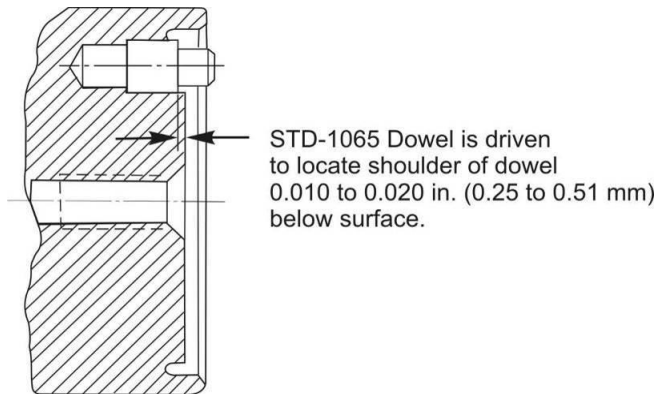
**Figure 6**  
**Section Through Crankshaft Counterbore End of Crankshaft Showing Driven Height of STD-1065 Alignment Dowel**

3. If the alignment dowel is smooth and round, make sure that it is installed correctly, by the following measurements.
  - A. Figure 6 for STD-1065-type alignment dowels, the shoulder of the alignment dowel is 0.010 to 0.020 in. (0.25 to 0.51 mm) below the surface of the crankshaft.
  - B. Figure 7 for alignment dowels STD-2078 shows that the end of the alignment dowel is 0.160 ± 0.010 in. (4.06 ± 0.254 mm) above the counterbore surface of the crankshaft.
4. Measure the diameter of the alignment dowel (Dimension A) shown in Figure 8 and determine if the measurement conforms to the values in Table 3 for the different alignment dowel part numbers.
5. If the alignment dowel is out of tolerance, out of round, or damaged, replace the alignment dowel with a new one as per instructions in the section “Alignment Dowel Replacement.”

11. Press the replacement alignment dowel into the alignment dowel hole, refer to Figure 6 or 7 for the correct driven height of the applicable alignment dowel.

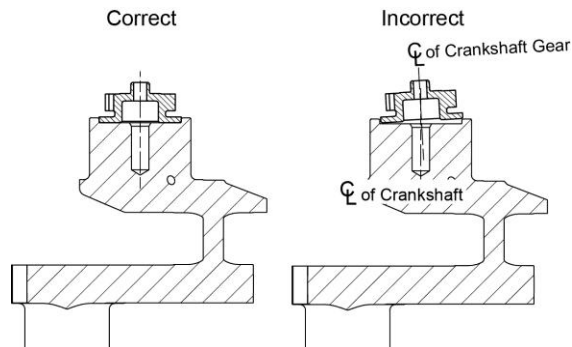
**Figure 9**  
**Crankshaft Gear Position**

**⚠ CAUTION:** FOR CORRECT ENGINE OPERATION, THE CRANKSHAFT GEAR MUST BE INSTALLED CORRECTLY WITH NO GAP BETWEEN THE MATING SURFACES OF THE COUNTERBORED-END OF THE CRANKSHAFT AND THE CRANKSHAFT GEAR PILOT FLANGE (FIGURE 9).

9. Make sure the crankshaft gear seats firmly and is perpendicular (not at a slanted angle) to the crankshaft as shown in Figure 9:
  - A. Try to put a pointed 0.001 in. (0.025 mm) feeler gage or shim stock between the crankshaft gear pilot flange and crankshaft counterbore at each of the three scallops on the crankshaft gear pilot flange. The feeler gage must NOT fit between the two surfaces at any location. There must not be any clearance between the crankshaft and crankshaft gear pilot flange.

- B. If clearance is found, remove the crankshaft gear bolt, lockplate, and crankshaft gear.
  - C. Make sure the mating surfaces of the crankshaft gear and crankshaft counterbore are clean and dry and that there is no debris.

- D. Reinstall the crankshaft gear, lockplate, and crankshaft gear bolt. Repeat the initial torque and seating check above.
  - E. Try again to put a pointed 0.001 in. (0.025 mm) feeler gage or shim stock between the crankshaft gear pilot flange and crankshaft counterbore at each of the three scallops on the crankshaft gear pilot flange.

- F. If there is still clearance, replace the crankshaft gear.
  - G. If there was no clearance, the crankshaft gear is seated correctly. Complete the final torque of the crankshaft gear bolt.
