MANDATORY SERVICE BULLETIN

DATE: August 31, 2005 Service Bulletin No. 548A
(Supersedes Service Bulletin No. 548)

SUBJECT: Diaphragm-Type Fuel Pump Inspection/Replacement

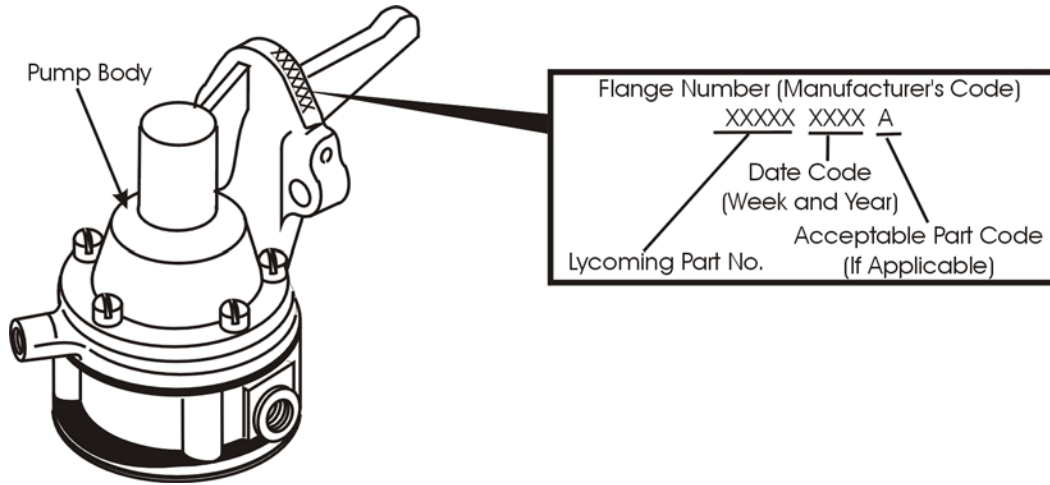
Figure 1

To identify affected pumps, check the manufacturer's code scribed on the flange of the pump (See Figure 1). If the first five digits are 15399, 15472, 15473, or 16335, and the 6th through 9th digits are 0700, 0800, 1100, 1200, 1300, 1400, 1500, 1600, 1800, 2000, 2100, 2200, 2300, 2400, 2800, 2900, 3000, 3100, 3200, 3300, 3400, 3500, 3600, 3700, 3800, 3900, 4000, 4100, 4200, 4300, 4400, 4500, 4600, 4700, 4800, 4900, 5000, 5100, 5200, 0101, 0201, 0301 or 0401, the pump is affected and must be replaced.

If the letter “A” is marked as a suffix to the date code, the pump has been brought into conformity and need not be replaced.

If your Lycoming engine has a diaphragm-type fuel pump with Lycoming P/N LW-15399, LW-15472, LW-15473, or LW-16335 installed, and has a date code of 0700 through 0401, the pump must be replaced within the next 100 hours of operation or 180 calendar days from the date of this Service Bulletin, whichever occurs first.
