MANDATORY

SERVICE BULLETIN

DATE: March 13, 2019 Service Bulletin No. 622A
 (Supersedes Service Bulletin No. 622)
 Engineering Aspects are
 FAA Approved

SUBJECT: Reprint of Slick/Champion Aerospace Service Bulletin SB1-15A
MODELS AFFECTED: All Lycoming engines equipped with Slick 4200, 4300, or 4700 Series (LASAR) magnetos.

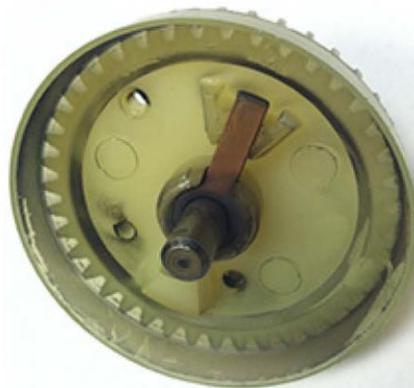
The initial release of SB1-15 was based on a limited number of field reports and product returns, Champion Aerospace has identified a possible condition in the distributor gear assemblies of 4-cylinder magnetos that can lead to decreased service life. Some of the returned products contained distributor gears exhibiting loosening of the electrode finger. This condition was observed in magnetos with a varying number of service hours. Typical symptoms are unusual RPM drop during magneto check, difficulty starting, and/or rough running engines.

Figure 3. Affected K3008 Distributor Gear With Copper Electrode

REMOVE affected distributor gear assembly in subject magnetos and REPLACE with replacement distributor gear assembly, K3008, as soon as possible, not to exceed the next 50 hours. Document Service Bulletin compliance as written entry in applicable Aircraft and/or Engine logbook.

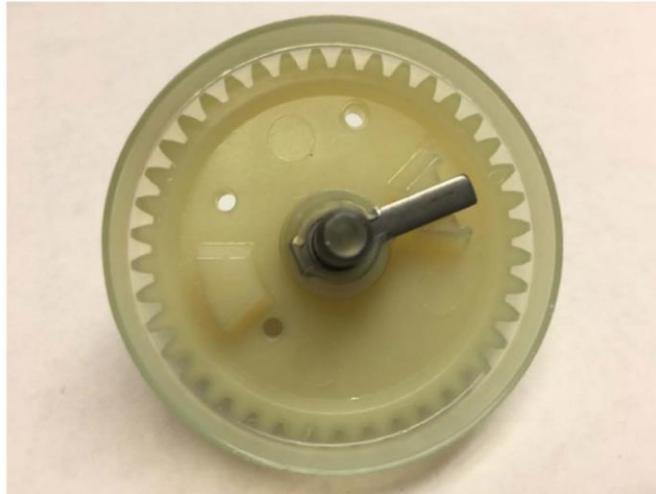
Figure 5. K3008 Distributor Gear With Monel Electrode

If it is not possible to confirm the version of the distributor gear that is installed in a given magneto from maintenance records, the magneto may be removed from the engine in order to have the housing and distributor block removed to allow visual inspection of the distributor gear. Distributor gears with Copper electrodes must be replaced with distributor gears with Monel electrodes.
