SERVICE BULLETIN

Service Bulletin No. 639
 Engineering Aspects are
 FAA Approved

SUBJECT: Inspection of Rocker Arm, Part Number LW-15014

MODELS AFFECTED: O-320-H2AD, O, LO, TO, LTO-360-E1A6D new, rebuilt, or overhauled engines shipped from Lycoming since June 2017 with less than 500 hours of operation or engines with less than 500 hours of operation since rocker arm replacement

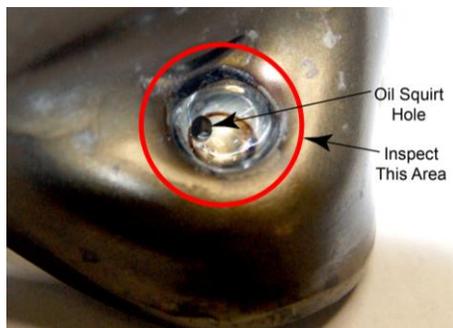
Figure 1
Area to Inspect
(Pushrod Socket Side of the Rocker Arm)

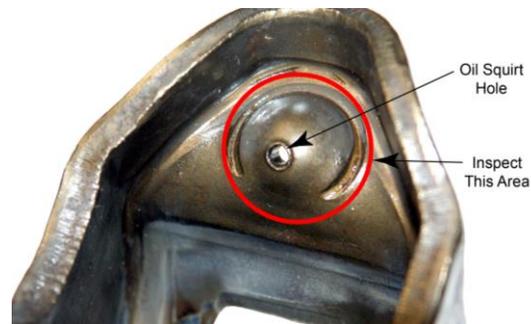
Figure 2
Area to Inspect
(Outside of the Rocker Arm)

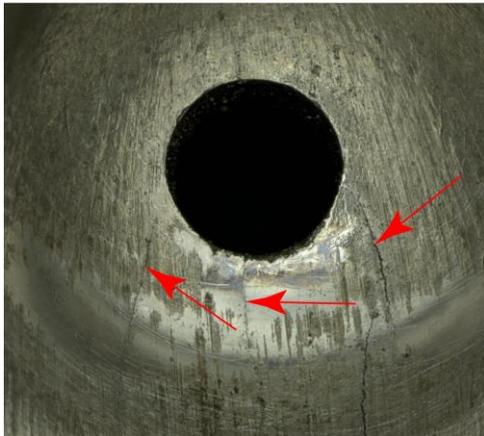
Figure 3

Cracks on the Pushrod Socket Side of the Rocker Arm, Around the Oil Squirt Hole

- B. Replace the damaged rocker arms. Return the damaged rocker arms to Lycoming Engines.
- C. Inspect all removed components for damage.
- D. Reinstall the hydraulic lifters, new shroud tube seals, shroud tubes, push rods, and new rocker arms with new self-locking nuts, per instructions in the Lycoming “76” Series Engines Overhaul Manual (60294-9).
- E. Check dry tappet clearance and adjust as necessary.
- F. Complete this inspection again at next 50-hour oil change until 500 hours of engine operation after rocker arm replacement.

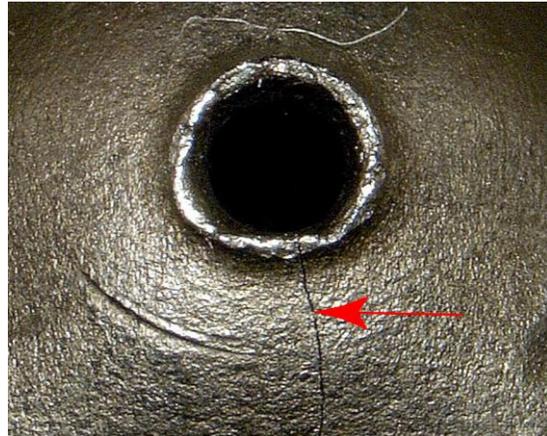
Figure 4

Crack on the Outside of the Rocker Arm, Around the Oil Squirt Hole
