SERVICE BULLETIN

Service Bulletin No. 647
 Engineering Aspects are
 FAA Approved

SUBJECT: Incorrect Markings on Service Tool# ST-310

MODELS AFFECTED: Lycoming Engines that have been inspected using the Incorrectly Marked Tool

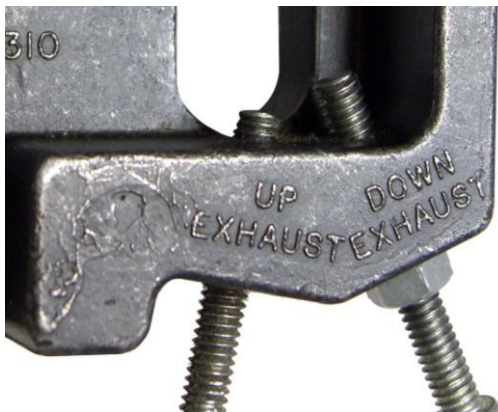
Figure 1
Correctly Labeled Tool

Lycoming has identified that seventeen Lycoming ST-310 tools sold between October 2016 and May 2021 were manufactured having the up exhaust and down exhaust locations incorrectly labeled. Figure 1 illustrates the correctly labeled tool and Figure 2 illustrates the incorrectly labeled tool.

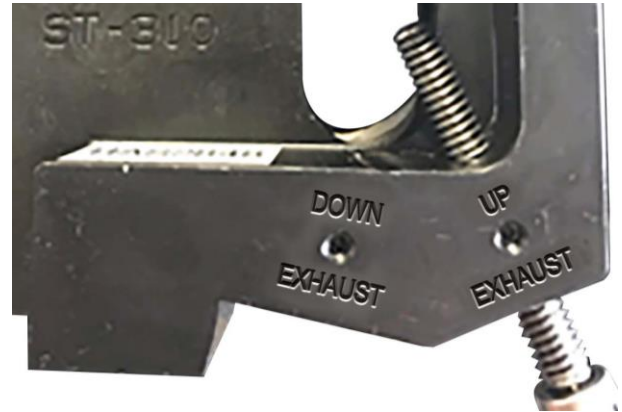
Figure 2
Incorrectly Labeled Tool

This could result in erroneous readings when using this tool to complete the inspection required by Service Bulletin No. 388C or the Mandatory Inspection - Exhaust Valve and Guide required by the Airworthiness Limitations Section of any FAA approved Lycoming Manual. Erroneous readings may allow exhaust valve guides with inadequate clearance to pass as acceptable when in fact the clearance was too tight, and reaming was required.

- Inspect any Lycoming ST-310 tool that you or your shop purchased between October 2016 and May 2021 for incorrect labeling (Figure 2).
- Discontinue use of all incorrectly labeled ST-310 tools immediately.

- Contact an Authorized Lycoming Distributor to order a replacement ST-310 tool.
- Return the incorrectly labeled ST-310 tool to Lycoming Engines through the same Authorized Lycoming Distributor that ordered a replacement ST-310 tool and file a warranty claim for:

- If an engine’s exhaust valve guides passed and did not require reaming, the engine must be reinspected with a correctly labeled ST-310 tool at the next scheduled maintenance event.
