Service Bulletin No. 648B (Supersedes Service Bulletin No. 648A)

SUBJECT: Wastegate Solenoid Valve Inspection and Cleaning

MODELS AFFECTED: TEO-540-C1A

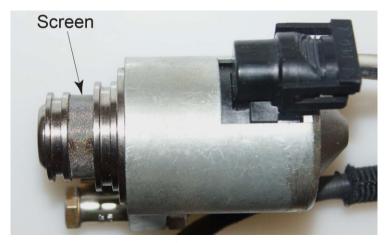
Figure 1 Wastegate Solenoid Valve Screen

Lycoming has received reports of wastegate solenoid valve screen obstruction resulting in non-desirable wastegate function affecting engine operability. Lycoming is recommending that a wastegate solenoid valve cleaning and inspection maintenance item be completed during each scheduled oil change.

2. Hand-wipe the wastegate solenoid valve screen (Figure 1) with a clean lint-free cloth soaked with Avgas or Mineral Spirits as necessary to remove any accumulated debris. **Do not use compressed air to clean the screen or the solenoid outlet.**

- 3. Inspect the wastegate solenoid valve screen to ensure there is no debris or cloth fibers remaining on the full circumference of the screen. If all debris cannot be removed from the screen, replace the wastegate solenoid valve.
- 4. Inspect the wastegate solenoid valve screen for damage. If the screen is damaged, the wastegate solenoid valve must be replaced.
- 5. Inspect the wastegate solenoid valve O-rings for damage or wear. If the O-rings are damaged or worn, replacement of two (2) O-rings P/Ns MS28775-018 and MS28775-021 is required.
