# SERVICE INSTRUCTION

Service Instruction No. 1554  
Engineering Aspects are  
FAA Approved

SUBJECT: Zip Strap Replacement

MODELS AFFECTED: TIO-540-J2B, -J2BD; LTIO-540-J2B, -J2BD

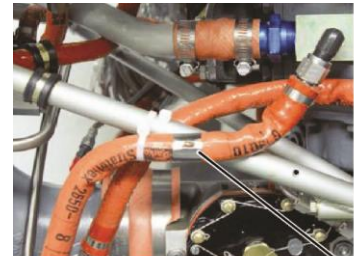
Evidence in the field has shown instances of chafing (Figure 1) on the turbocharger support rod (of affected Lycoming engine models). Figure 2 shows the proximity of the identification tag on an oil hose to one of the turbocharger support rods. Rub marks also were found in the turbocharger support rod where the paint/plating was worn away.

- Friction from the identification tag (Figure 3) on the oil supply hose for the bypass valve and on the turbocharger oil inlet hose
- Zip straps which attach the oil hoses to the turbocharger support rod positioning the identification tags on each of the oil hoses too closely to the turbocharger support rod

Figure 3  
Identification Tag

This Service Instruction is notification of corrective action to improve protection against chafing of the turbocharger support rod. The zip straps are to be replaced with four clamps and hardware identified in Table 1 as per corrective action instructions herein. **The zip straps are no longer to be used.**

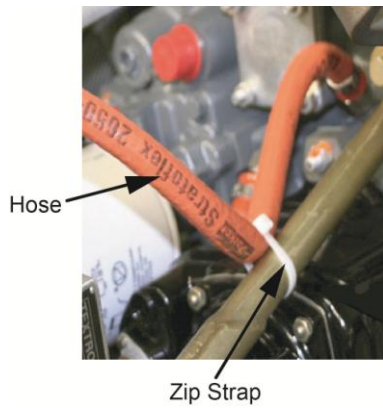
Zip Strap  
Figure 4

Zip Strap Attached to the Oil Supply Hose for the Bypass Valve and Lower Turbocharger Support Rod

1. Remove and discard the zip strap from the oil supply hose for the bypass valve (Figure 4) and the oil inlet hose for the turbocharger (Figure 5).
2. Examine the turbocharger support rod for chafing or wear from any of the metal identification tags. If chafing or wear is found on any of the support rods, replace the entire turbocharger mount assembly.

3. Examine the oil supply hose for the bypass valve (Figure 4) for chafing. Examine the turbocharger oil inlet hose (Figure 5) for chafing. Replace any worn or chafed oil hose.
4. Install the two new clamps (P/N LW-16266-10-63 and P/N LW-16266-10-75) with fasteners on the oil supply hose for the bypass valve in the specified location shown in Figure 6.
5. Install the two new clamps (P/N LW-16266-10-75) with fasteners on the oil inlet hose for the turbocharger as shown in Figure 7.
6. Make sure the oil hoses can move freely, are not bent, kinked, or stressed, and not touching any part of the engine or engine accessory.
7. Record zip strap removal, clamp installation, (and any oil hose or turbocharger support rod replacement) in accordance with this Service Instruction in the engine logbook.

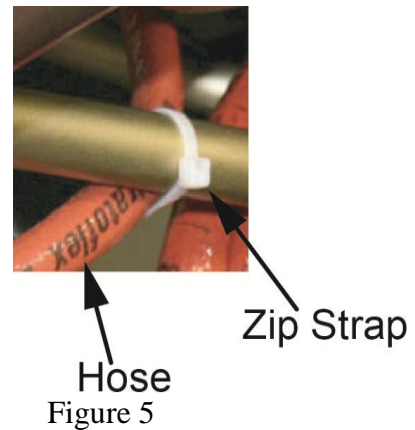
Figure 5

Zip Strap Attached to Turbocharger Oil Inlet Hose and Upper Turbocharger Support Rod

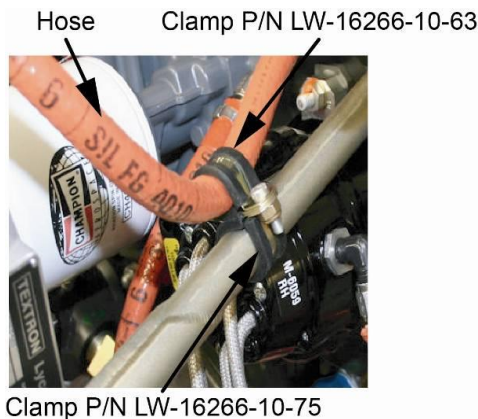
Figure 6

Installed Clamps on Oil Supply Hose for the Bypass Valve and Lower Turbocharger Support Rod

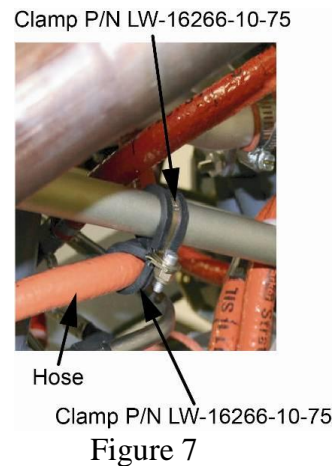
Figure 7

Installed Clamps on Turbocharger Oil Inlet Hose and Upper Turbocharger Support Rod
