**MANDATORY
SERVICE BULLETIN**

DATE: May 6, 1957 Service Bulletin No. 183A
(Supersedes Service Bulletin No. 183)

SUBJECT: Magneto Timing Discrepancies

MODELS AFFECTED: All Lycoming Opposed Series Aircraft Engines.

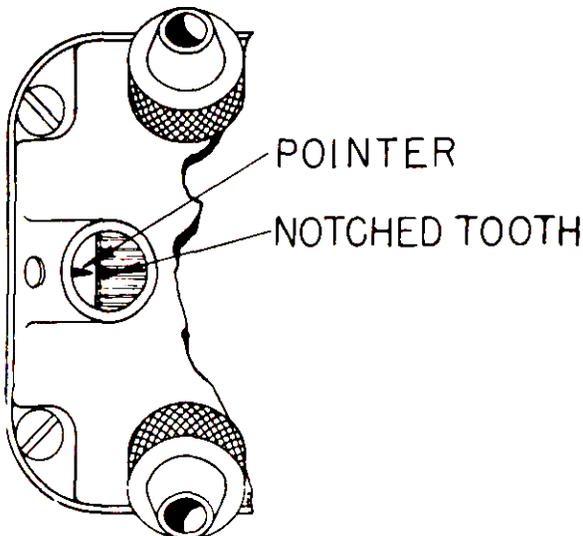
The degree of accuracy necessary to correctly time the ignition cannot be achieved by this method. The white notched tooth and the pointer on the magneto as shown in figure 1 are provided only as a means of correctly positioning the magneto during its assembly on the engine and are definitely not intended as an indicator of the point of breaker opening.

Figure 1 - Alignment of Notched Tooth and Pointer

This is accomplished only by the use of a timing light to indicate point of breaker opening and close adherence to instruction on ignition timing referenced in the handbook applicable to the particular engine model. Furthermore, when ignition timing marks are inaccessible or engine parts having ignition timing marks have been replaced, we recommend positioning the crankshaft relative to degrees before top dead center by using Time-Rite Piston Position Indicator.

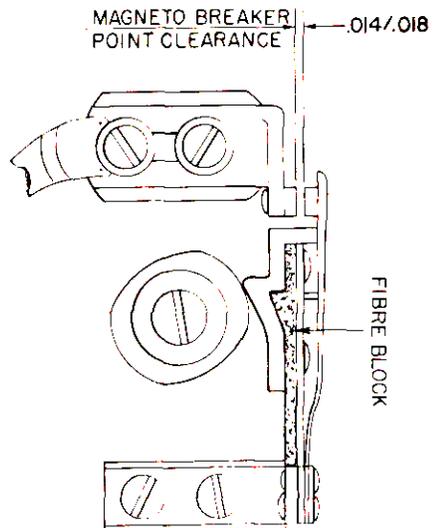
Figure 2 - Adjusting Breaker Point Clearance on Heavyweight Magnetos

On engines with heavyweight magnetos, if it is found the magneto breaker point clearances have closed due to wear of fiber block, check the point gap, using feeler gages, and adjust to no less than .014 inch or to no more than .018 inch. (See figure 2). If it is necessary to adjust the points; it will also be necessary to recheck the ignition timing, using the timing light and in accordance with the instructions in the applicable engine manual. Breaker points on lightweight magnetos are not to be adjusted to a given clearance.
