# SERVICE BULLETIN

DATE: December 8, 2022 Service Bulletin No. 628A  
 (Supersedes Service Bulletin No. 628)  
 Engineering Aspects are  
 FAA Approved

SUBJECT: Reprint of Hartzell Engine Technologies' (HET) Alert Service Bulletin (ASB) 076

### 200F, 201F, 202F Fuel Pump Leak Inspection and Diaphragm Replacement

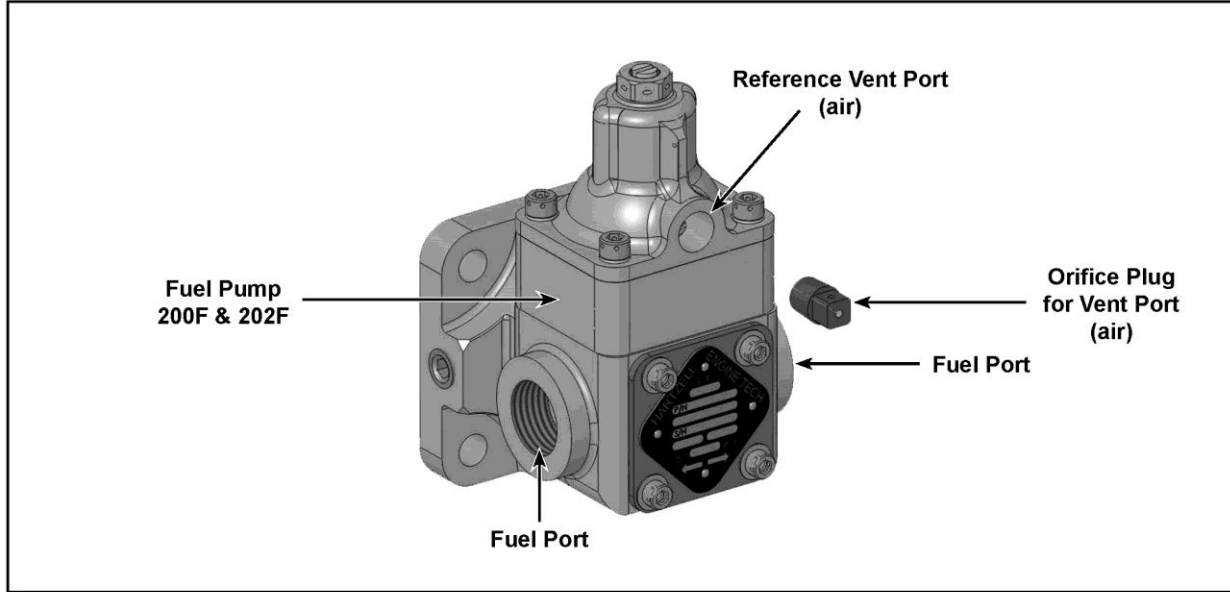
Figure 1 - 200F & 202F Identification

- (a) Inspection of the orifice plug requires only a visual inspection. Look around the plug and into the orifice for fuel or blue dye stains. Refer to Fig. 1 or Fig. 2.

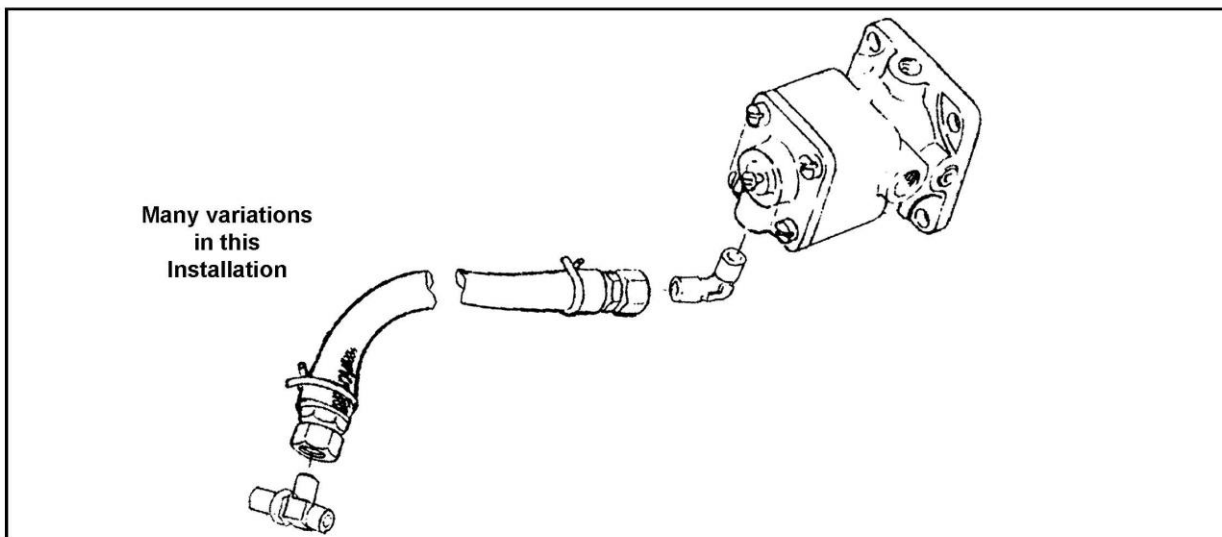
Figure 5 - Typical HET 201F Fuel Pump Plumbed to Upper Deck Reference

- (b) Inspection of the upper deck reference line requires that the line be disconnected and the inside of the fitting be inspected for fuel or blue dye stains. Refer to Fig. 5 and 6.

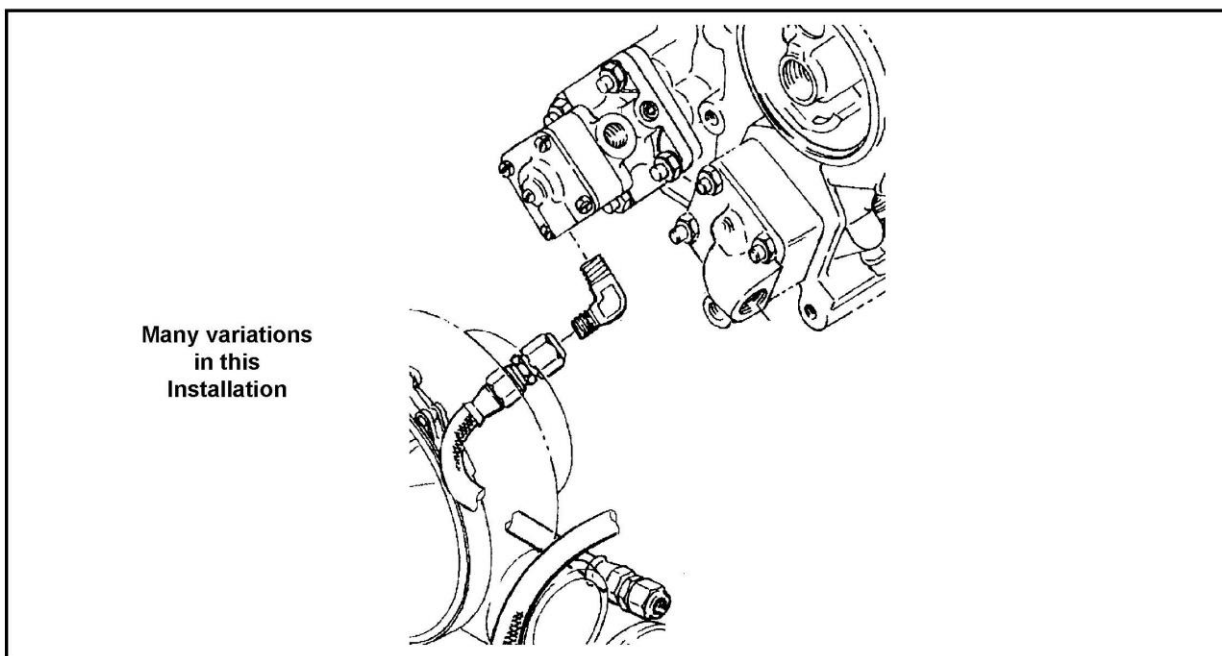
Figure 6 - Typical HET 201F Fuel Pump Turbocharger Reference Line Connection

- (c) Inspection of the engine turbocharger reference line will require that the "B" nut be removed and the inside of the fitting be inspected for fuel or blue dye stains.
