# SERVICE INSTRUCTION

Service Instruction No. 1577A  
(Supersedes Service Instruction No. 1577)  
Engineering Aspects are FAA Approved

SUBJECT: Intake Valve In-Service Data

MODELS AFFECTED: O-540-F1B5 engines with serial number ending with “-40E” installed in Robinson R44 Raven I and R44 Cadet helicopters

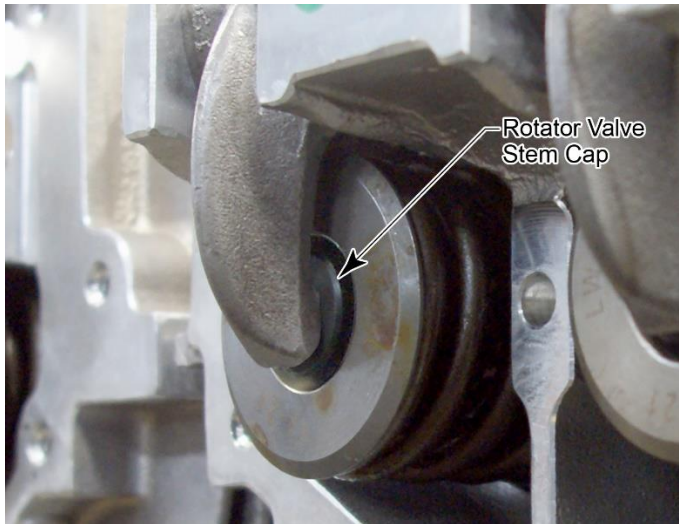
**Figure 1**

**Rotator Valve Stem Cap on Intake Valve**

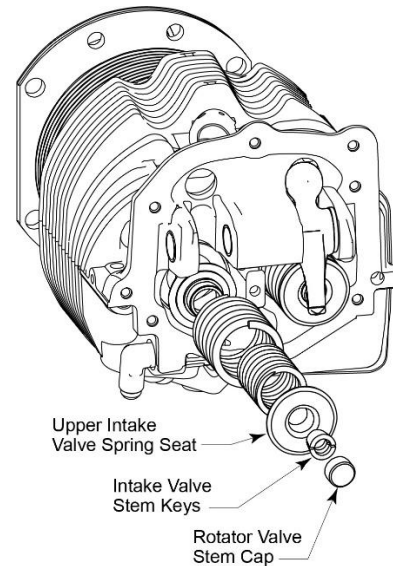
**Figure 2**

**Rotator Valve Stem Cap on Intake Valve**
