SERVICE BULLETIN

DATE: January 04, 2024 Service Bulletin No. 655
Engineering Aspects are
FAA Approved

SUBJECT: Hartzell Engine Tech (HET) Service Bulletin (SB) No. 203

Undersized Turbocharger Journal Bearing

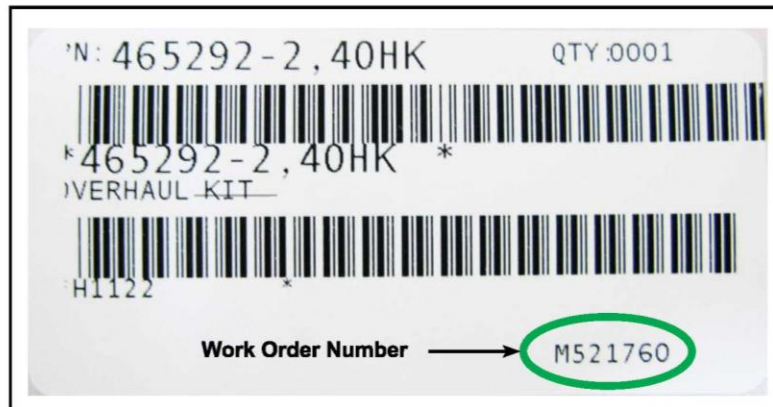
Figure 1 - Overhaul Kit Label

Overhaul Kit P/N	Work Order Number *
465292-2, 4OHK	M521760
	M539140
	M594240
	M683290
465398-2OHK	M683300
466011-2OHK	M585130
	M645270
	M665190
	M683310
	M705810
4466304-3OHK	M493570
	M521700
	M521710
	M535540
	M539050
	M539060
	M539070
	M594170
	M594180
	M645290
	M664370
	M665150
	M665160
466642-1, 2OHK	M521780
	M534500
	M594220
	M665130
	M683280
* Refer to Figure 1, Overhaul Kit Label, for Work Order Number Identification

* Refer to Figure 1, Overhaul Kit Label, for Work Order Number Identification
