SERVICE BULLETIN

DATE: September 20, 2024 Service Bulletin No. 660
Engineering Aspects are
FAA Approved

SUBJECT: Reprint of Slick/Champion Aerospace Service Bulletin SB1-24A

MODELS AFFECTED: All 4 and 6-cylinder Lycoming engines equipped with Slick 4300 or 6300 Series Impulse Coupled Magnetos.

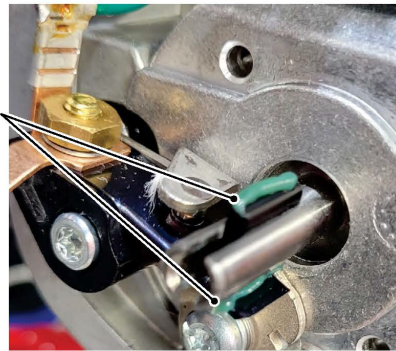
Figure 2 Proper cam grease application

There have been reports of excessive cam wear causing reduced engine performance. The excessive cam wear results from little to no cam grease applied during manufacturing. Excessive cam wear adversely affects the internal timing of the magneto and reduces engine performance over time, causing the engine to run rough and reduced starting performance.

Apply a bead of cam grease to both cam lobes

- (a) For Category 1 magnetos per this service bulletin, disassemble the magneto and inspect the cam for cam grease. If no cam grease is present, apply cam grease M1827 or equivalent (Fig. 2), per the latest revision of F-1100 Master Service Manual.
- (b) For Category 2 magnetos per this service bulletin, disassemble the magneto and inspect the cam for cam grease and wear conditions. If no cam grease is present, and cam shows signs of wear, replace the contact breaker points assembly and the cam, per the latest revision of F-1100 Master Service Manual is required.

WARNING: The cam and contact breaker points **MUST** be replaced together. The practice of replacing only the points or only the cam is not approved and can lead to poor engine performance and incorrect internal timing.
