# SERVICE BULLETIN

DATE: February 20, 2025 Service Bulletin No. 648C  
(Supersedes Service Bulletin No. 648B)

SUBJECT: Wastegate Solenoid Valve Inspection and Cleaning

MODELS AFFECTED: TEO-540-C1A

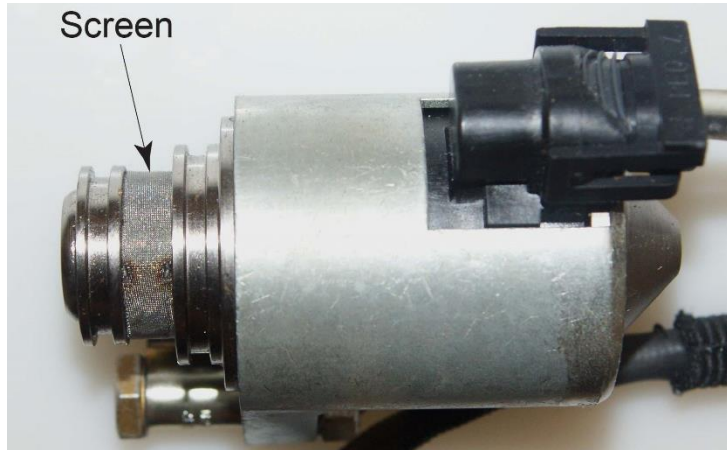
**Figure 1**  
**Wastegate Solenoid Valve Screen**

Lycoming has received reports of wastegate solenoid valve screen obstruction resulting in non-desirable wastegate function affecting engine operability. Lycoming is recommending that a wastegate solenoid valve cleaning and inspection maintenance item be completed during each scheduled oil change.

- Inspect the wastegate solenoid valve screen to ensure there is no debris or cloth fibers remaining on the full circumference of the screen. If all debris cannot be removed from the screen, replace the wastegate solenoid valve.
- Inspect the wastegate solenoid valve screen for damage. If the screen is damaged, the wastegate solenoid valve must be replaced.
- Inspect the wastegate solenoid valve O-rings for damage or wear. If the O-rings are damaged or worn, replacement of two (2) O-rings P/Ns MS28775-018 and MS28775-021 is required.

- Hand-wipe the wastegate solenoid valve screen (Figure 1) with a clean lint-free cloth soaked with Avgas or Mineral Spirits as necessary to remove any accumulated debris. **Do not use compressed air to clean the screen or the solenoid outlet.**
