SERVICE INSTRUCTION

Service Instruction No. 1593
Engineering Aspects are FAA Approved

SUBJECT: Incorrectly marked alternator belts.

MODELS AFFECTED: TEO-540-C1A

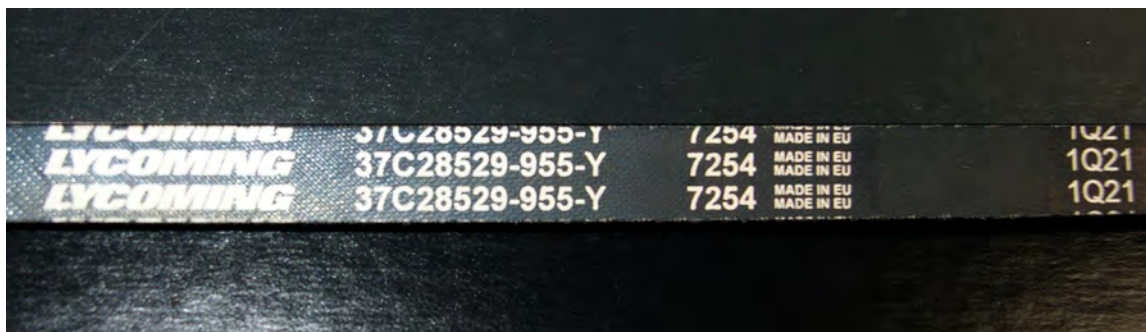
Figure 1
Alternator Belt

Lycoming has discovered that a population of 37C28529-955 alternator belts were released to the field identified as 37C28529-955-Y. These belts may be installed on engines or received as spare parts through Lycoming Distributors.

These alternator belts marked with a -Y suffix (Figure 1) are production parts and acceptable for use.
