SERVICE BULLETIN

DATE: June 11, 2025 Service Bulletin No. 630B
(Supersedes Service Bulletin No. 630A)
Engineering design data in this service document is FAA approved.

SUBJECT: Connecting Rod Bushing Inspection After Cylinder Removal

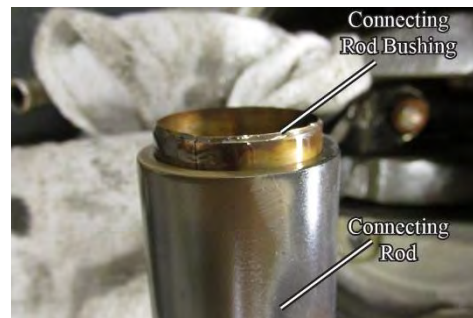
Figure 5
**Example of Connecting Rod Bushing
Raised Above the Connecting Rod**

- (5) Measure the distance from the surface of the connecting rod to the edge of the connecting rod bushing installed in the connecting rod (Figure 6) on both sides of the connecting rod.
- (a) If the sum total of the measurements from both sides of the connecting rod is 0.038 in. (0.965 mm) or less, this feature is acceptable. Go to Step 2.
- (b) If the sum total of the measurements from both sides of the connecting rod is greater than 0.038 in. (0.965 mm) (it is an indication the connecting rod bushing is loose or has moved or is out of place) (Figure 5). Remove, discard, and replace the connecting rod bushing.

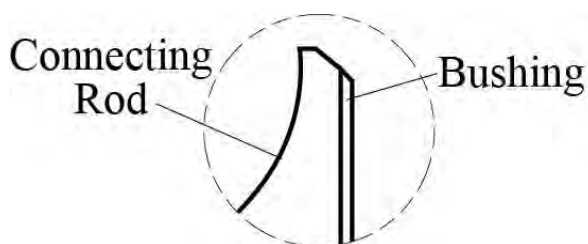
Figure 7
**Connecting Rod Bushing
in Correct Position**

- B. On *chamfered connecting rod bushings* (Figure 3), look at the perimeter edge of the applicable connecting rod bushing within the connecting rod.
- (1) If the chamfer of the connecting rod and the chamfer of the connecting rod bushing align (Figure 7), this feature is acceptable. Go to Step 2 on the next page.
- (2) If the chamfer of the connecting rod and the chamfer of the connecting rod bushing do not align (Figure 8), the connecting rod bushing has moved within the connecting rod. Remove, discard, and replace the connecting rod bushing. Contact Lycoming Engines' Product Support at +1 (877) 839-7878 (Toll Free) or +1 (570) 327-7222 or email Technicalsupport@lycoming.com.

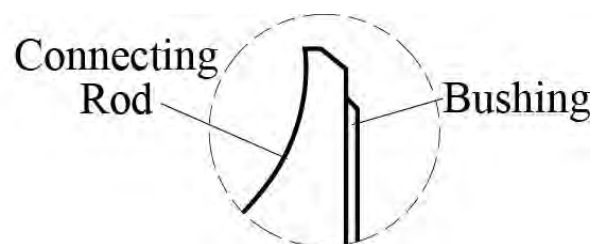
Figure 8
**Connecting Rod Bushing
Out of Place**

NOTICE: As the connecting rod bushing moves further out of place, the piston at the piston pin hole could show wear. If the connecting rod bushing is out of position, examine the piston for wear.

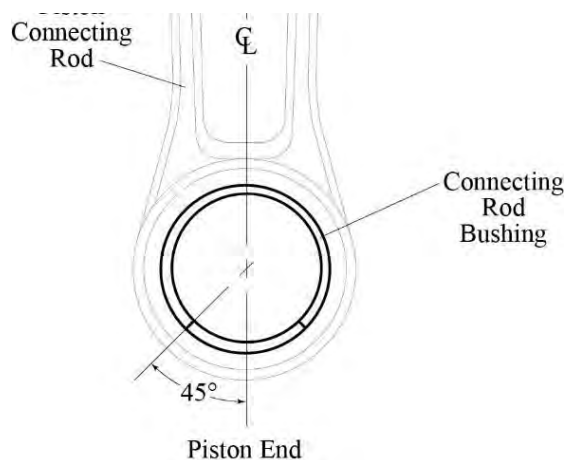
Figure 9

NOTICE: Connecting rod bushings are manufactured with a split line in the bushing. When installed, the split line of the bushing is positioned approximately at a 45° angle from the center line of the connecting rod as shown in Figure 9.

If the split line is visible at any other location other than approximately at a 45° angle from the center line of the connecting rod, the connecting rod bushing has moved and must be removed, discarded, and replaced.

Connecting Rod Bushing Split Line Position

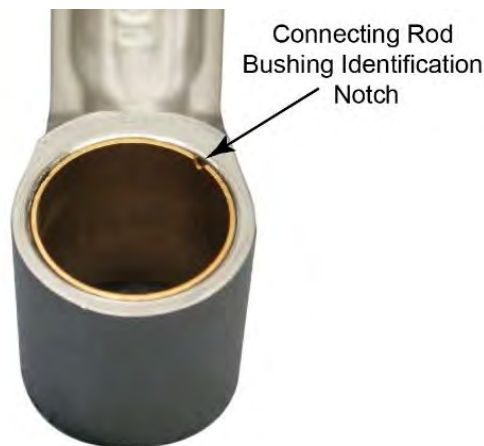
Figure 11
Single Identifying Notch in The Connecting Rod Bushing

This Section contains required action to inspect connecting rod bushings and replace unacceptable connecting rod bushings. Acceptable connecting rod bushings, P/N 01K28983, installed or shipped as spares after September 9, 2021, can be identified by a single notch (Figure 11).

Prior to introduction of the connecting rod bushing P/N 01K28983, the LW-13923 bushing was in use. Between January 30, 2009, and September 9, 2021, LW-13923 bushings were installed in new, rebuilt, overhauled, and repaired engines shipped from Lycoming. LW-13923 bushings were also available to the field as replacement parts and in replacement connecting rod assemblies during the same time. Engines that were field overhauled or repaired during this time could have received these bushings or replacement connecting rod assemblies containing these bushings. Section 2 applies only to engines that contain Lycoming LW-13923 connecting rod bushings. LW-13923 bushings do not have an identifying notch. Engine maintenance records should be reviewed for parts installed at time of last field overhaul or repair.

1. If the maintenance requires connecting rod removal and the connecting rod bushing does not have the identifying single notch (Figure 11), refer to the latest revision of Service Bulletin No. 240 for additional instructions.
2. If the maintenance does not require connecting rod removal, complete the “Connecting Rod Inspection” in this Service Bulletin.
3. If more than one cylinder must be removed, complete this inspection on each cylinder, one at a time. After completing the Connecting Rod Inspection in this service bulletin and any other required maintenance, reinstall the cylinder and torque the cylinder base fasteners to the proper torque before moving on to the next cylinder.

4. Remove all connecting rod assemblies with a connecting rod bushing that does not have the identifying single notch (Figure 11) and all connecting rod bushings that do not have the identifying single notch (Figure 11) from your spares inventory.
 - Spare Bushings that do not have the identifying single notch (Figure 11) should be considered unusable and discarded.
 - Spare Connecting Rod Assemblies that do not have a bushing with the identifying single notch (Figure 11) should be considered unusable and discarded or have the bushing replaced with a notched bushing.

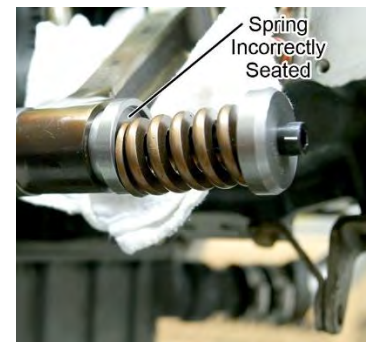
Figure 17
Spring Incorrectly Seated in the Tool

5. Make sure:
- The bottom section of the tool is in contact with the connecting rod
 - The shoulder of the center section of the tool is in contact with the connecting rod bushing
 - The head of the bolt is in contact with the top section of the tool
 - The spring is seated correctly in the tool as shown in Figure 16. Figure 17 shows **incorrect** seating of the spring.
