# SERVICE INSTRUCTION

Service Instruction No. 1290F  
(Supersedes Service Instruction No. 1290E)  
Engineering Aspects are  
FAA DER Approved

SUBJECT: Repair of Oil Leakage at Crankcase Thru-Stud Locations; Assembled and Unassembled Engines.

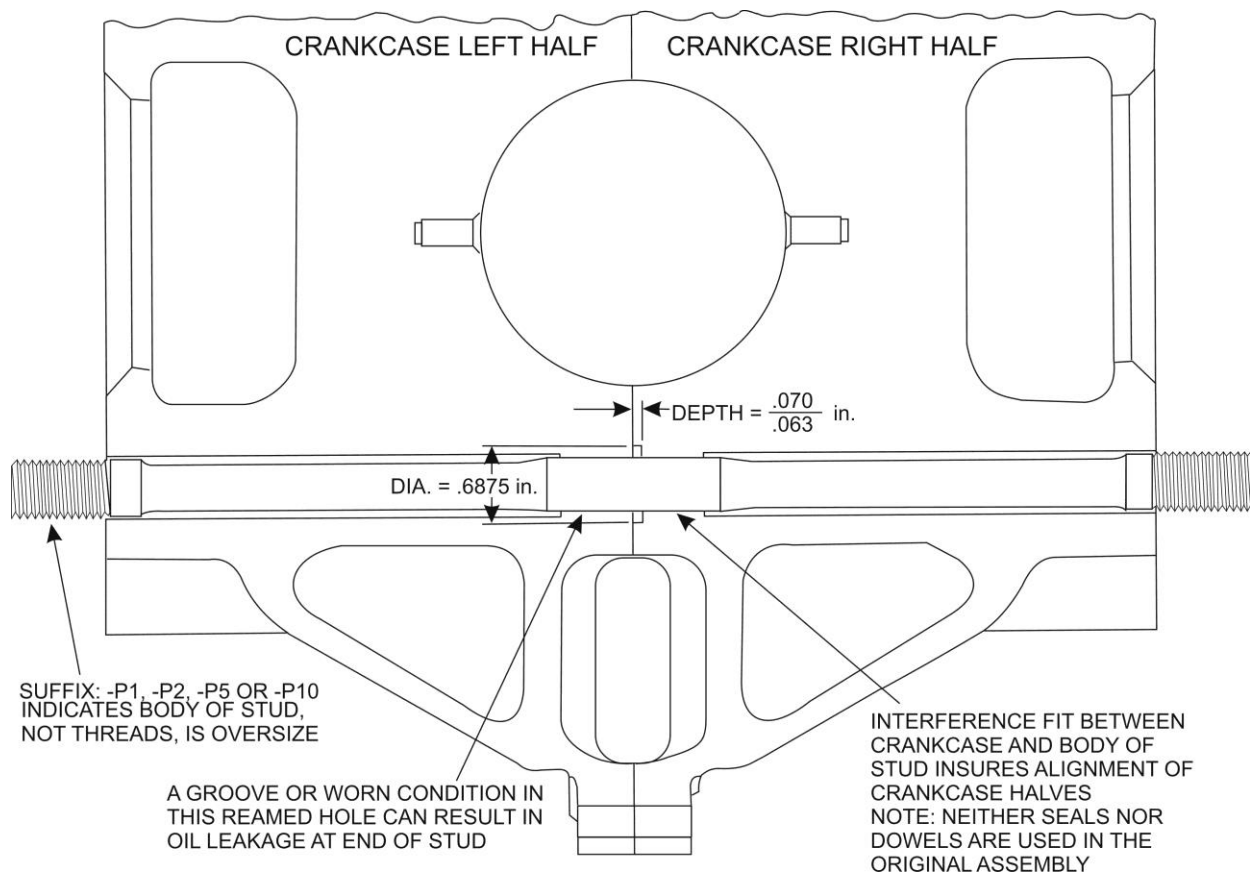
**Figure 1. Section Through Crankcase at Thru-Stud Location Showing Dimensions of Recess for the P/N 72075 Oil Seal**

Engines listed in the MODELS AFFECTED section of this publication achieve crankcase alignment thru the interference fit of the body-fit thru-studs and the crankcase thru-stud bores located in the main bearing webs. This interference fit is illustrated in Figure 1 which shows a section through the crankcase at a thru-stud location; note the two halves of the crankcase are supported at the parting surface by the body of the stud. Evidence of oil on the crankcase or cylinder mounting flange which can be traced to a thru-stud location indicates that the seal formed by the interference fit between the stud and the crankcase is incomplete. This can be the result of an oversized bore or a groove traced in the bore during installation of the thru-stud.

3. Assemble the P/N ST-463-5 stop collar on the ST-463-1 counterbore. Set the stop collar to allow the counterbore to cut to a depth of .063/.070 inch. Refer to Figure 1.

5. Clean the seal recess and thru-stud bore of all chips and shavings. Use a small abrasive stone to smooth the edge of the recess.
6. Measure the depth of the recess with a depth micrometer. Insure the depth is within the dimensions specified in step 3 and illustrated in Figure 1.
