SERVICE BULLETIN

Service Bulletin No. 665

SUBJECT: Heat Shield Removal

MODELS AFFECTED: TEO-540-C1A

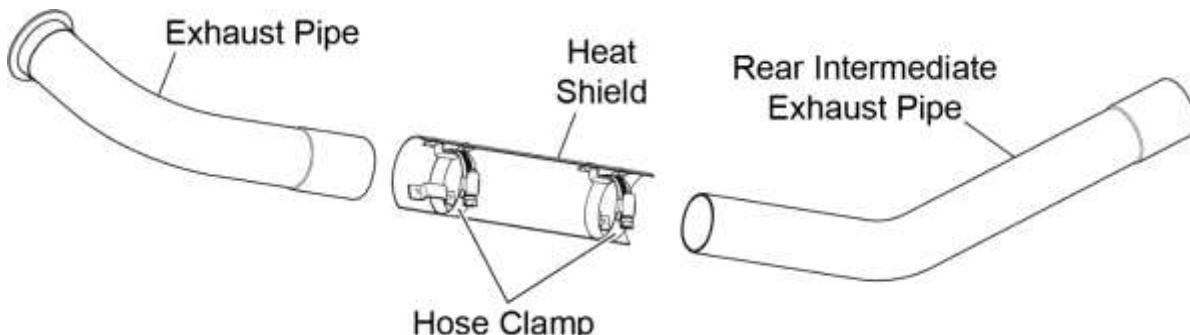
Figure 1
Removal of Heat Shield

Lycoming has determined that the heat shield (P/N LW-16406) installed between the Exhaust Pipe and Rear Intermediate Exhaust Pipe (Figure 1) could restrict the movement of the pipes and prevent the exhaust system slip joints from functioning properly.

Remove and discard the heat shield and hose clamps in accordance with instructions in the latest revision of the **TEO-540-C1A Engine Maintenance Manual**.
