# SERVICE INSTRUCTION

Service Instruction No. 1366B  
(Supersedes Service Instruction No. 1366A)

SUBJECT: Repair Procedure for Worn Rocker Shaft Bushing Hole

MODELS AFFECTED: 0-235 and 0-290 Series Engines

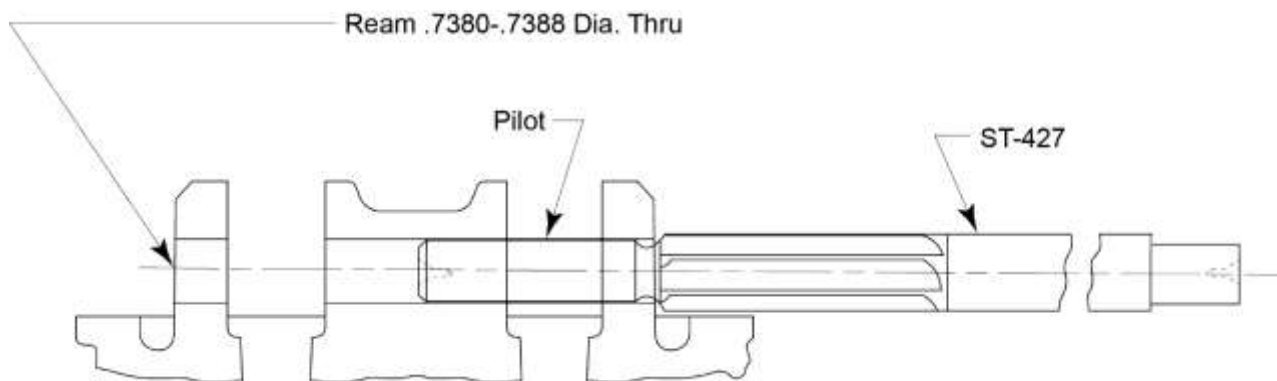
CYLINDER HEAD ASSEMBLY SHOWING REAMER  
AND SECTION THRU AREA TO BE REAMED

1. Inspect the rocker shaft holes in the cylinder head for size. This must be done with a telescoping gage or similar small hole gage that is sufficiently accurate to indicate differences in diameter through the total length of each hole. If any rocker shaft hole exceeds .6270 inch diameter at any location within the hole the rocker shaft holes must be reworked.
2. Secure the cylinder to a suitable fixture P/N 64501. on the workbench and insert the pilot of reamer ST-427 in the rocker shaft holes. See illustration. Hand ream, allowing the reamer cutting blades to pass through all the rocker shaft holes.

**CAUTION** A LIBERAL AMOUNT OF COOLANT MUST BE USED IN ORDER TO LUBRICATE AND CLEAR THE FLUTES OF THE REAMER TO PREVENT SCORING.

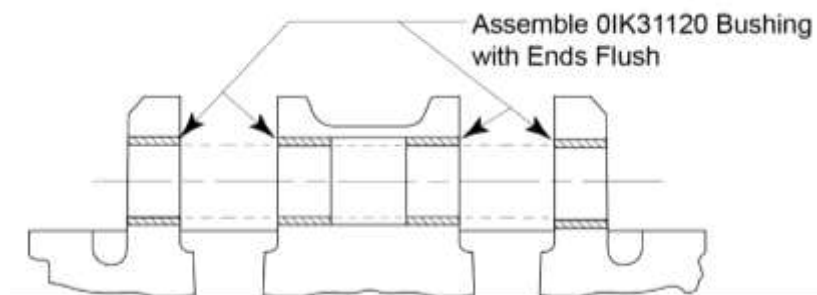
CYLINDER HEAD ASSEMBLY SHOWING REAMED  
AREA WITH BUSHINGS INSTALLED

3. Clean up all rough edges caused by the reaming operation. Wash and clean the cylinder thoroughly. Check the newly reamed holes with plug gage P/N 64810.
4. Install rocker shaft bushings as described in the applicable Overhaul Manual.
