SERVICE BULLETIN

DATE: April 21, 2026 Service Bulletin No. 640
Engineering Aspects are
FAA Approved

SUBJECT: Reprint of Slick/Champion Aerospace Service Bulletin SB2-19B

SUBJECT: Mandatory inspection of impulse coupled Slick by Champion magnetos.

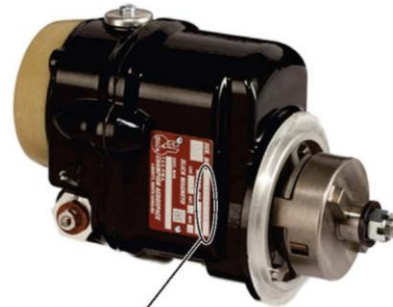
LETTER "B" INDICATES REPAIRED MAGNETO

SERIAL NUMBER LOCATED ON MAGNETO DATAPLATE

MANUFACTURED DATE LOCATED ON IMPULSE COUPLING REPLACEMENT KIT

1. Locate magneto serial number on magneto dataplate or purchase date of replacement impulse coupling kits. If the magneto serial number or impulse coupling purchase date is determined to be within the range specified in this bulletin and the dataplate is not stamped with the letter "B" per the WARRANTY description above, remove the magneto from engine in accordance with the latest revision of the engine manufacturer's manual(s).

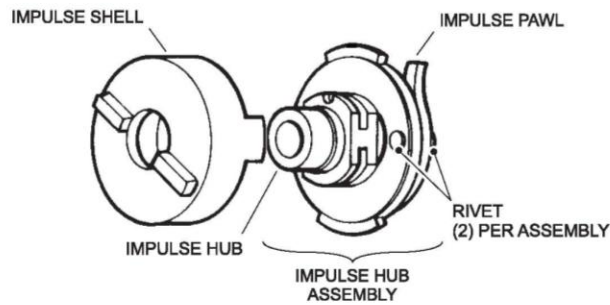
2. Remove, disassemble, and clean the impulse coupling per current revision of applicable magneto manual and per current revision of F-1100 Master Service Manual or L-1500 LASAR Master Service Manual.
3. Inspect the impulse coupling per the maintenance manual. If any movement is found in the rivets, the impulse coupling must be rejected. Reference WARRANTY INFORMATION for resolution options.

4. Repeat this recurring inspection per the requirements listed in the COMPLIANCE section.
5. In no instance shall a repair of the impulse coupling be attempted for loose rivets.
6. Liberally oil ALL new or removed impulse couplings with clean engine oil prior to installation. Make sure all castellated drive nuts are torqued to 120-320 in-lbs. Reference Champion Service Letter SL1-17 for additional information.
