# SERVICE INSTRUCTION

Service Instruction No. 1485B  
(Supersedes Service Instruction No. 1485A)

SUBJECT: Exhaust Valve and Guide Identification Procedure

MODELS AFFECTED: All Lycoming reciprocating aircraft engines unless installed in a rotary-wing aircraft.

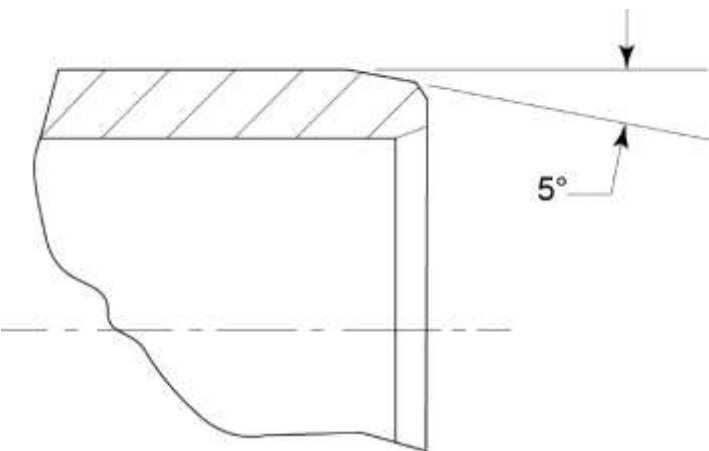
Figure 1.

Cylinder assemblies which incorporated the improved "Hi-Chrome" exhaust valve guides when the engine was shipped from Lycoming are identifiable by the letter "C" stamped inside a circle on the boss for the drain back fitting. The individual guides made with the improved material can be identified by a 5° chamfer at the top of the guide (See Figure 1).

Once guides made from the improved material are installed in all cylinders on the engine, it is no longer necessary to complete the mandatory 400 hour inspections specified in the latest revision of Service Bulletin No. 388. It is recommended that the inspection procedure from the latest revision of Service Bulletin No. 388 be completed every 1000 hours of operation.

**NOTICE:** Prior to discontinuing the mandatory 400 hour inspections specified in the latest revision of Service Bulletin No. 388, you must confirm that all cylinders on the subject engine have the new exhaust guides installed. A logbook entry should be made for future reference.
