## SERVICE BULLETIN

DATE: August 5, 2026 Service Bulletin No. 670  
SUBJECT: E-MAG Spark Plug Adapter Inspection,  
Hartzell Engine Tech (HET) Alert Service Bulletin No.232  
MODELS AFFECTED: All experimental Lycoming Engines using E-MAG ignition systems shipped  
before June 1, 2026  
TIME OF COMPLIANCE: Before next flight.

## Alert Service Bulletin No. 232

### E-MAG Spark Plug Adapter Inspection

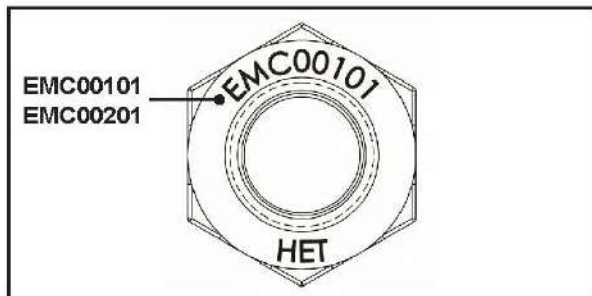
Figure 1 - Spark Plug Adapter Identification  
(HET) EMC00101 & EMC00201 - NOT AFFECTED

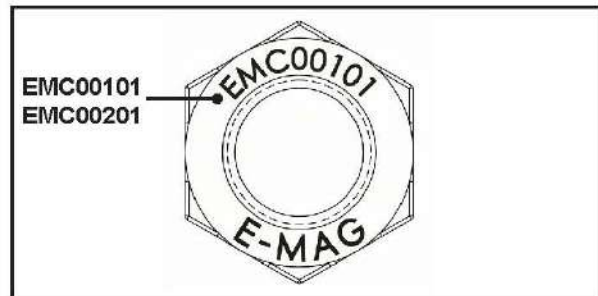
- (1) HET has discovered that a number affected spark plug adapters were found to be undersized at the external thread major diameter.
  - (a) This condition may cause the spark plug adapter to lose torque and/or dislodge from the cylinder during engine operation.

Figure 2 - Spark Plug Adapter Identification  
(E-MAG) EMC00101 & EMC00201 - AFFECTED

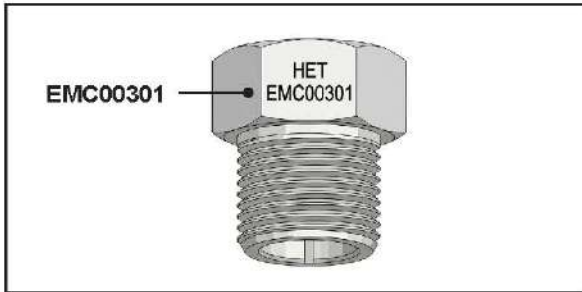
**Figure 3 - Spark Plug Adapter Identification  
(HET) EMC00301 - NOT AFFECTED**

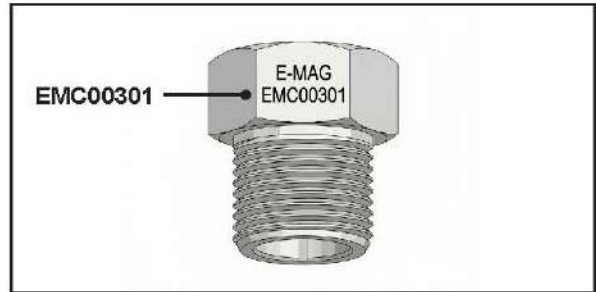
**Figure 4 - Spark Plug Adapter Identification  
(E-MAG) EMC00301 - AFFECTED**

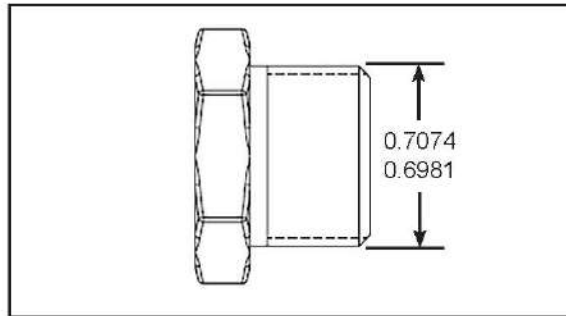
**Figure 5 - Spark Plug Adapter Thread  
Major Diameter**

- 4) Using calipers, measure the external thread major diameter of the spark plug adapter (See Figure 5):
  - a) Measurement must be within 0.6981 - 0.7074 (17.73 – 17.97mm).

- b) If the spark plug adapter measurement is within tolerance, continue to step 5.
  - c) If the measurement is found out of tolerance, replace the spark plug adapter with a new adapter that is not affected by this ASB. Continue to step 6.
