## SERVICE BULLETIN

DATE: August 24, 2026 Service Bulletin No. 671  
Engineering Aspects are FAA Approved

SUBJECT: Fuel Pump Leak Inspection and Diaphragm Replacement,  
Hartzell Engine Tech (HET) Alert Service Bulletin No.233

### 200F, 201F, 202F, & 500F Fuel Pump Leak Inspection and Diaphragm Replacement

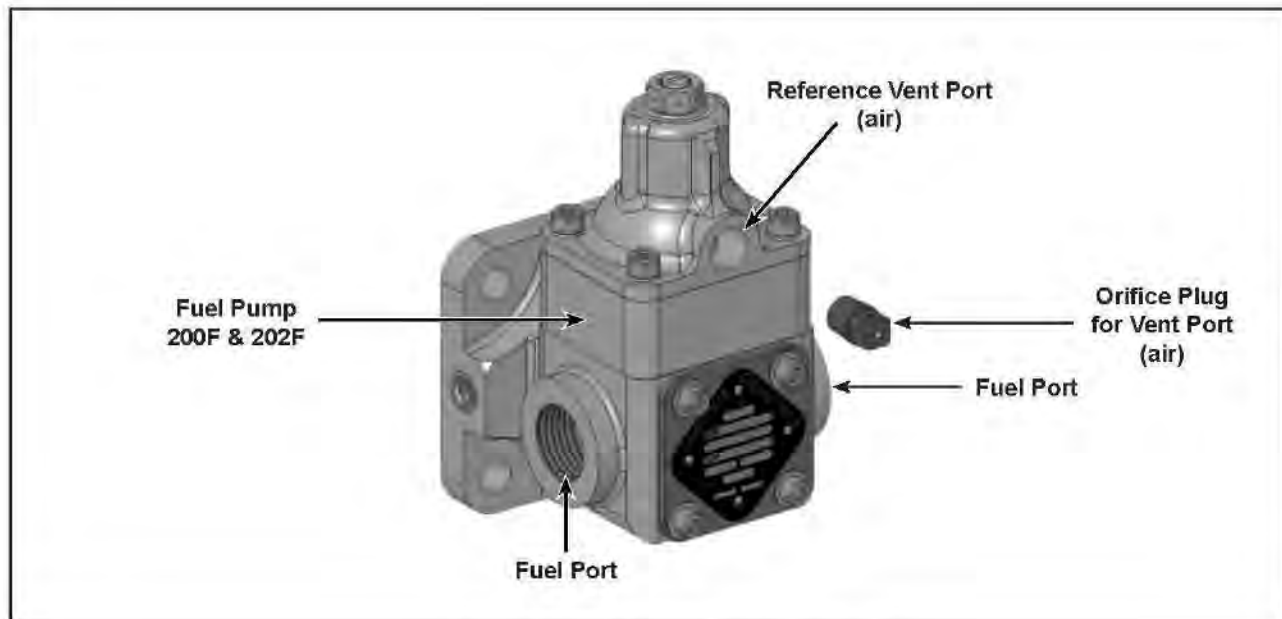
Figure 1 - 200F & 202F Identification

(a) Inspect the vent reference port and surrounding area on the exterior of affected fuel pumps for indications of fuel leakage, such as staining or wetting of the port. See Figures 1 thru 3.

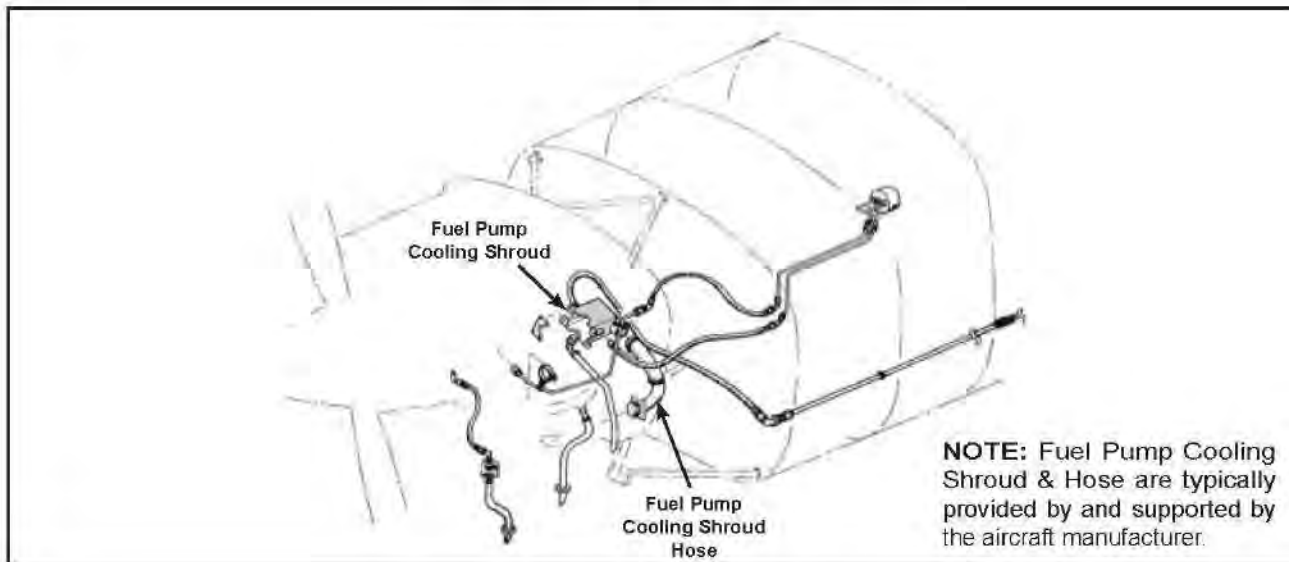
Figure 4 - Typical Cooling Shroud Installation

**NOTE:** Some engine applications will have a cooling shroud installed over the fuel pump. It may be necessary to remove this shroud for initial identification and for recurring inspection.

- (2) Inspection for fuel or blue dye stains may require use of a "Q" tip cotton swab or similar device to check for the presence of fuel or blue dye.
- (3) If fuel or blue dye stains ARE NOT found:
  - (a) Continue inspection interval in accordance with 1.E.(1)(a), Compliance, or; continue to 3.C., Corrective Action.
  - (b) Reassemble the connection for the upper deck reference or the engine turbocharger reference lines.
  - (c) If removed, reinstall the fuel pump cooling shroud and air hose (if applicable) in accordance with the latest engine/airframe service instructions or maintenance manual and continue to 3.D.(1), Return to Service. Refer to Fig. 4.
